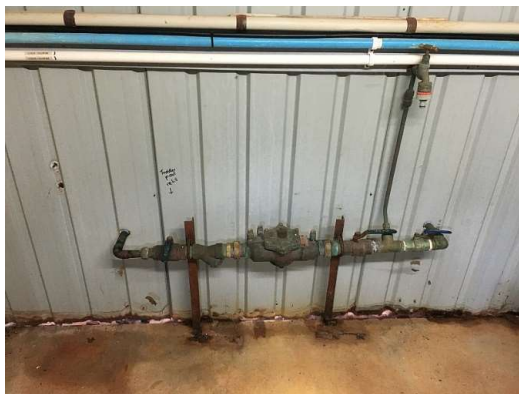
Water Supply to Pool.

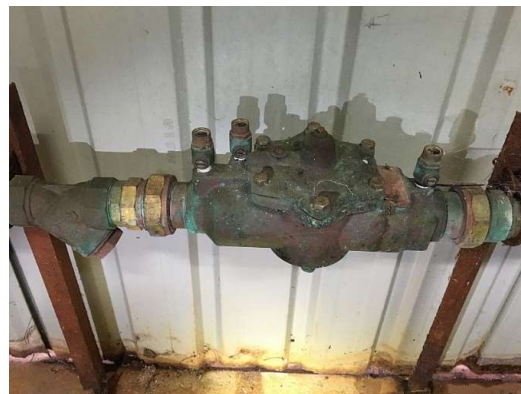
device prevents water that may become contaminated by the pool system or other activities from leaving the site and contaminating the public water main.

The backflow prevention device provided at the property boundary (the containment device), is required to be a medium hazard testable device.

Backflow Prevention Device.

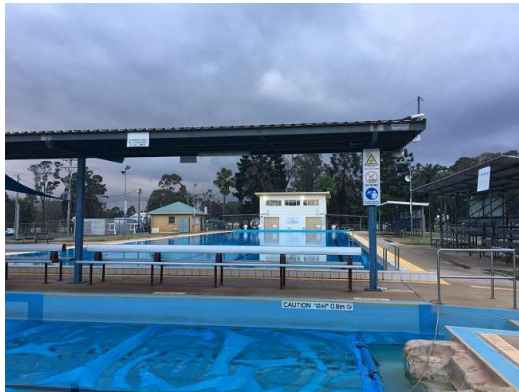
Typical Pool Signage at Concourse and Pool.

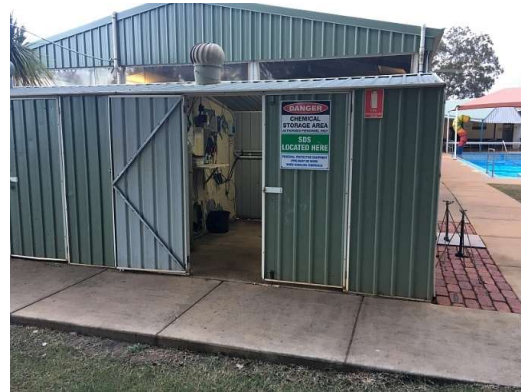
Signage and Pool Plantroom.

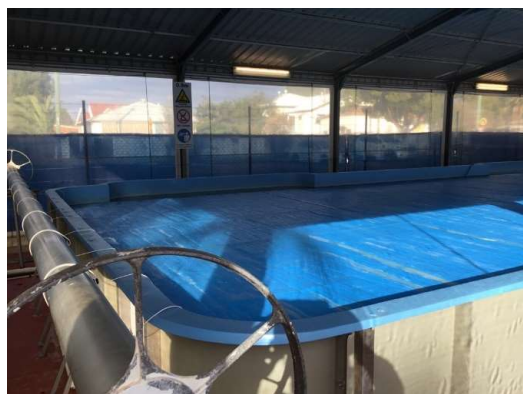
Leaks from the pool are visible at the panel joints. The pool is in a sheet metal enclosure (shed) with exposed trusses.

Existing Learn to Swim Pool.

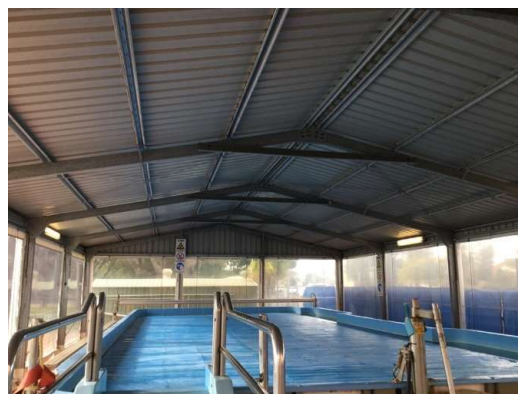
Exposed Roof Trusses.

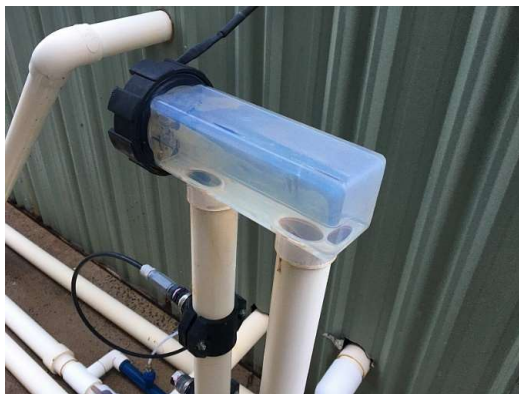
A salt chlorinator was originally used for used for disinfection. This unit has since been disconnected.

Existing Disconnected Salt Chlorinator Cell.

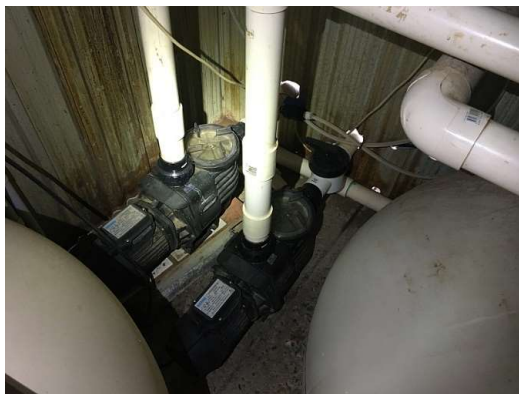
2 No. Waterco Hydrostorm 150 filtration pumps are provided. At average pressure differential to simulate filtration resistance (between clean and dirty filters), each pump is capable of approximately 4 l/s flow at 150 kPa pressure. This flow equates to a pool water treatment plant duty of approximately 28 m³/hr (both pumps operating) which provides a pool turnover rate of approximately 1.8 hours which is satisfactory depending on bather load although not compliant with the Health Guideline value of 1 hour turnover.

In order to retain the existing pool water treatment flow rate and to comply with the relevant standards, the pool bather load would need to be restricted to a maximum of 16 No. bathers.

Pool Filter Pumps.

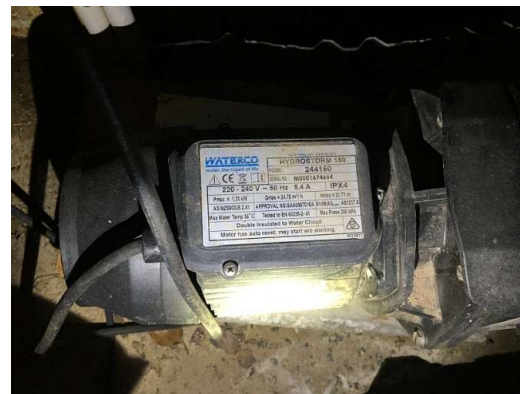
Pump Name Plate.

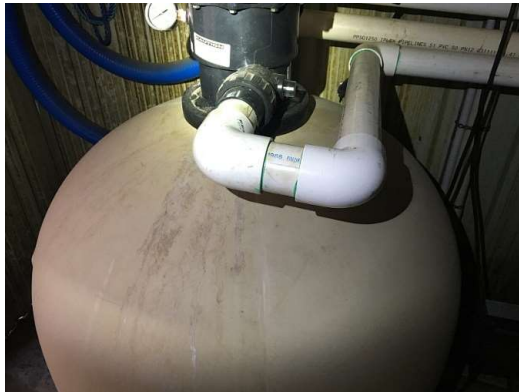
Existing Pool Filter 1 of 2.

Pool Filters.	4	3	\$167,000	Replacement of existing 2 No. pool filters including pipework connections and sand filter media change.
Chemical Truck Bund.	5	3	\$57,000	Demolition of existing hardstand area and construction of compliant truck bund with valved drain.
Pool Leaks.	4	2	\$17,000	Testing and investigation of existing sub-surface pipework and tanks. Scanning / camera / pressure testing required. Pool shell will be made watertight if pool liner option adopted. Cost for rectification of damaged pipework not known or included in costs.
Valves and pipework.	3	3	\$5,000	Replacement of existing compact ball valves. Improvement to pipe fixings (more clips).
Equipotential Bonding Testing.	0	1	\$1,500	Cost for testing. Additional costs will apply if equipotential bonding installation is required.
Total			\$576,400.00

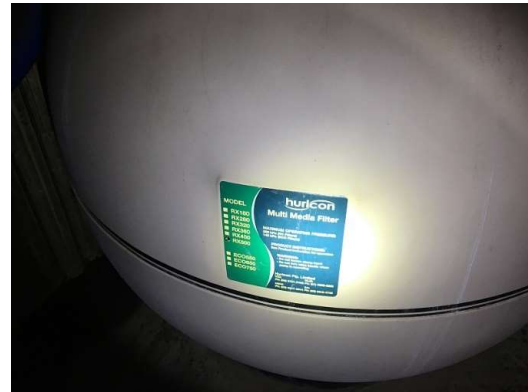
Filter Name Plate.

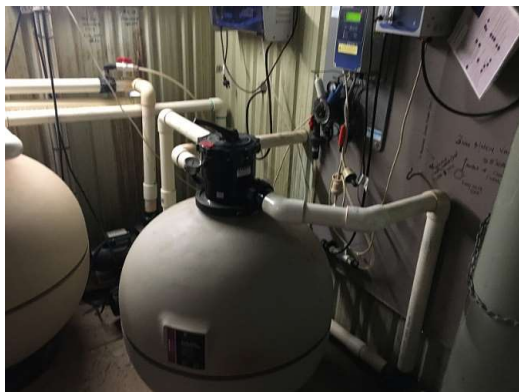
Existing Pool Filter 2 of 2.

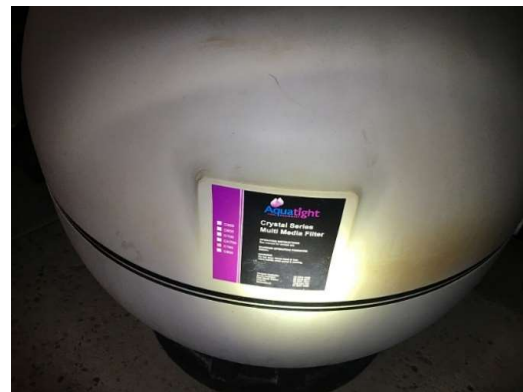
Filter Name Plate.

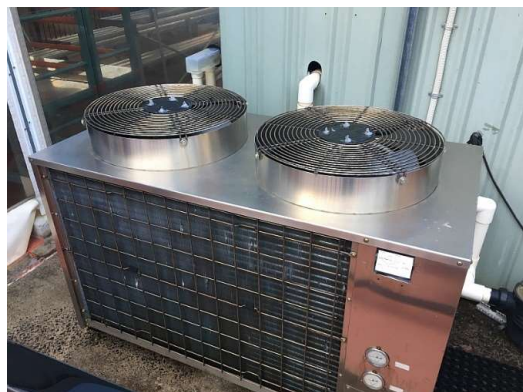
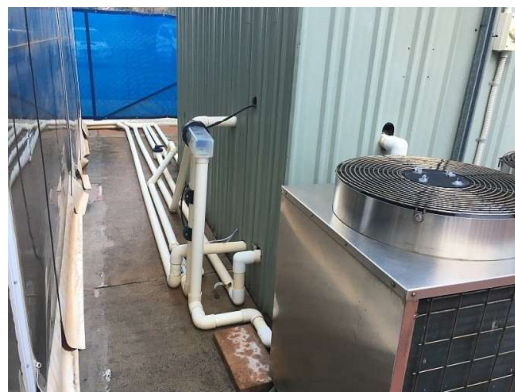
Existing Pool Heat Pump.

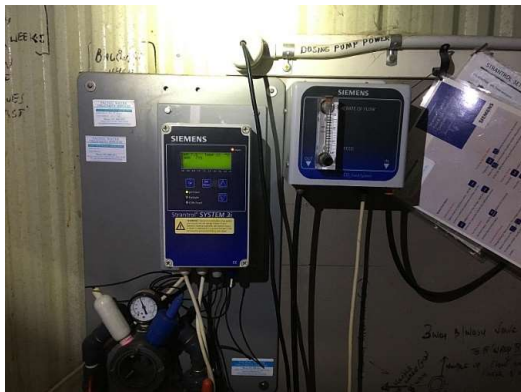
The Strontrol instrument model installed at the site is a current model which suggests that the water chemistry system has been upgraded over time.

Pool Water Chemistry Instrument (left).

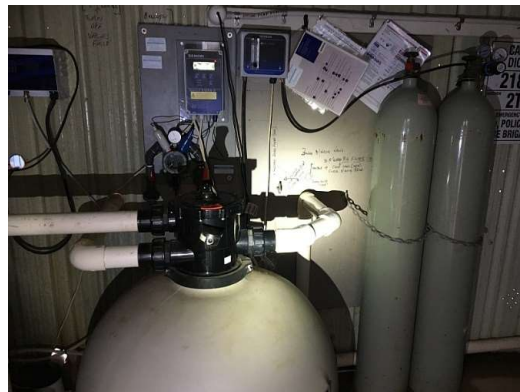
Pool Water Chemistry Dosing.
