SOUTH BURNETT
REGIONAL COUNCIL

AGENDA

Liveability Standing Committee Meeting Wednesday, 10 August 2022

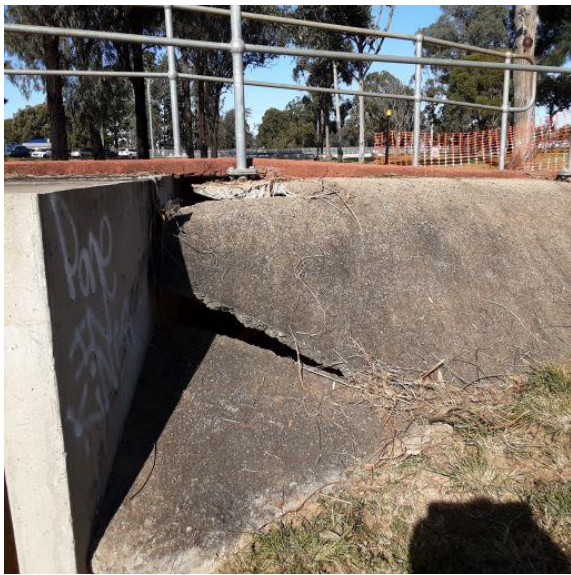
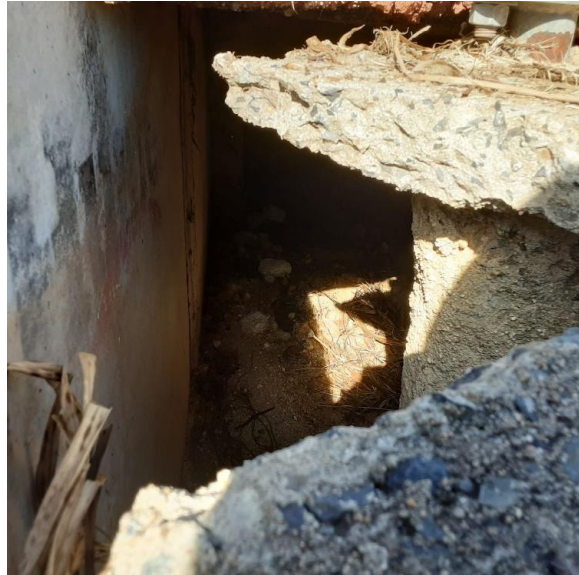
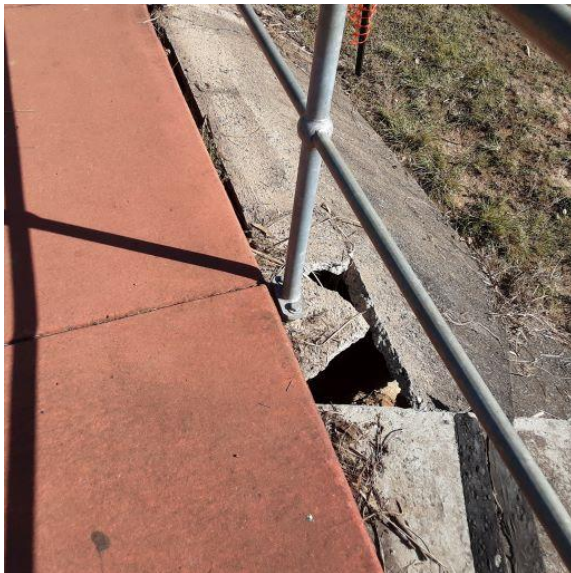
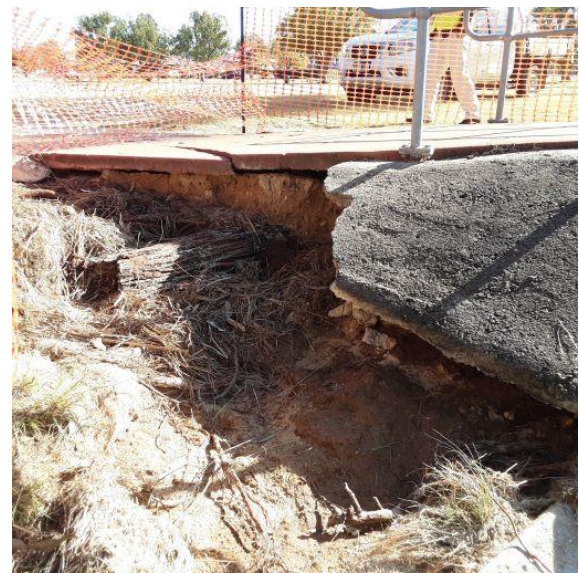
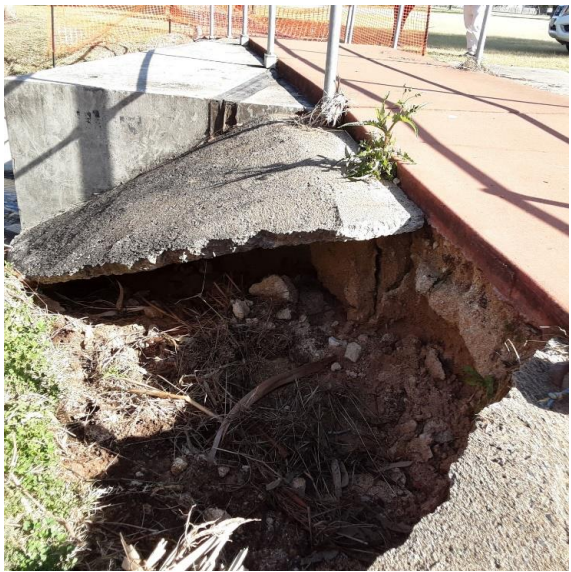
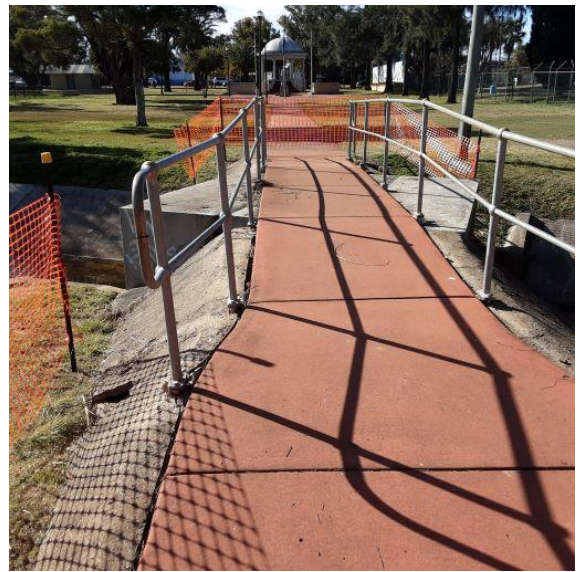
Accessed damaged to bridge damaged from weather event

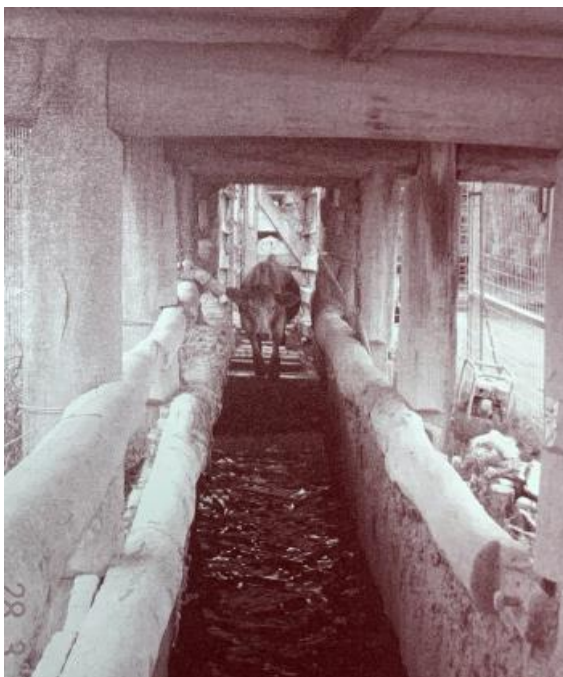
Figure 27. A heifer entering the Boondooma cattle dip, noting the unique construction of very thick layers of impervious clay bounded by hardwood slabs to create a channel. *Source:* DPI (2002, 22).

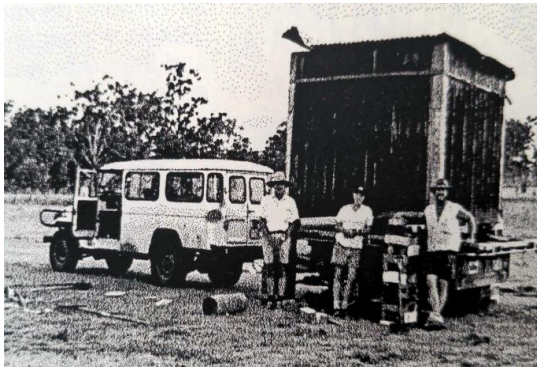
Figure 30. Lionel, Helen, and Phill pose in front of the structure known as the boundary rider's hut following its relocation to Boondooma, where it was re-stumped. *Source:* Boondooma Museum & Heritage Association (2021)⁵⁴

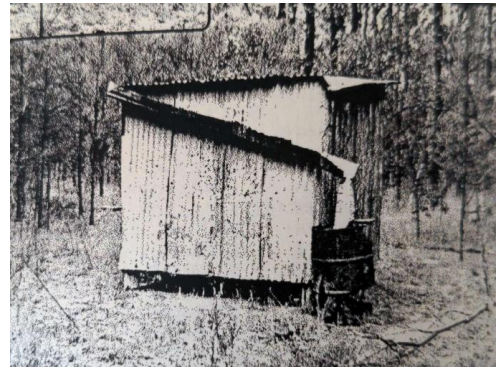
Figure 31. The structure known as the boundary rider's hut photographed in situ prior to 1999 on the property known as *Delger*. *Source:* Boondooma Museum & Heritage Association (2021)⁵⁵

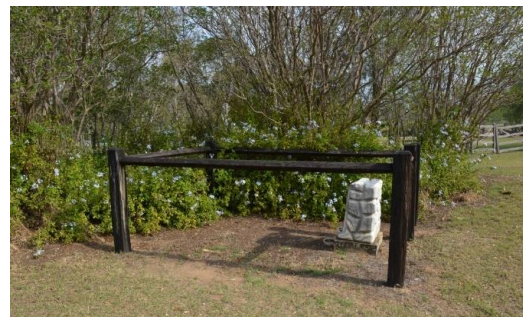
Figure 35. The marble headstone of George Munro, bounded by a simple timber enclosure, which survives in the north-eastern aspect of the homestead's garden.

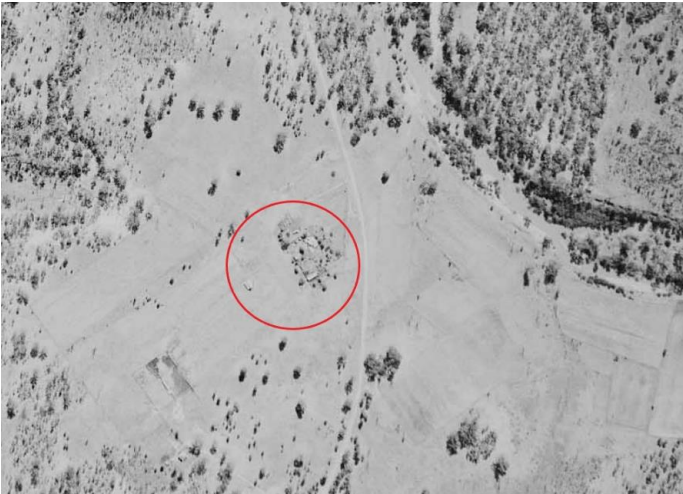
Year	Comments	Historical aerial image
1952	<p>Boondooma Homestead is positioned centrally in the property, and presents as a carefully curated complex within a rural, pastoral setting.</p> <p>The homestead complex appears to have surrounding trees and vegetation. Beyond this, the land has been cleared for grazing purposes.</p> <p>Note the stone store building, which is located a short distance to the south-west of the main homestead complex (but still within the area marked by the red circle).</p> <p>The DPI cattle dip is situated further to the south-west.</p>

<p data-bbox="635 1008 1321 1097">Figure 45. Aerial image of Boondooma Homestead (red circle) and its immediate surrounds, 1 June 1952. Image FilmWAP0281 Frame 044. <i>Source: QImagery (2021).</i></p>
1966	<p>Tracts of land surrounding the Boondooma Homestead complex appear to have been set aside and utilised for agricultural and pastoral purposes.</p> <p>A small dam has been constructed to the north-west of the complex.</p>

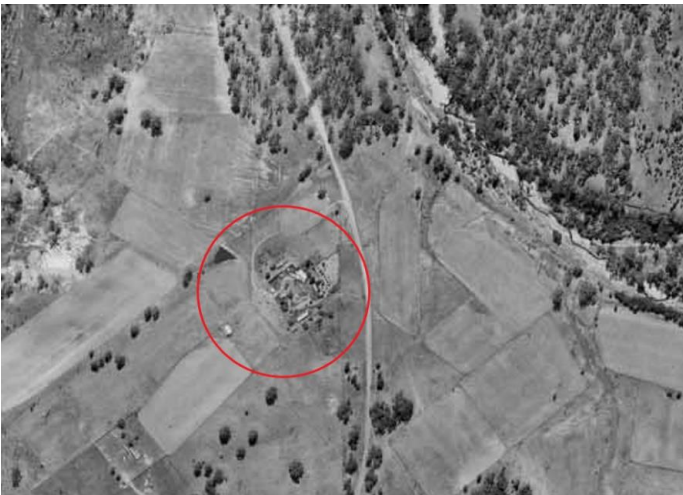
<p data-bbox="635 1724 1321 1814">Figure 46. Aerial image of Boondooma Homestead (red circle) and its immediate surrounds. 1 May 1966. Image Film QAP1684 Frame 050. <i>Source: QImagery (2021).</i></p>

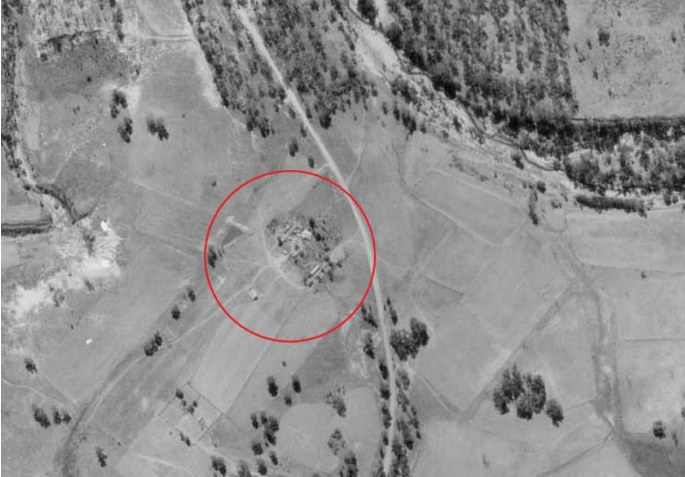
Year	Comments	Historical aerial image
1971	<p>A track is now visible between the DPI cattle dip to the south-west and the Boondooma Homestead complex.</p> <p>Several pockets of trees to the west have been removed, particularly near Boondooma Creek.</p>

<p>Figure 47. Aerial image of Boondooma Homestead (red circle) and its immediate surrounds, 1 June 1971. Image Film QAP2233 Frame 065. <i>Source: QImagery (2021).</i></p>
1984	<p>Evidence of further land clearing activities by this time.</p> <p>A new access track has been constructed connecting the Boondooma Homestead complex and Mundubbera-Durong Road.</p>

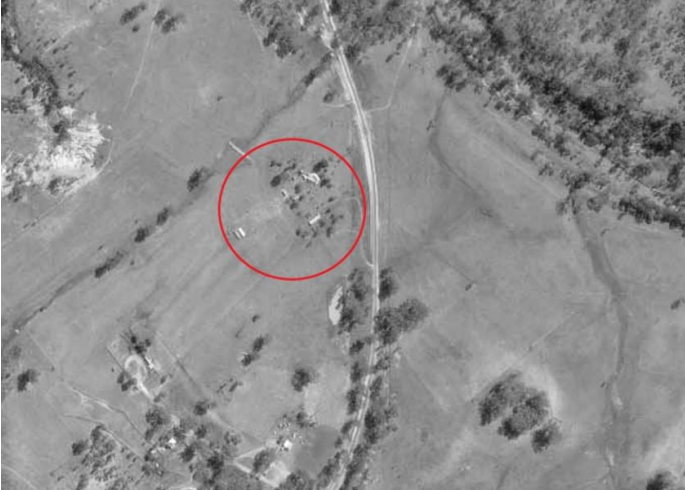
<p>Figure 48. Aerial image of Boondooma Homestead (red circle) and its immediate surrounds, 1 August 1984. Image Film QAP4306 Frame 171. <i>Source: QImagery (2021).</i></p>

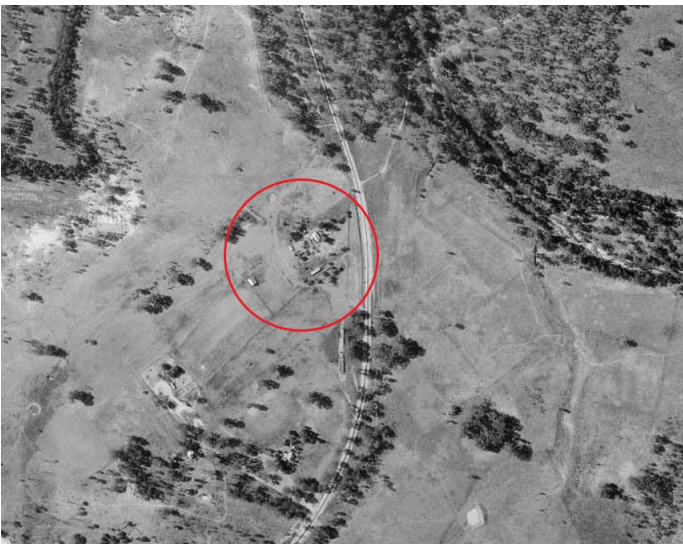
Year	Comments	Historical aerial image
1991	<p>Evidence of informal access tracks between the main section of the homestead complex and the stone store building to the south-west.</p> <p>Evidence of vegetation regrowth within the homestead complex and surrounds.</p>

<p>Figure 49. Aerial image of Boondooma and its immediate surrounds, 1 March 1991. Image Film QAP4929 Frame 157. Source: QImagery (2021).</p>
2002	<p>A caretaker's cottage has since been relocated to the Boondooma Homestead complex.</p> <p>A number of additional structures have since been constructed including the 'Big Top' entertainment area, archives building and museum building, all within the area between the stone store building and the main homestead.</p>

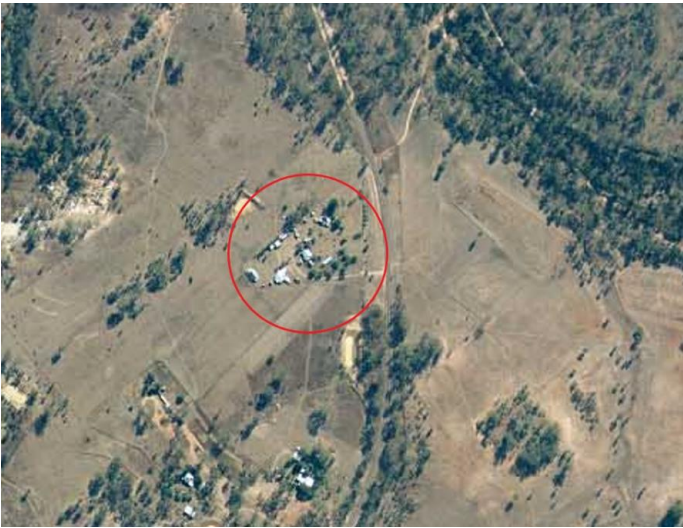
<p>Figure 50. Aerial image of Boondooma and its immediate surrounds, 1 July 2002. Image Film QAP6010 Frame 048. Source: QImagery (2021).</p>

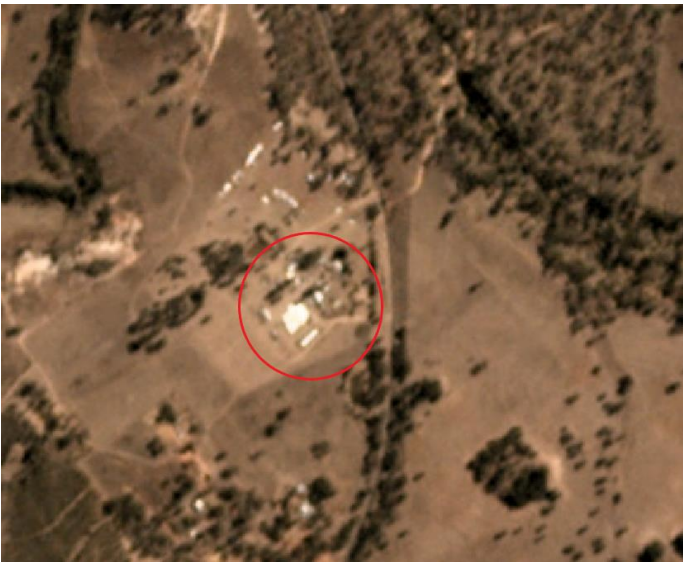
Year	Comments	Historical aerial image
2017	<p>At the time this image was captured, caravans are visible parking on the Boondooma property.</p> <p>An accommodation block has been constructed to the south of the 'Big Top' area, and an extension to latter has also been constructed.</p> <p>An access road has been constructed to the north.</p> <p>Vegetation has been planted along Mundubbera-Durong Road has been planted.</p>

<p>Figure 51. Aerial image of Boondooma and its immediate surrounds, 1 July 2017. Image L16-7538E-3477N. Source: QImagery (2021).</p>

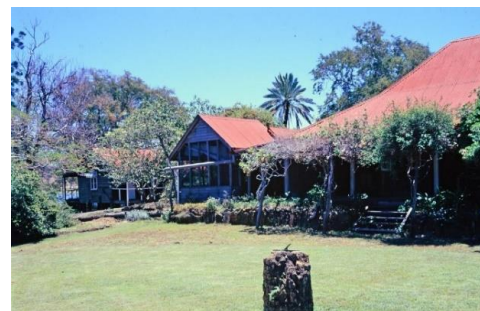
Figure 54. The main elevation of the Gracemere Homestead set within landscaped grounds. *Source:* Queensland Government (2016d).

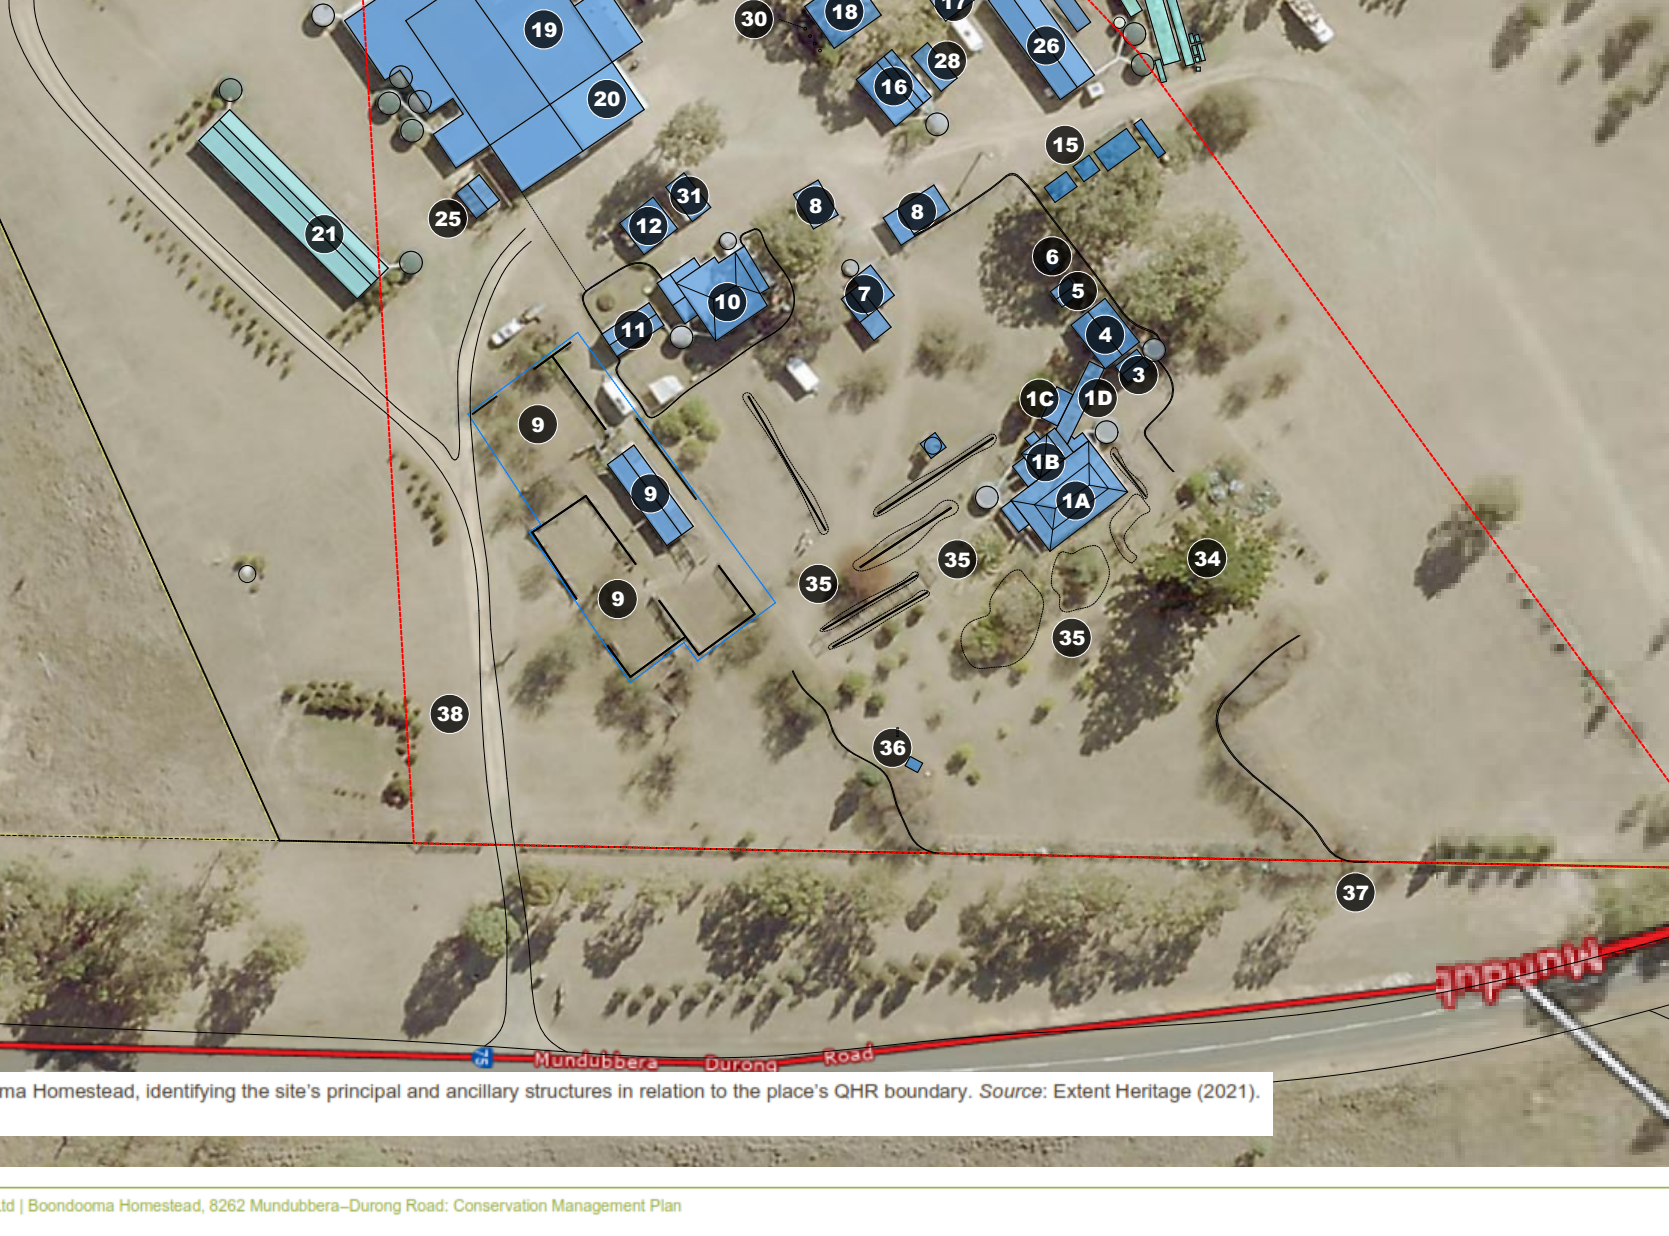
A number of other structures are arranged according to their functional relationship to one another in the intervening space between the main homestead and the stone store building. These buildings and structures are either of contemporary construction or have been relocated from other pastoral properties to Boondooma over the years as part of its operations as a heritage tourism destination. This includes: the 'Big Top' entertainment area and extension; toilet and accommodation blocks, an ablution block, the archives, museum, and administration buildings; toilets; a camp kitchen; a caretaker's cottage and store; a camp kitchen; a large shed; and administration, museum, and archives buildings.

- 12 Caravan store
 - 13 Brownies' hut
 - 14 DPI shelter
 - 15 Boundary riders' hut
 - 16 Chicken coop and timber outhouses
 - 17 Administration building
 - 18 Archives
 - 19 Museum
 - 20 'Big Top' entertainment area and extension
 - 21 'Big Top' extension
 - 22 Accommodation block
 - 23 Camp kitchen
 - 24 Machinery shed (former)
 - 25 Blacksmith (former)
 - 26 Toilet blocks
 - 27 Contemporary shed
 - 28 Dam
 - 29 Demountable amenities
 - 30 Covered servery
 - 31 ANZAC memorial and flagpole
 - 32 Carport
 - 33 Cattle loading ramp
 - 34 Caravan parking
 - 35 Hoop pine
 - 36 Landscaped garden area
 - 37 George Munro's grave
 - 38 Potential former entrance
 - 39 Main vehicle entrance
- - - Queensland Heritage Register Boundary
Boondooma Homestead (600967)
 - - - Lot Boundary
 - Items located inside the QHR boundary
 - Items located outside of QHR Boundary

Figure 55. Existing aerial view site plan for Boondooma Homestead, identifying the site's principal and ancillary structures in relation to the place's QHR boundary. Source: Extent Heritage (2021).

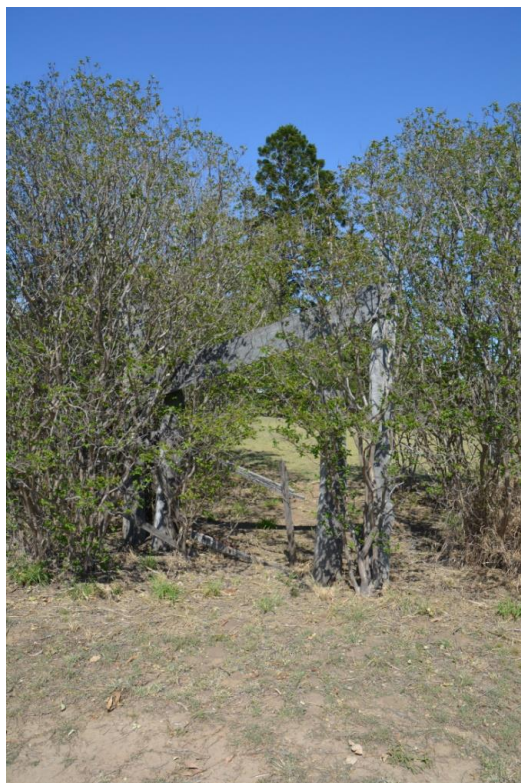
Positioned in line with the main elevation of the Boondooma Homestead, along the eastern boundary fence, is a potential former entrance comprising two dilapidated timber posts with entrance. a timber board that has partially collapsed across the entrance way. The posts and entrance way is overgrown with vegetation. It is possible that the collapsed timber board may have had signage attached originally.

It is possible that these timber posts may be the remnants of a former, earlier entrance to the main homestead, which is located in a direct line approximately 60 m to the front steps of the main homestead. This gate and entrance is a poor condition, is not easily accessed and is not in use; however, it is noted that it faces and aligns with the main elevation of the homestead, appearing to lead from the present-day road to the property.

Figure 78. The potential former entrance facing west towards the main homestead of the.

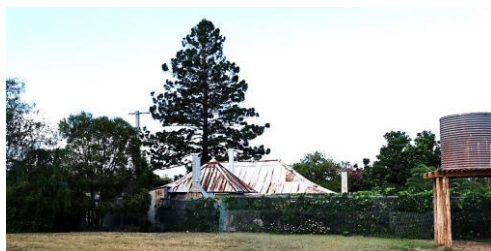
Figure 80. The south-west (rear) elevation of the main homestead.

Note the pyramid roof profile of the detached kitchen.

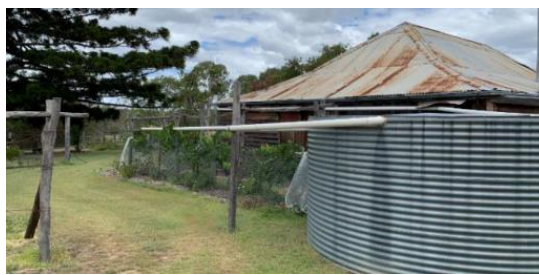
Figure 83. The north-west elevation of the main homestead.

Note the long-ridge hipped roof with 'broken back' profile, clad in corrugated galvanised iron and the ad-hoc configuration of the rainwater goods.

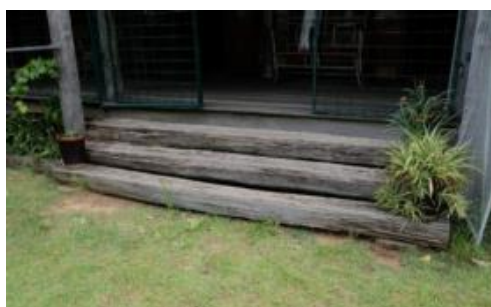
Figure 84. The timber entrance steps providing access to the front verandah of the homestead.

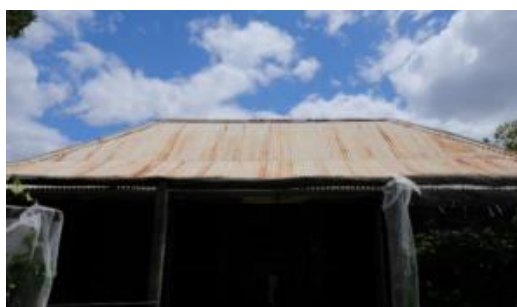
Figure 85. The north-east (front) elevation of the main homestead, showing the long-ridge hipped roof, clad in corrugated galvanised iron.

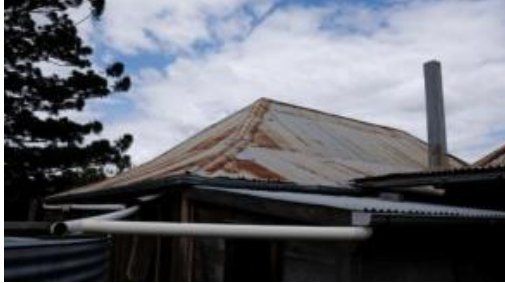
Figure 86. View facing north-east showing the 'broken back' roof profile of the main homestead, and the skillion-roof of one of the small extensions.

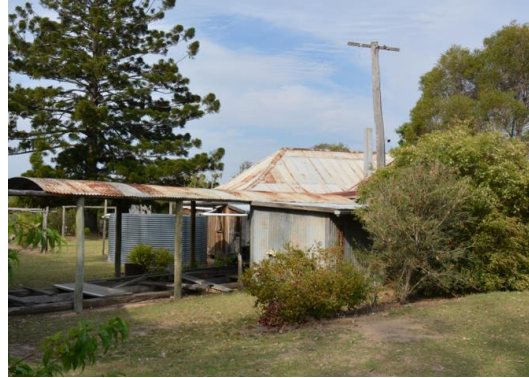
Figure 87. View facing north-east showing covered walkway, constructed of a post-and-sapling frame with a corrugated iron roof, connected to the main homestead.

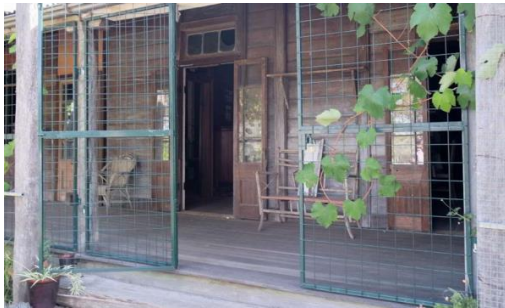
Figure 88. The front verandah of the main homestead, showing the modern, powder-coat steel, grid-mesh screening that encloses the verandah for security purposes.

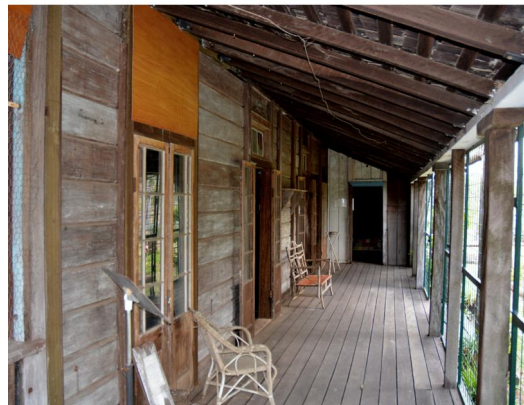
Figure 89. View along the front verandah of the main homestead, showing the French timber doors providing access to the core internal rooms (left) and the bedroom created by the enclosure of the verandah at its western end.

Note the original timber shingles surviving under the verandah roof.

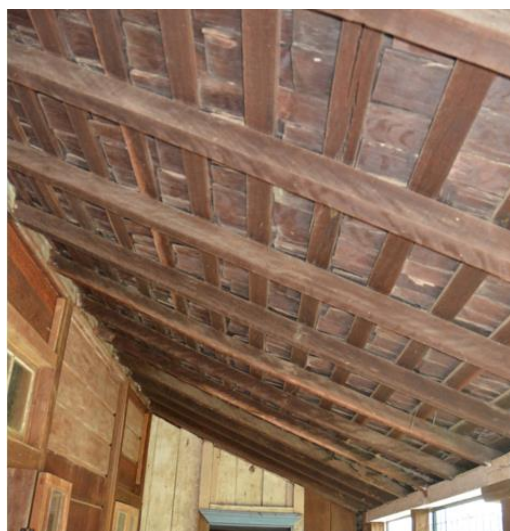
Figure 90. The underside of a section of the front verandah roof, showing the early timber shingles.

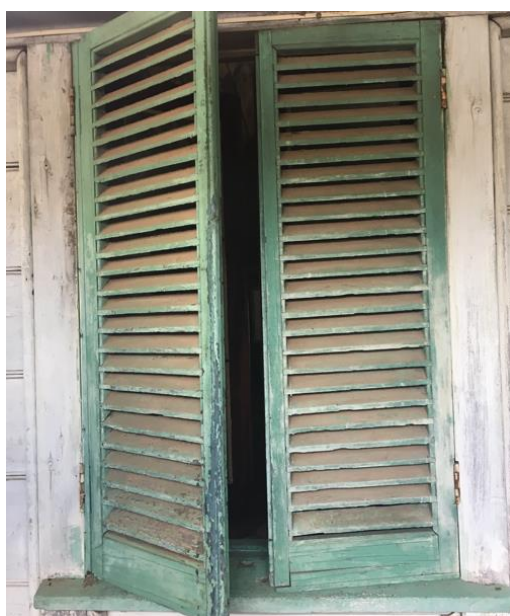
Figure 92. Example of the homestead's timber-framed windows with fixed-louvre shutters.

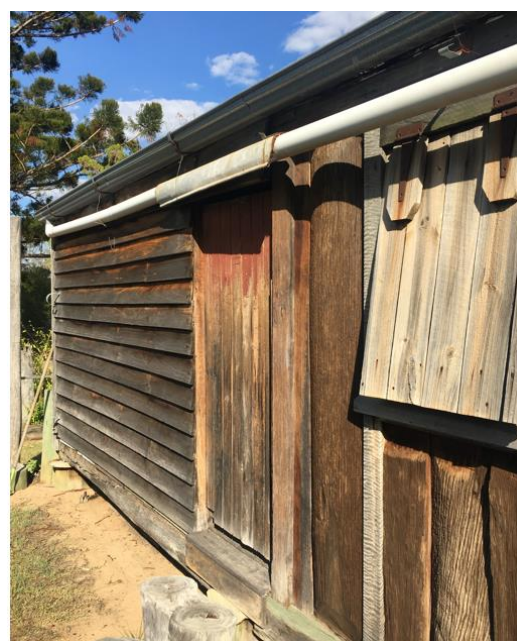
Figure 93. Detail of the external wall of the homestead's north-west elevation, illustrating the use of a variety of materials including unpainted weatherboards, fixed horizontally, and wide chamber boards, fitted vertically.

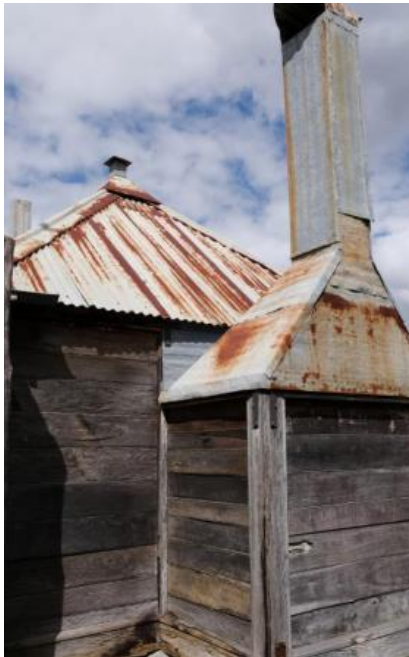
Figure 94. Rear of the detached kitchen on the south-west elevation of the main homestead, showing the pyramid roof profile and galvanised metal-clad chimney.

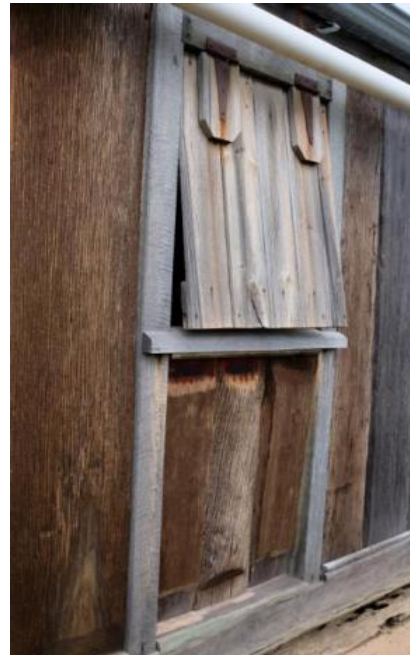
Figure 95. Example of the reconstructed timber window awnings fitted to window openings on the homestead's north-west elevation.

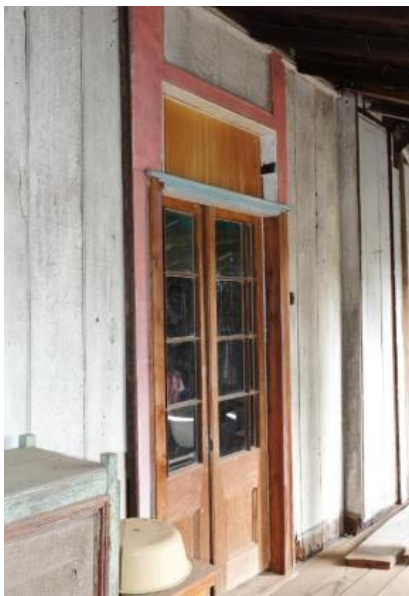
Figure 96. Example of the timber French doors leading from the main bedroom onto the rear verandah, noting the infilled fanlight.

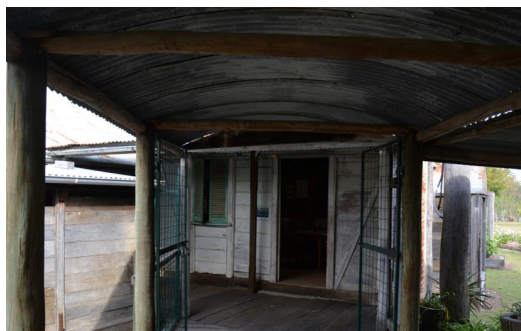
Figure 98. View from underneath the covered walkway facing towards the detached kitchen of the main homestead.

Note the walkway's barrel-vaulted sprung roof.

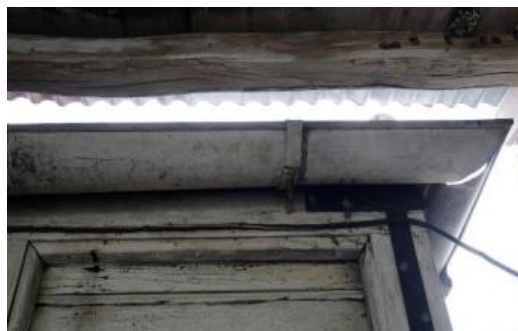
Figure 99. Detail of the half round gutters surviving attached to the northern wall of the homestead's detached kitchen.

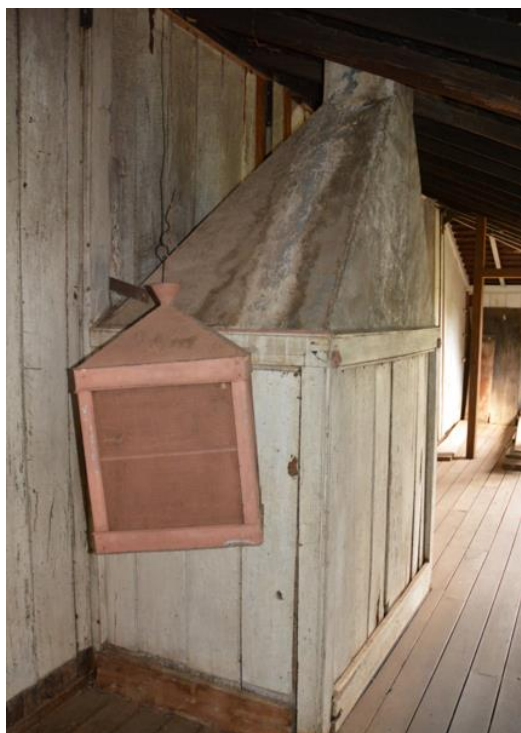
Figure 100. Detail of the exterior of the dining room fireplace, which projects into the verandah space on the south-west of the homestead.

Note the lower half is clad in wide, vertical timber boards, and the upper half is clad in sheet steel up to the chimney stack.

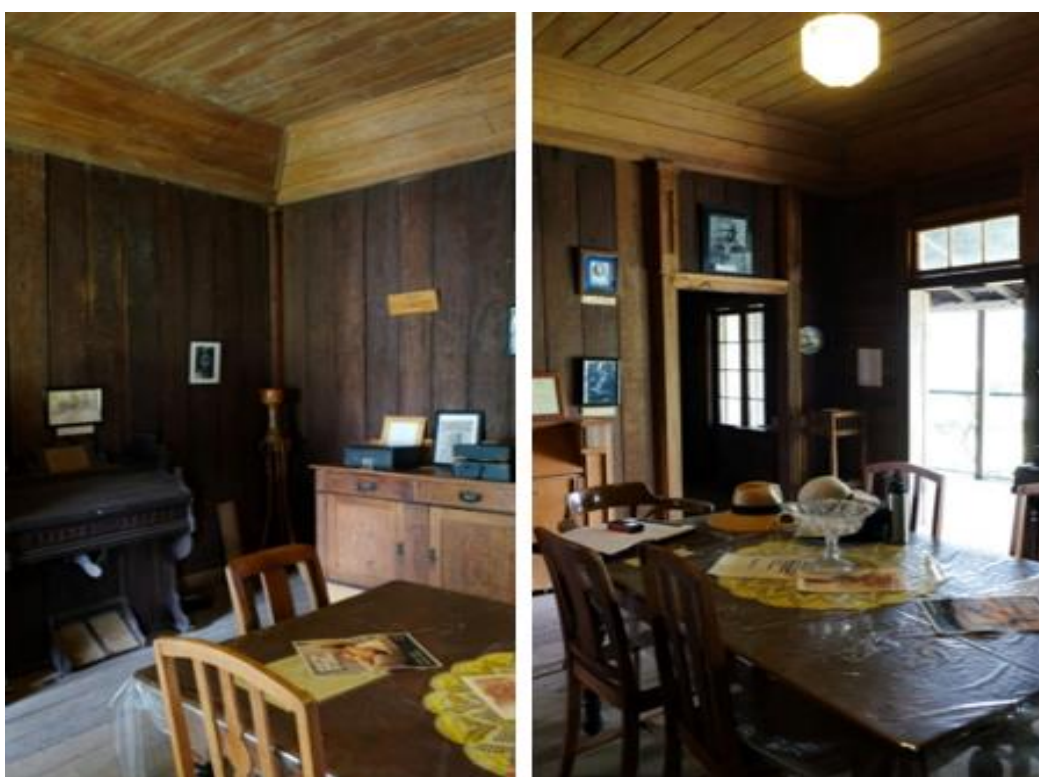
Figure 102. *Left and Right:* Interior of the main homestead's dining room.

Note the finely detailed timber joinery in this main section of the house, and the contrast between the dark hardwood timber used for the internal walls compared to the lighter milled timber used to line the ceiling. The early paint/lime wash finish on the ceilings is no longer extant.

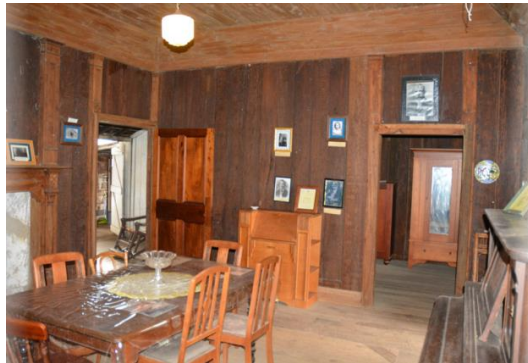
Figure 103. Interior of the main homestead's central dining room.

The door at the right leads to Bedroom 2, and the door at the left leads to the rear, semi-enclosed verandah and detached kitchen.

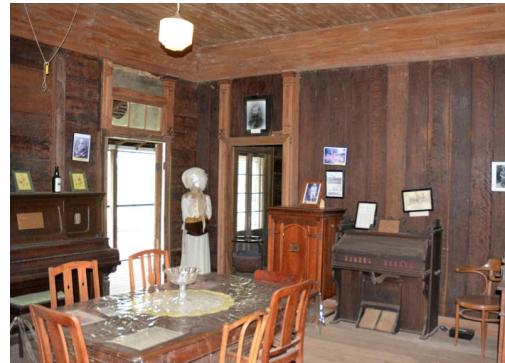
Figure 104. Interior of the main homestead's central dining room.

Note the internal walls of dark hardwood, rough-hewn slabs, fitted vertically. The door to the right of the mannequin leads to Bedroom 1.

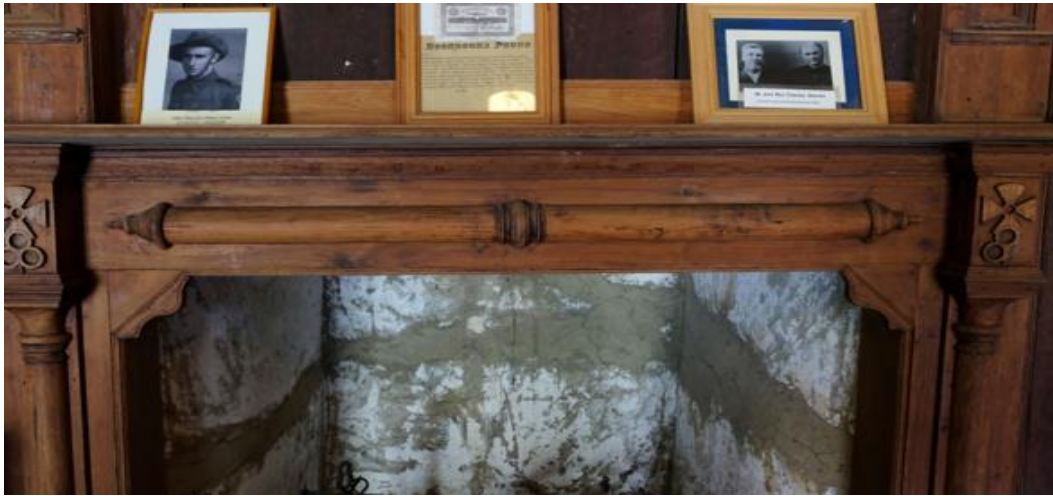
Figure 107. Detail of the timber mantelpiece of the dining room fireplace in the main homestead.

Note the finely-detailed timber joinery and mouldings. The early shellack and wax finish of the mantelpiece has been removed.

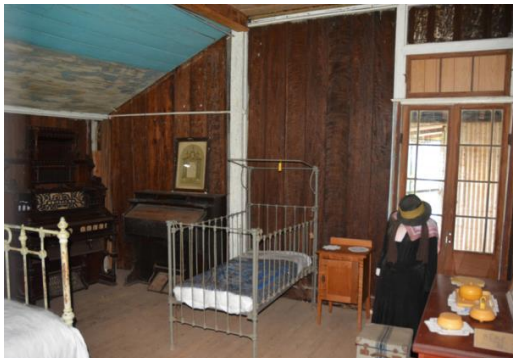
Figure 108. Interior of Bedroom 1, the main bedroom in the homestead.

Note the low-pitched ceiling, partly painted, falling from the beam that may once have contained a wall. Some of the timber framing elements are also painted.

Bedroom 1 may have been extended at some point, and opens through to include a section of verandah area. This is evident in the low-pitched ceiling, partly painted, falling from the beam that may once have contained a wall. The wall under the low side of the ceiling has a doorway that accesses the small additional room, which is considered to have been used as a nursery. A reconstruction clad in galvanised iron sheet replicates a fireplace adjacent to the nursery door. Some framing elements are painted and remnants of wall paper are found above the doorway leading to the dining room. The room is fitted with period furniture. The room has a four-panel timber door to the dining room and French doors open to the front and rear verandah.

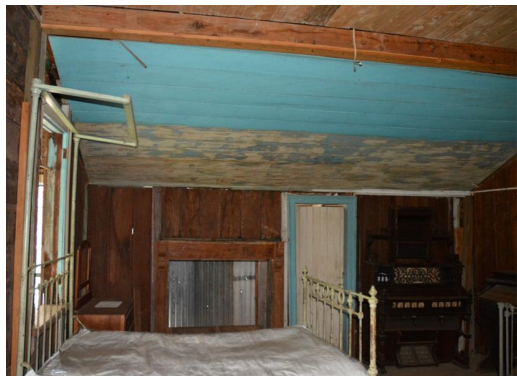
Figure 110. Interior of Bedroom 1 showing the wall under the low side of the ceiling with a small timber slab door that accesses an additional room, which is considered to have been used as a nursery.

Note the reconstruction clad in galvanised iron sheet that replicates a fireplace, adjacent to the nursery door.

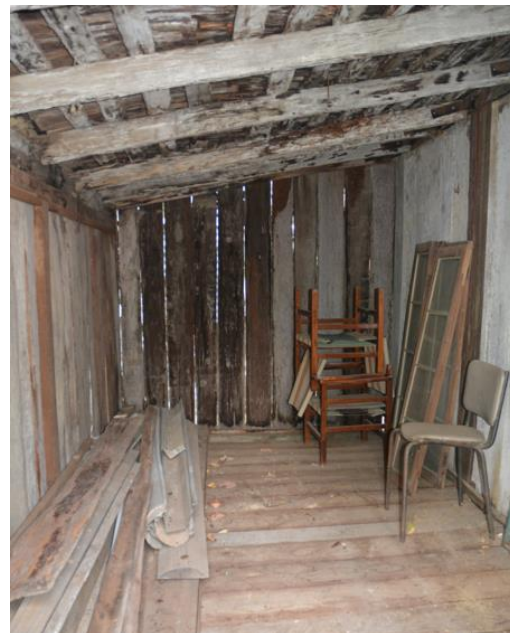
Figure 111. Interior of the addition to the eastern wall of Bedroom 1, which is considered to be a former nursery area.

This former nursery room is in a partly-repaired condition, with a reconstructed floor and surviving timber framing and shingles (albeit dilapidated).

The former nursery adjoining Bedroom 1 is in a partly-repaired condition, with a reconstructed floor. However, the roof, framing, and surviving shingles are dilapidated and in danger of collapsing. The small room may have once been painted; however, there is little evidence of any surviving internal linings or finishes. The small door leading to Bedroom 1 is constructed with beaded boards in a rough-ledged and braced panel.

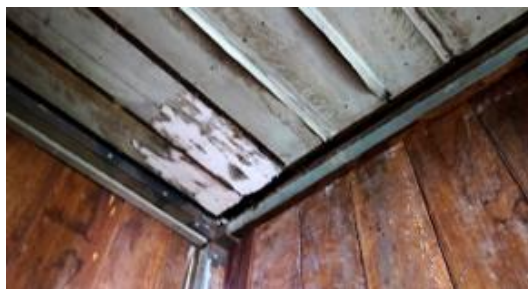
Figure 112. Detail of the north-west corner of the ceiling in Bedroom 2, showing water penetration affecting the ceiling, and movement at wall and ceiling junction.

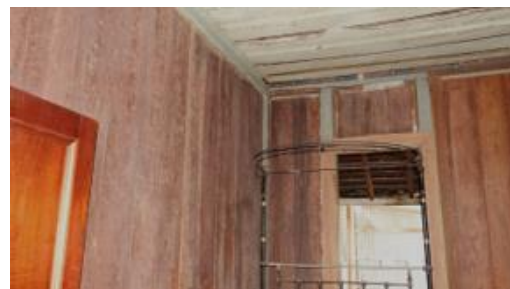
Figure 113. The south-east corner of Bedroom 2, which is showing evidence of water penetration affecting the timber ceiling fabric.

Bedroom 2 is constructed and finished in a similar manner to the dining room: a sash window opens to the rear verandah, and a French door opens to the front verandah. The four-panel door through to the dining room is restored; however, significant water damage is evident, with calico ceiling linings becoming dilapidated. Substantial movement at the north-west corner is also evident.

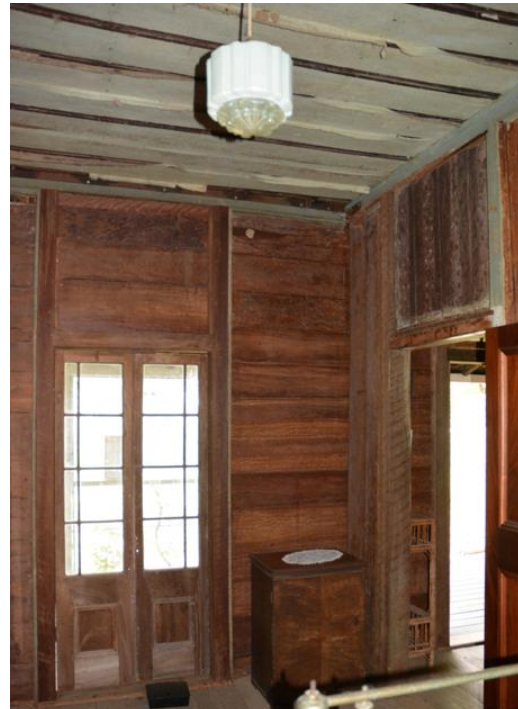
Figure 115. Interior of Bedroom 2.
Note the French door opening to the front verandah and the dilapidation of the calico ceiling lining.

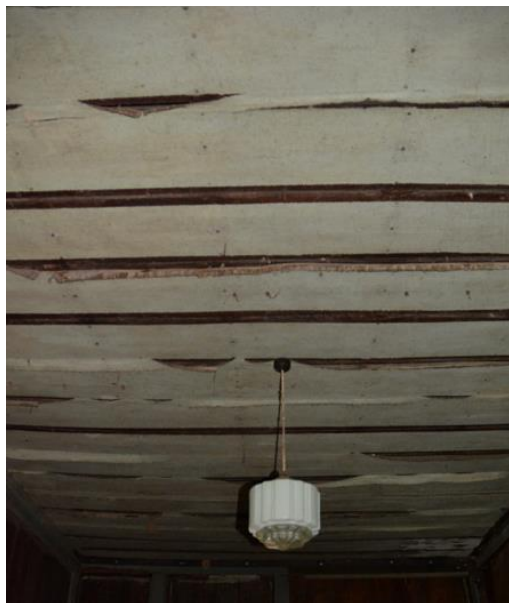
Figure 116. Detail of the dilapidated calico ceiling lining in Bedroom 2.

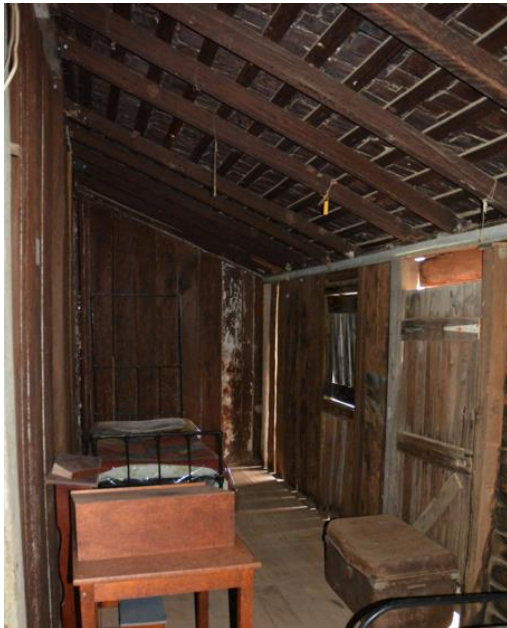
Figure 118. Interior of Bedroom 3, showing the surviving roof shingles fixed under the roof sheet.

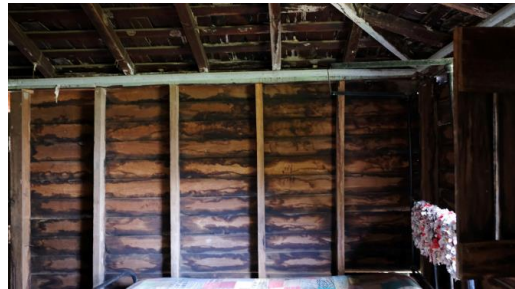
Figure 119. Interior of Bedroom 3 showing the single-skin construction framing exposed in this room.

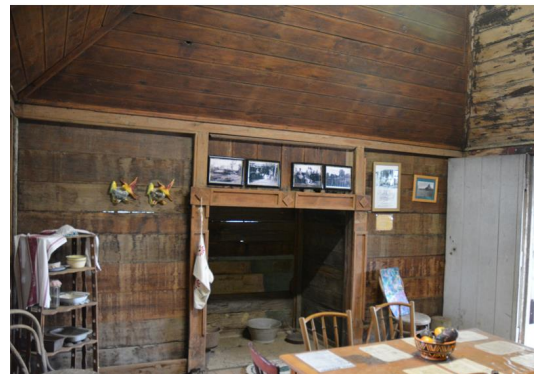
Figure 123. Interior of the detached kitchen, showing the fireplace recess with simple timber mouldings fixed at the joints with the framing.

In the detached kitchen, the walls are unlined and the single-skin construction framing is exposed. The boards are painted, and simple mouldings are fixed at the joints with the framing. The stove recess is lined with corrugated iron. Its pyramid ceiling profile is lined on the rake with unpainted, horizontal timber boards.

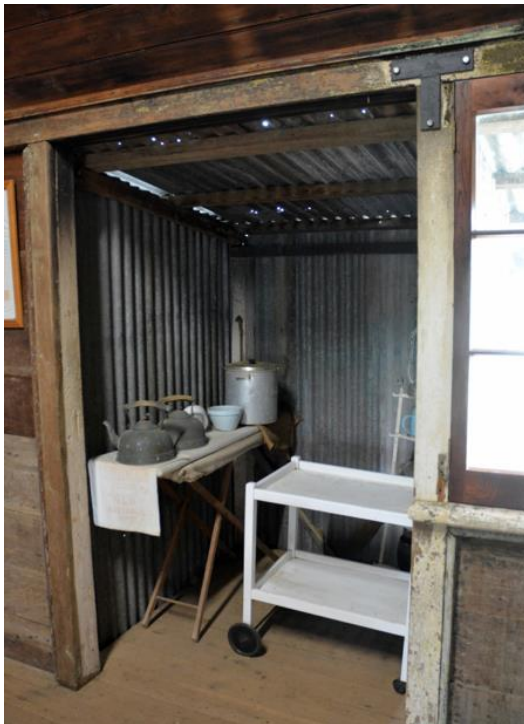
Figure 124. The kitchen stove recess, lined with corrugated iron contained with a skillion-roof addition.

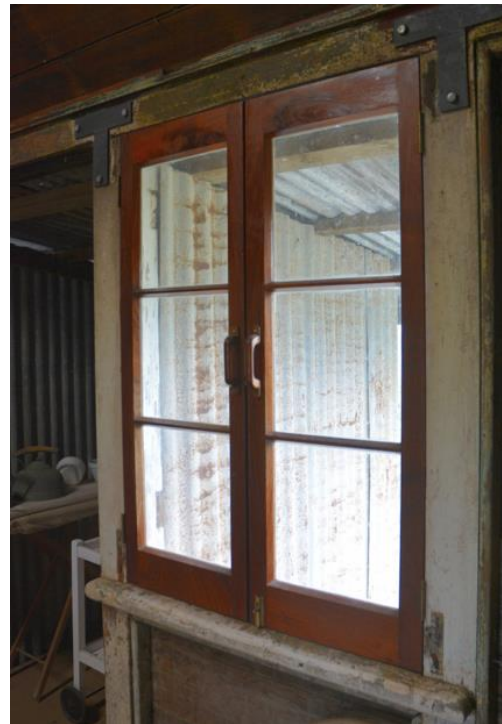
Figure 125. Example of the replacement timber casement windows in the kitchen, which are non-sympathetic additions.

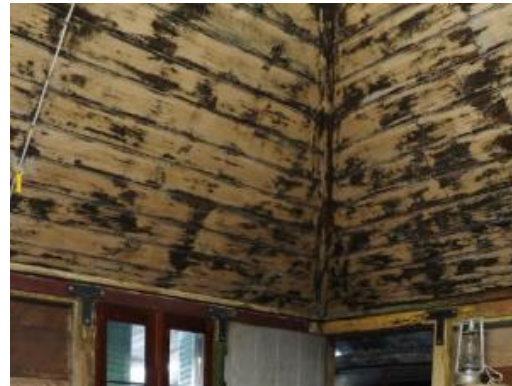
Figure 127. Detail of the ceiling of the detached kitchen, lined on the rake with unpainted, horizontally-fixed beaded boards.

Note the boards show evidence of being smoke or fire affected.

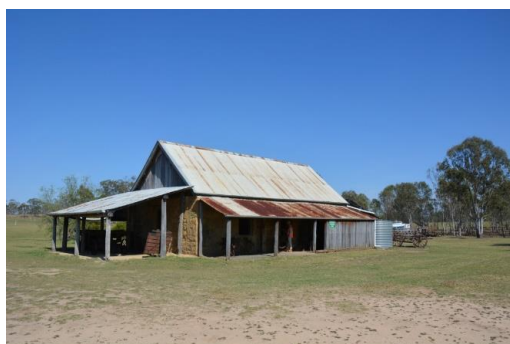
Figure 131. The north-east elevation of the stone store building.

Note the lean-to verandah additions, constructed of post-and-sapling frames with a corrugated iron sheeting roof, on all sides.

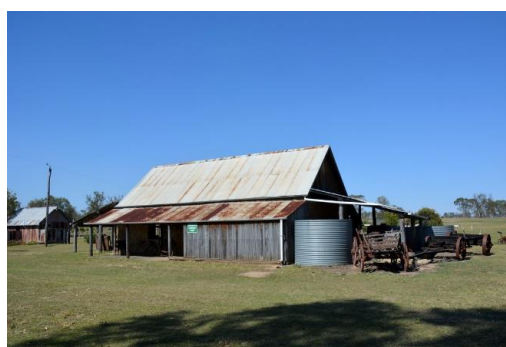
Figure 134. View facing south-west of the stone store building.

Note the verandah addition has been enclosed with vertical timber slabs on the western end of its northern façade, and on its short western façade.

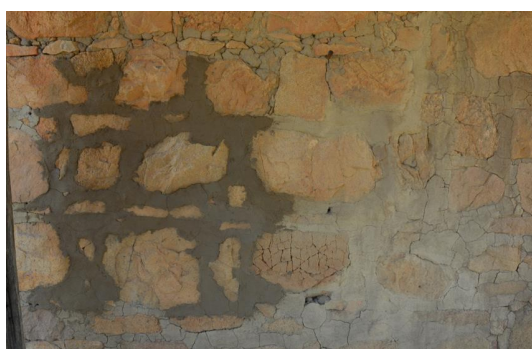
Figure 139. Detail of a section of re-pointed stonework utilising the incorrect mortar mix, as part of previous restoration works.

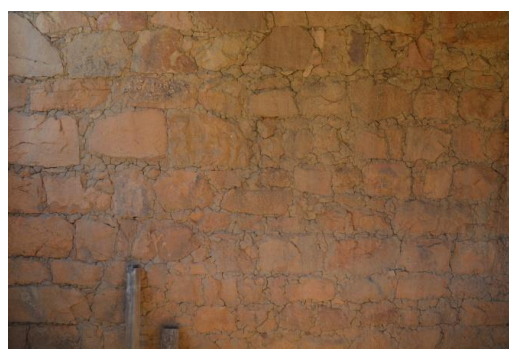
Figure 140. Detail of the typical stonework held together with ant bed mortar.

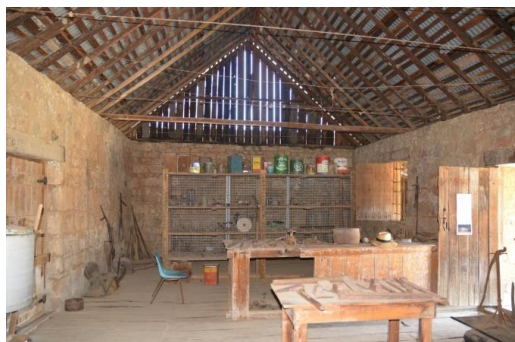
Figure 141. Interior of the north-west end of the stone store.
Note the exposed timber rafters and roof framing.

Internally, the building is rectangular in plan and features no internal walls or partitions, although paint on the stonework may be indicative of previous partitioning. The stone walls are unlined. The timber rafters and roof framing are exposed and the battening from the original shingle roof is still visible. A number of ironbark roof ties are also in place. The floor is constructed of wide, hardwood shot-edge boards atop timber joists and bearers, which were restored and reconstructed in the early 2000s.

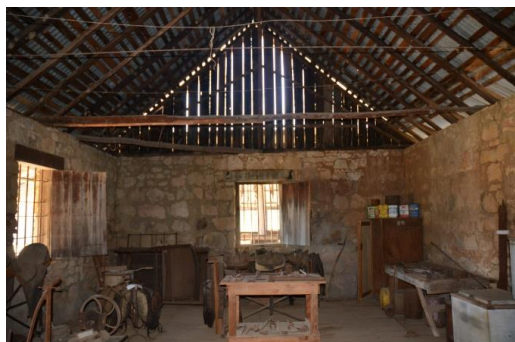
Figure 143. Interior of south-east end of the stone store.
Note the two windows with vertical iron bars and timber shutters.

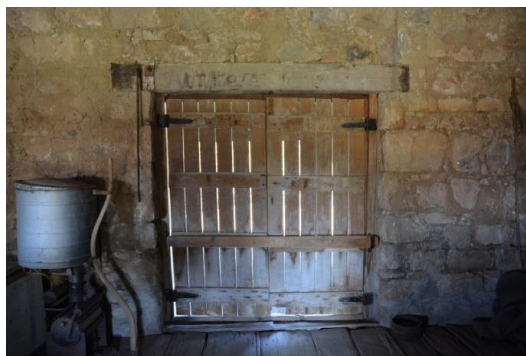
Figure 144. Detail of the timber double doors, which provide access to the stone store.

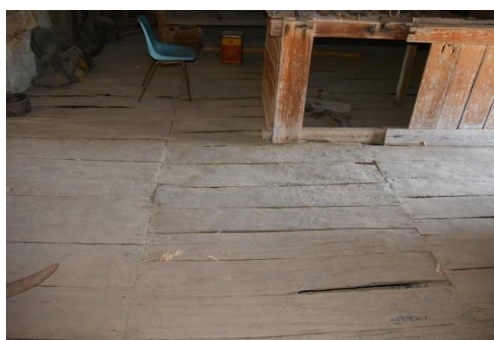
Figure 146. Interior view of hardwood shot-edge boards of the Stone Store.
