SOUTH BURNETT
REGIONAL COUNCIL

AGENDA

Liveability Standing Committee Meeting Wednesday, 10 August 2022

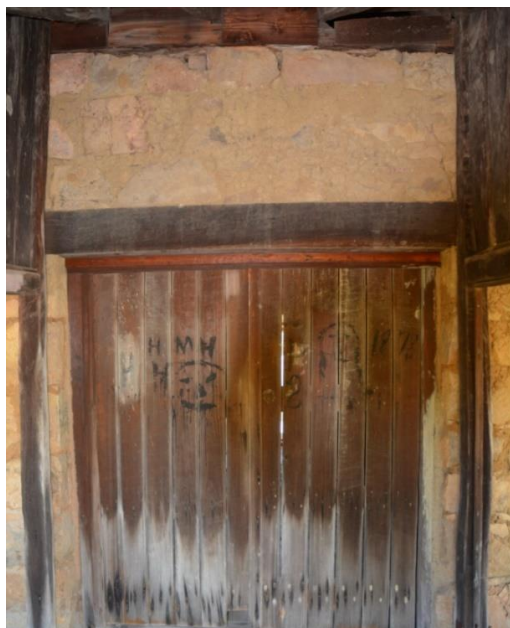
Figure 147. Exterior view of the store's double entrance doors.

Note here how the stonework continues to the underside of the main roof.

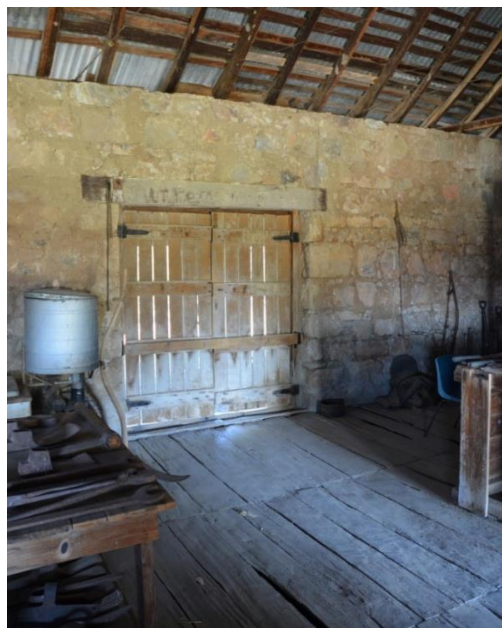
Figure 148. Interior view of the south-west wall of the stone store, showing the floor constructed of wide, hardwood shot-edge boards atop timber joists and bearers, which were restored and reconstructed in the early 2000s.

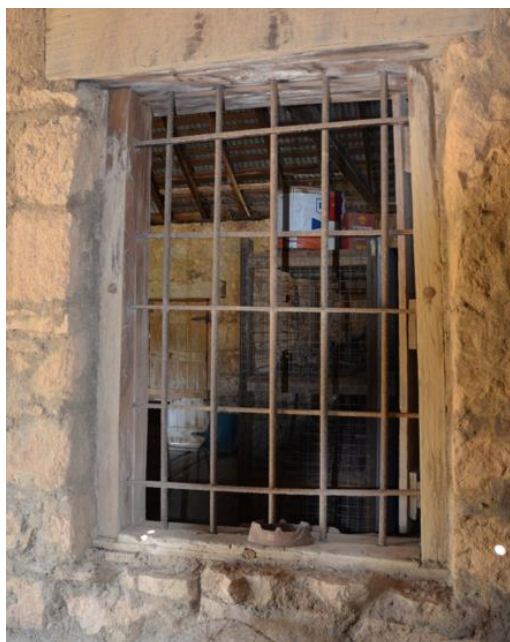
Figure 149. Detail of a typical window with timber lintels and frames and iron bars.

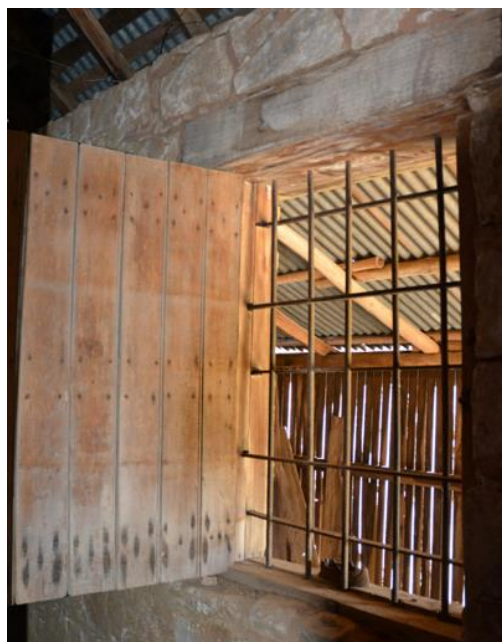
Figure 150. Detail of a typical window shutter made of vertical timber slabs.

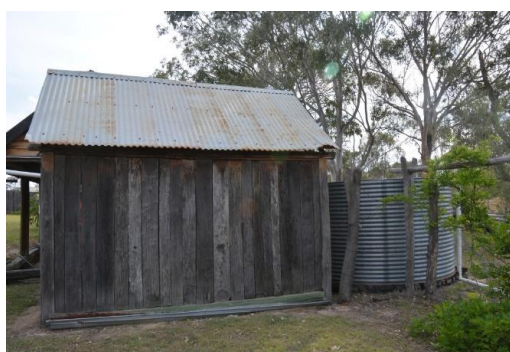
Figure 151. The north-east elevation of the meat house with a large water tank adjacent.

Note the timber slab and bed log construction and gable roof clad in corrugated iron.

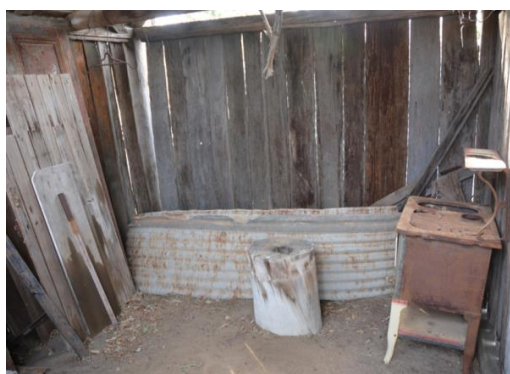
Figure 153. Interior of the meat house.

Note the rusted stove and pieces of timber currently stored inside.

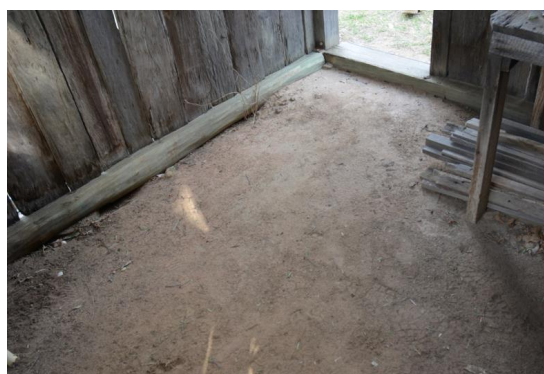
Figure 154. Interior of the meat house showing the compacted earth floor.

Note the bed logs, which are replacements.

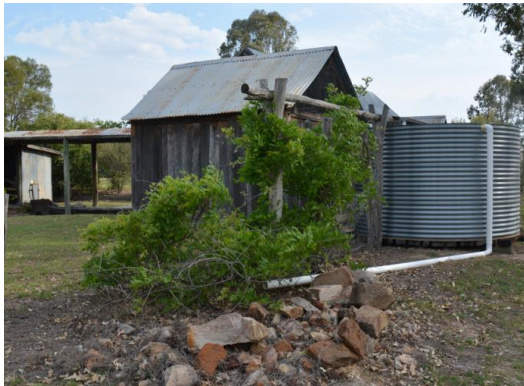
Figure 155. View facing south-west of the meat house, showing the adjacent water tank and timber trestle supporting the rainwater goods.

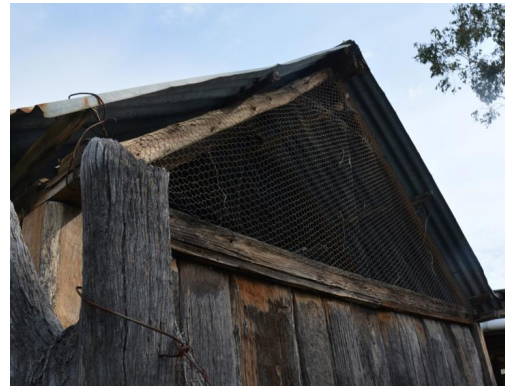
Due to the structure's natural deterioration, it was reconstructed in the early 2000s. The two gable ends are now infilled with chicken wire mesh and a large contemporary water tank and timber trestle are positioned on the north and north-east sides of the structure.

Figure 156. Detail of the chicken wire mesh gable infill.

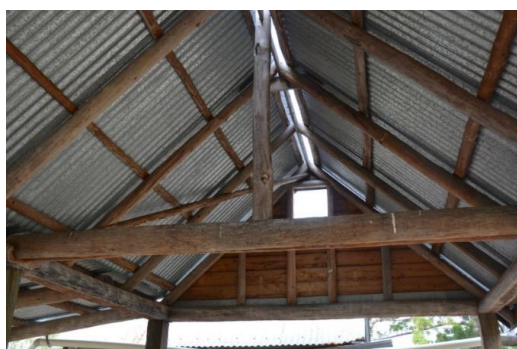
Figure 159. Interior view of the reconstructed timber roof framing built using traditional bush carpentry construction.

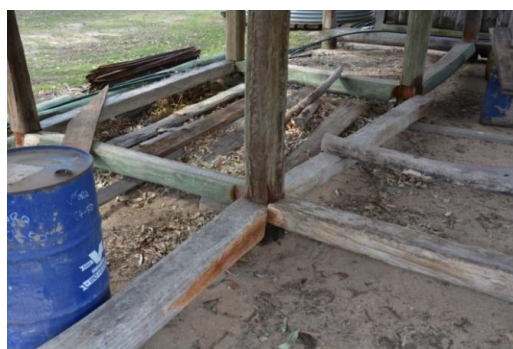
Figure 160. The reconstructed timber bearers and columns comprising the structure.

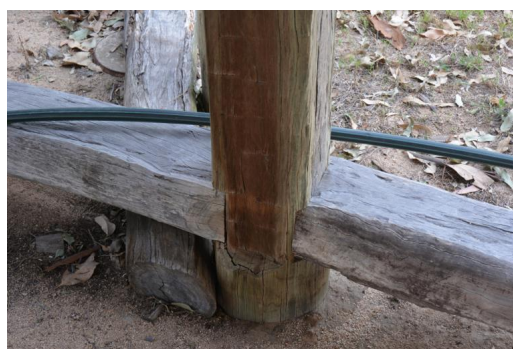
Figure 162. Detail of the intersection of a column and bearer reconstructed using traditional bush carpentry techniques.

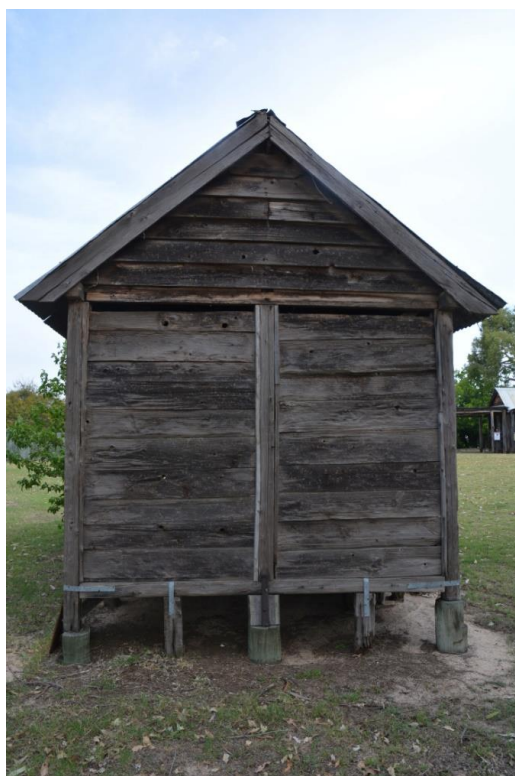
Figure 163. The rear north-west elevation of the cool house, which has been re-stumped in recent years.

Note the contemporary steel tie-downs.

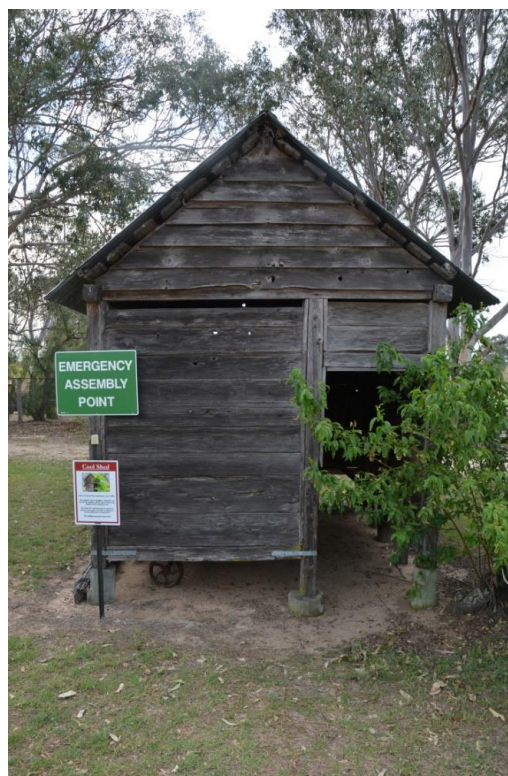
Figure 164. The main south-east elevation of the cool house, constructed of Cypress pine slabs, horizontally fitted.

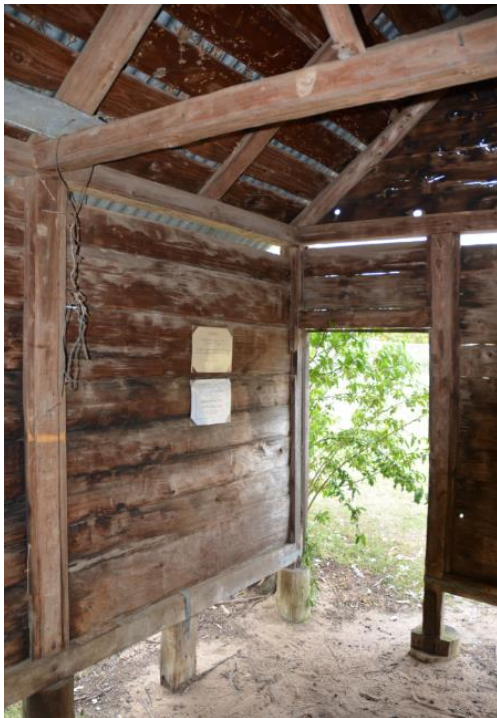
Figure 167. Interior of the cool house, illustrating its construction of horizontal timber slabs of Cypress pine.

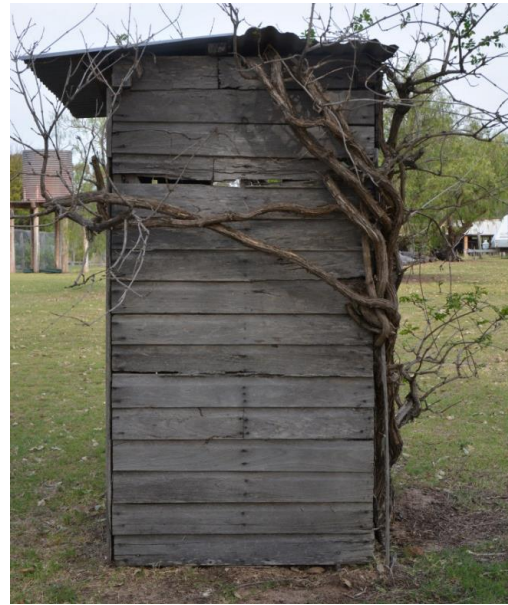
A single timber outhouse is located adjacent to the cool house, west of the main homestead, and is constructed of timber chamferboards with a bent corrugated iron sheet roof. The outhouse is in a dilapidated condition, and a tree has wrapped itself along the western and northern sides. It has been disused for decades, and currently stores miscellaneous items.

Figure 170. The north-west elevation of the outhouse, showing the extent of the tree growth around the structure.

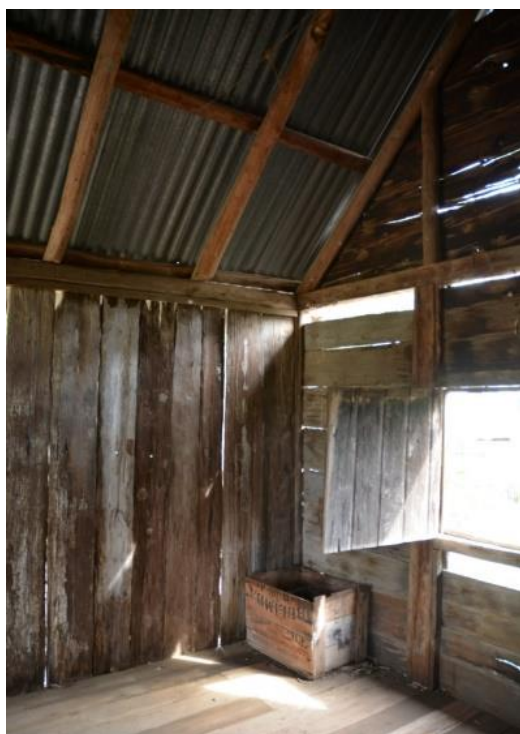
Figure 173. Interior of the postal receiving office, showing the timber slab case window in the rear elevation.

Note the left wall is clad in vertically-fitted timber slabs, compared to the use of horizontally-fitted timber slabs on the right wall.

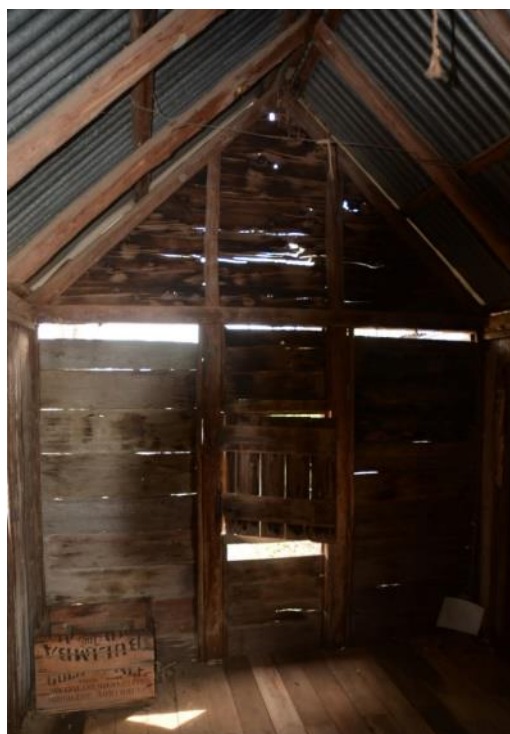
Figure 174. Interior of the postal receiving office with the timber casement window visible in the centre.

Note the reconstructed timber floor.

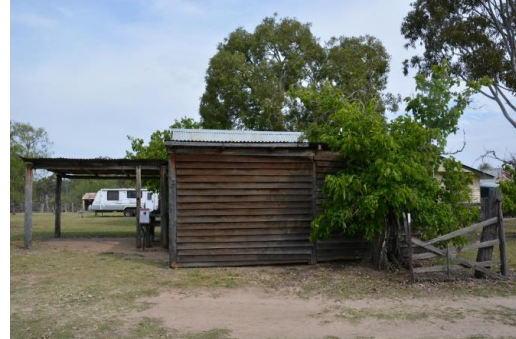
Figure 176. The north-west elevation of the postal receiving office, showing the thin chamferboards used in the c.1950s construction of the carport extension.

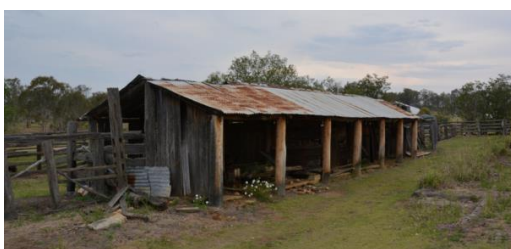
Figure 181. The north-west elevation of the milk bails structure.

Note the rough-sawn timber slabs, fitted vertically, that partially enclose the structure at this end and the timber posts supporting the structure.

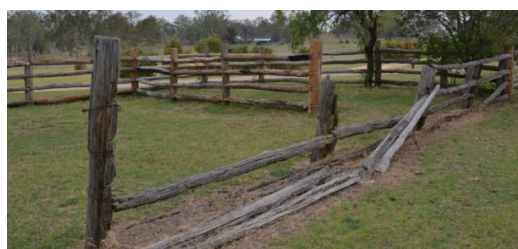
Figure 182. View facing south-west from showing the combination of dilapidated timber posts and rails comprising the former stockyards and recently reinstated erect sections.

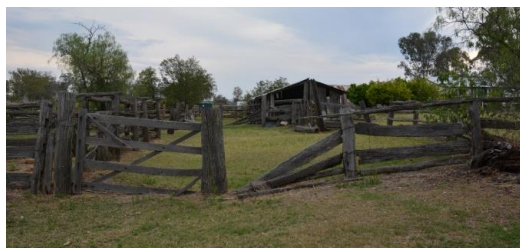
Figure 183. View facing south-west showing the dilapidated section of the stockyards and the milking bails structure behind.

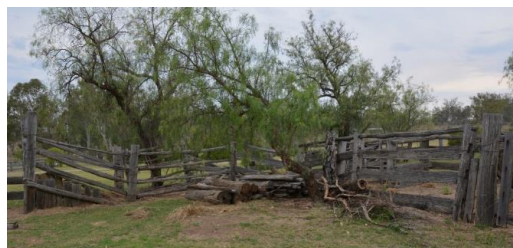
Figure 184. The dilapidated cattle-loading dock, which has a few pepperina plantings either side.

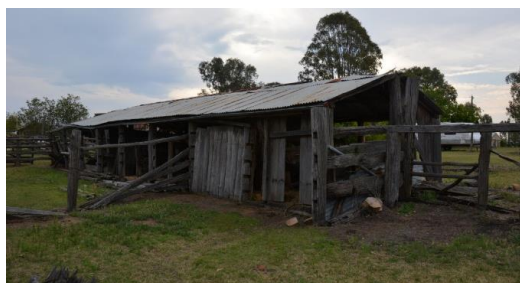
Figure 185. View facing west of the milking bails structure from within the stockyards.

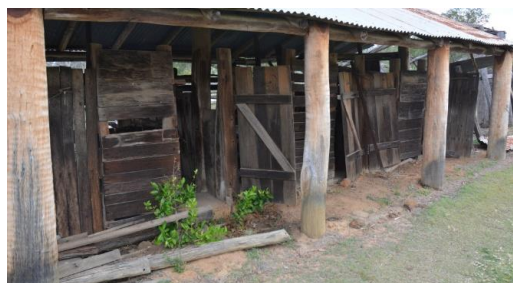
Figure 186. The timber slabs doors that divide the milking bails structure internally to create individual stalls.

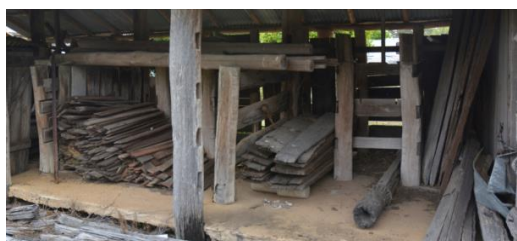
Figure 187. Typical interior view of the milking bails structure, which is not readily accessible due to the use of the structure for storage of timber.

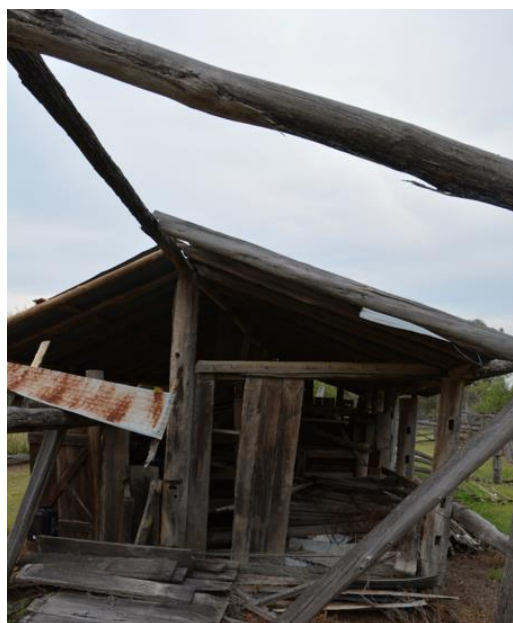
Figure 188. The north-eastern end of the milking bails structure, which is substantially deteriorated.

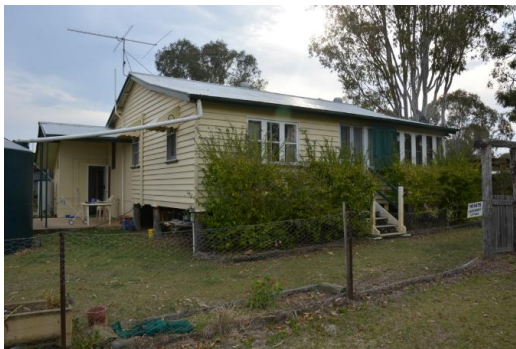
Figure 189. The south-east elevation of the caretaker's cottage.

Note the timber post and wire fencing, which encloses the cottage's small garden.

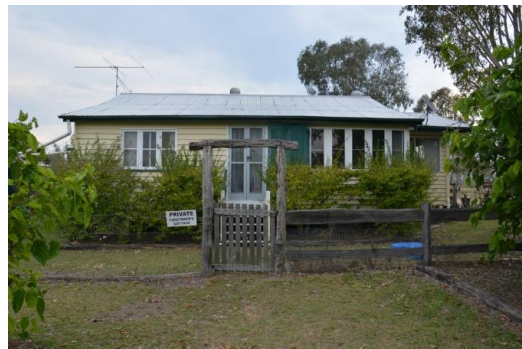
Figure 190. The main north-west elevation of the caretaker's cottage.

Note the timber entrance gate and fencing.

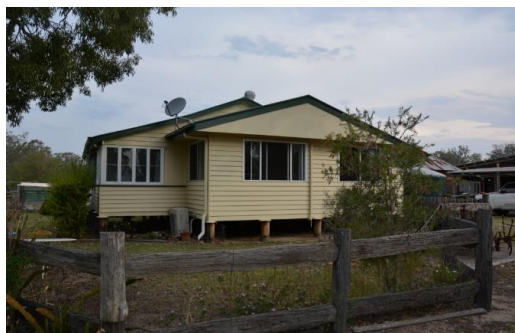
Figure 191. The south-west elevation of the caretaker's cottage, showing the contemporary extension in the foreground.

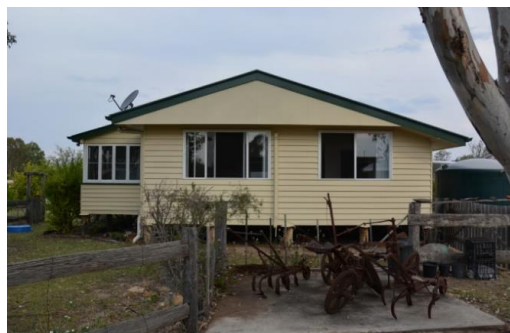
Figure 192. The south-west elevation of the caretaker's cottage.

Note the contemporary aluminium-framed windows on this elevation.

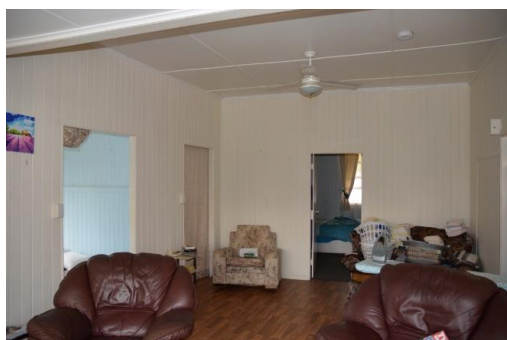
Figure 193. Typical interior of the caretaker's cottage.

Note the contemporary timber flooring.

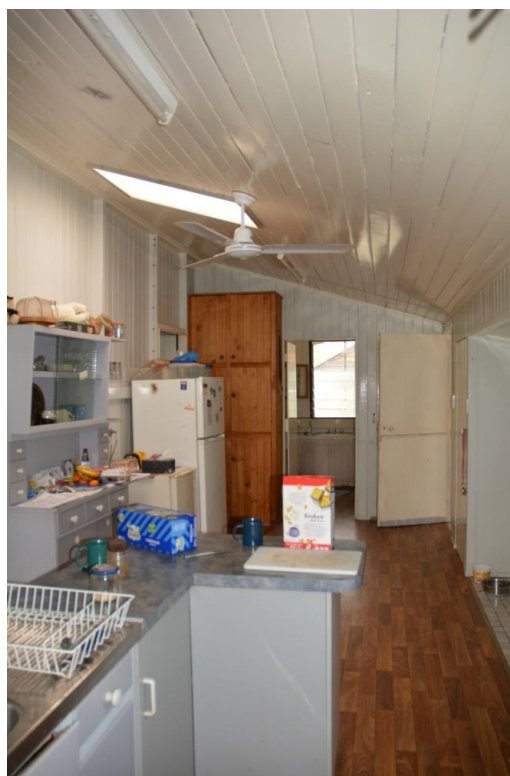
Figure 194. Internal view of the caretaker's cottage.

Note the VJ-lined walls and ceilings and exposed internal stud typical of worker cottage construction.

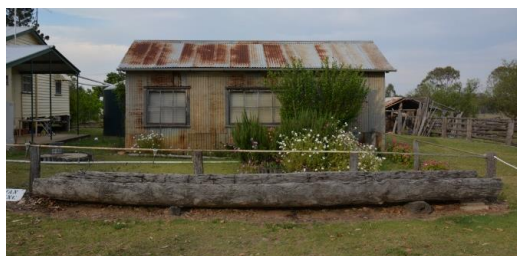
Figure 195. The south-west elevation of the caretaker's store.

Note the two six-pane awning windows on this elevation.

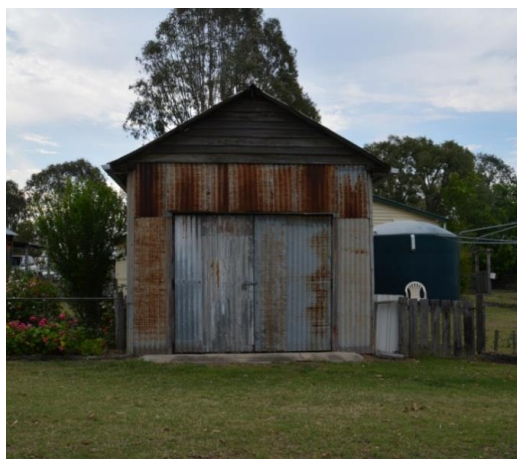
Figure 197. The south-east elevation of the caretaker's store, showing the double door access.

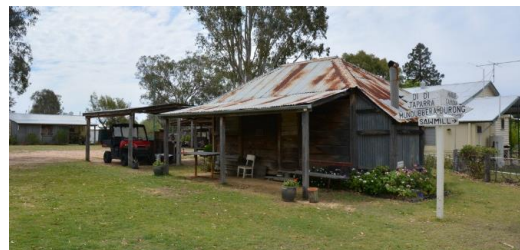
Figure 200. View facing north of Brownie's hut.
Note the adjacent carport shelter used for storing the caretaker's buggy.

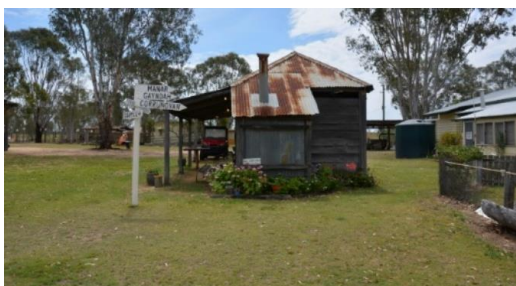
Figure 201. The south-east elevation of Brownie's hut.
Note the fireplace/stove skillion extension.

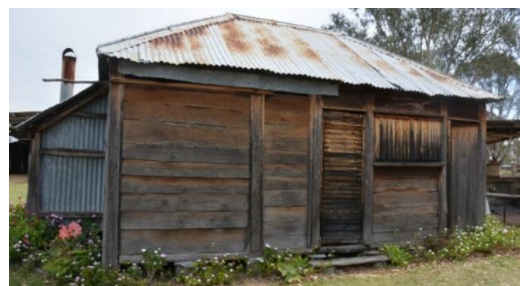
Figure 202. The north-east elevation of Brownie's hut.
Note the wide timber weatherboard slabs, fitted horizontally.

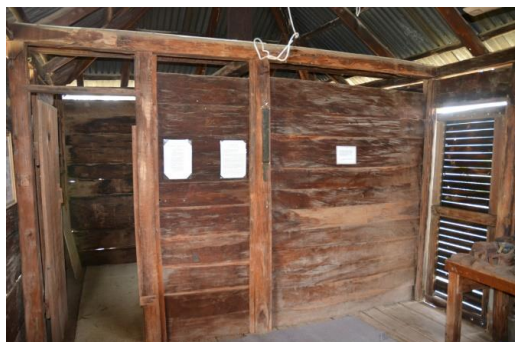
Figure 203. Interior of Brownie's hut showing the dividing wall between the two internal spaces.

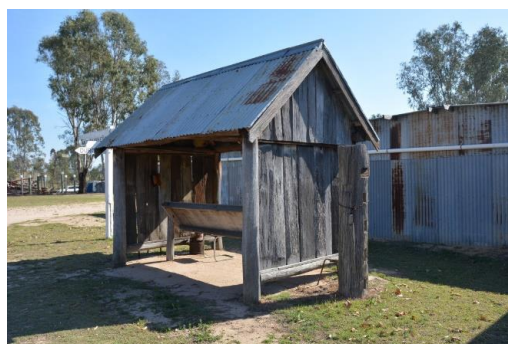
Figure 206. The south-west elevation of the DPI shelter, showing the remnant timber post of the cattle dip installed herein 2006 known as 'Stockie's Stump'.

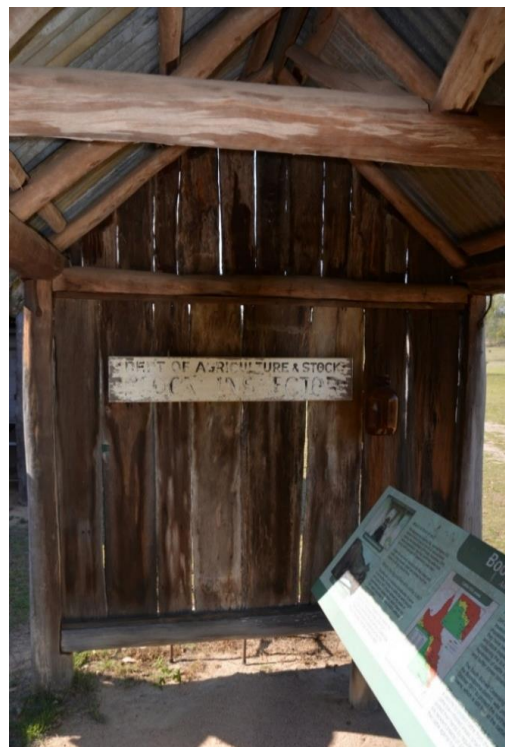
Figure 208. Interior of the DPI shelter, showing the existing interpretation signage.

The shelter is located adjacent to the rear (south-west facing) elevation of the 'Big Top' entertainment area and structure. The Boondooma cattle dip reserve itself, which is still operational and not publicly accessible, is located approximately 200 m further south-west of the shelter. Internally, the shelter contains interpretation signage summarising the history of cattle tick management in Queensland and the importance of the Boondooma clearing dip. This signage is deteriorating and in need of replacement.

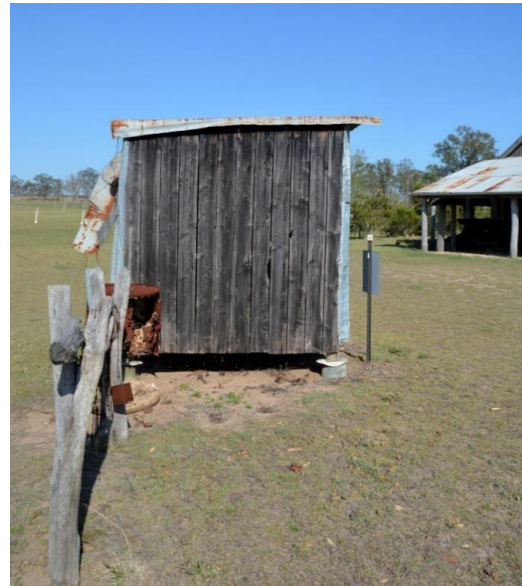
Figure 210. The eastern elevation of the boundary rider's hut, with the stone store building partially visible at the right.

Note the rusted water barrel and make-shift guttering attached to the structure.

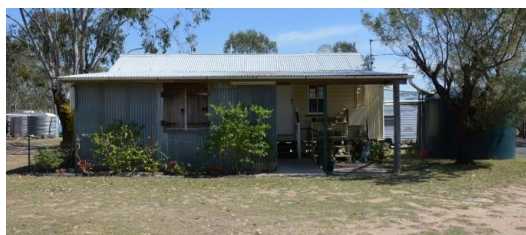
Figure 213. The main south-eastern elevation of the administration building.

Note the partially enclosed skillion extension at the left of the main entrance.

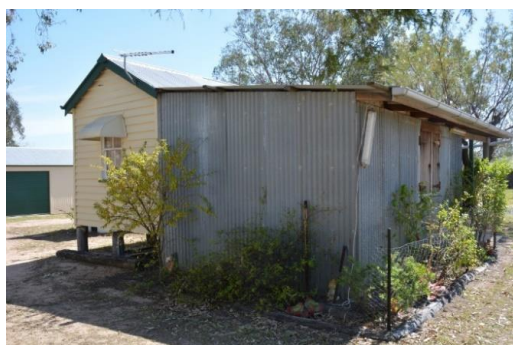
Figure 215. The south-eastern corner of the administration building, showing the corrugated iron skillion extension.

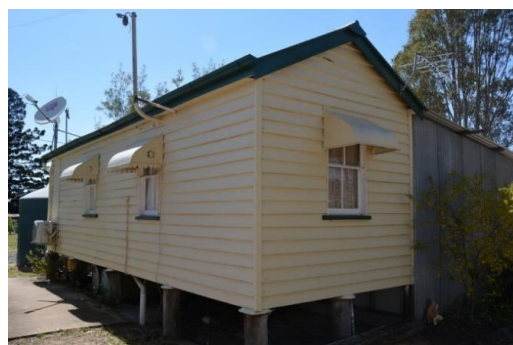
Figure 216. The south-western corner of the administration building.

Note the single sash windows with decoratively-cut, galvanised iron hoods.

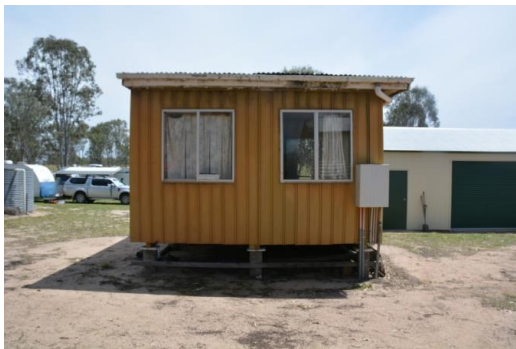
Figure 217. The north-eastern elevation of the archives building.

Note the two aluminium-framed sliding windows.

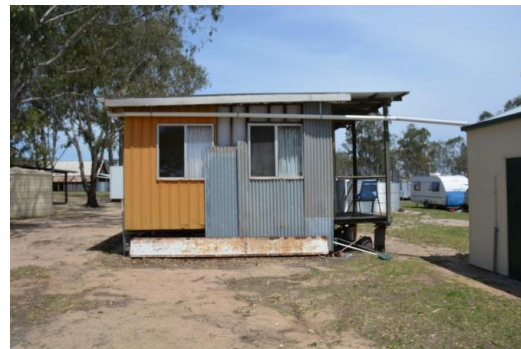
Figure 218. The north-eastern elevation of the archives building.

Note the different corrugated iron sheeting, which creates a patchwork effect.

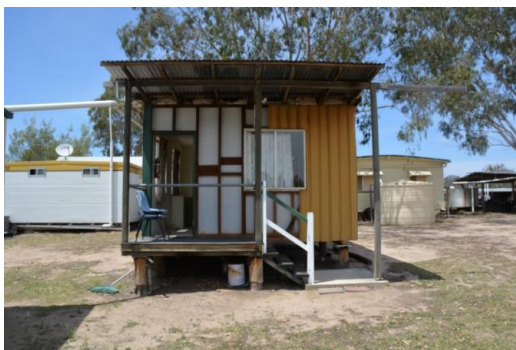
Figure 219. The main north-western elevation of the archives building, showing the external timber stair and landing.

Note the exposed timber stud framing visible on this elevation.

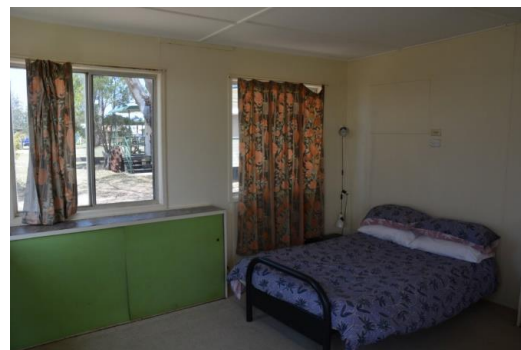
Figure 220. Interior of the archives building, which is currently being used for accommodation purposes.

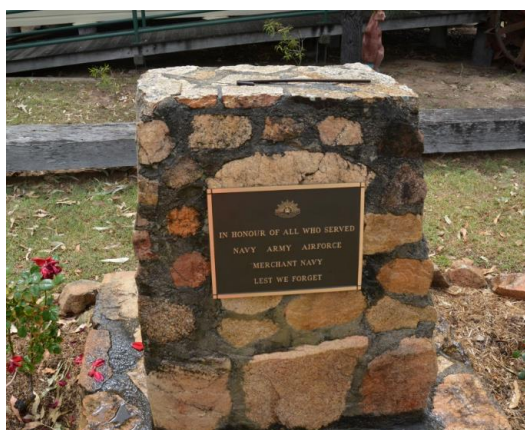
Figure 221. The shaped, commemorative stone cairn forming part of the site's ANZAC memorial.

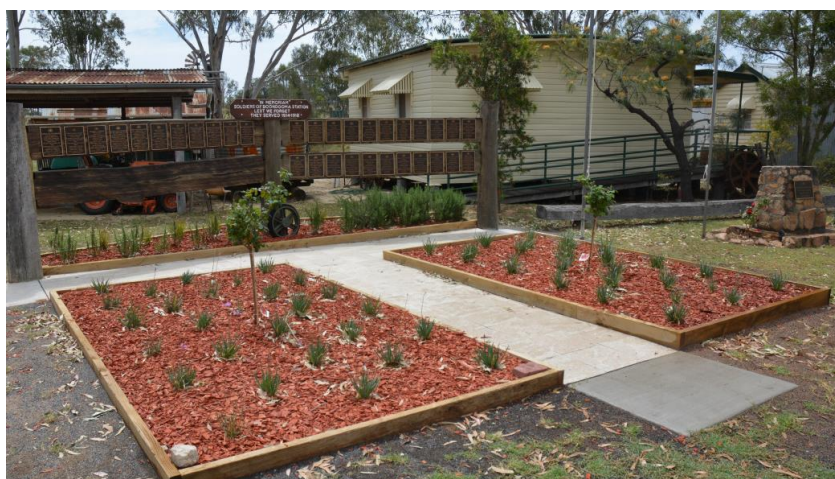
Figure 223. The more recent memorial installation comprising a contemporary timber post-and-rail frame with individual plaques for service personnel associated with Boondooma station and district. *Note the museum building behind to the north-west.*

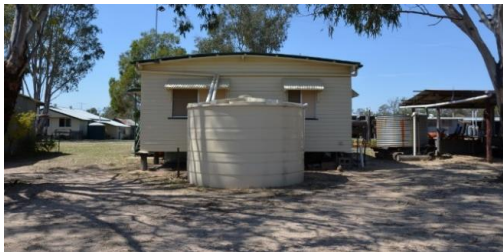
Figure 224. The south-western elevation of the museum building, showing the adjoining water tank.

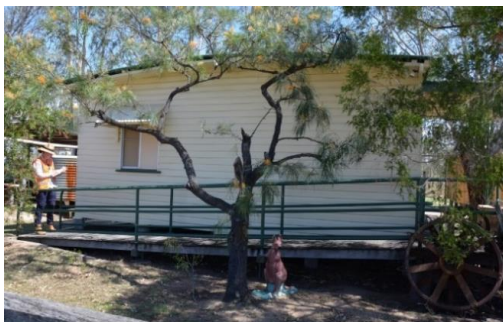
Figure 226. The south-eastern elevation of the museum building, showing timber-framed ramp providing disabled access.

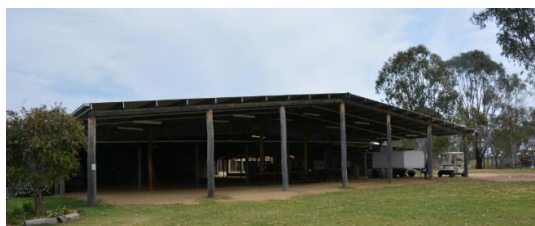
The full width of the main roof of the ‘Big Top’ was extended on its north-eastern gable during the late 2000s. This extension is rectangular in plan and supported on tall timber log posts. The roof is framed in substantial steel purlins and clad with corrugated galvanised iron sheeting.

Figure 228. The north-eastern elevation of the ‘Big Top’ extension.

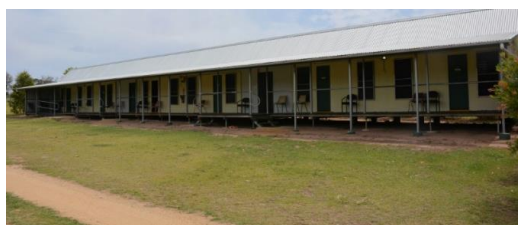
The accommodation building is a long rectangular building above the ground on steel stumps, comprising several individual accommodation bedrooms, a separate kitchenette, and a disabled access bathroom. The building is of contemporary construction in steel framing with corrugated iron sheet cladding. A large verandah with timber floorboards runs the length of the main south-east-facing elevation and provides access to each of the bedrooms.

Figure 240. The south-east elevation of the accommodation building.

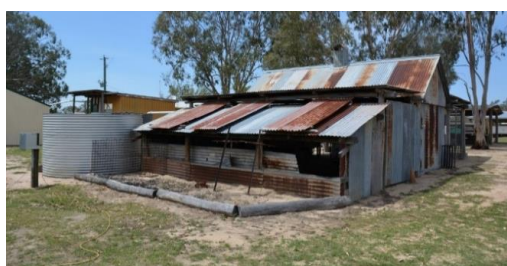
Figure 246. The north-western elevation of the camp kitchen.

Note the enclosed skillion extension on this elevation.

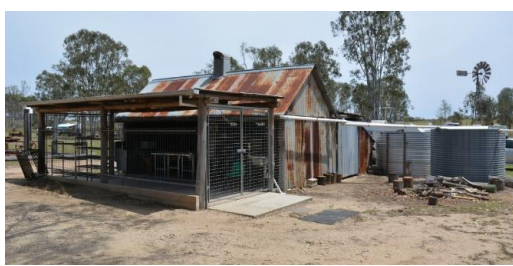
Figure 247. The south-eastern elevation of the camp kitchen.

Note the skillion extension.

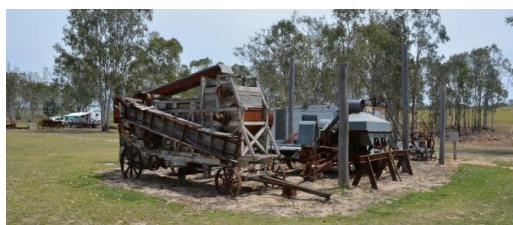
Figure 250. The south-eastern corner of the former machinery shed, with contemporary timber posts re-erected in recent decades to show where the structure once stood.

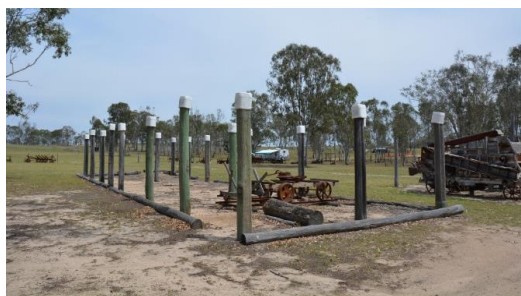
Figure 254. The south-eastern corner of the former blacksmith's shop, with contemporary timber posts and bearers re-erected in recent decades to show where the structure once stood.

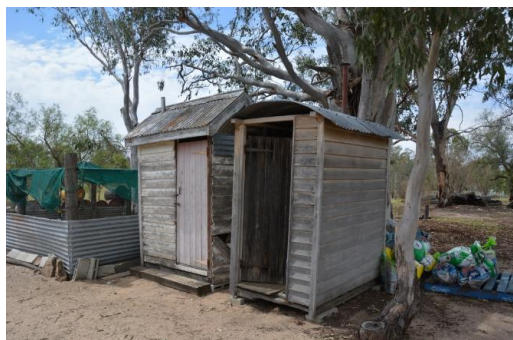
A chicken coop of recent construction and two, dilapidated timber outhouses are positioned north of the cool house and original homestead (former) or 'dining room' structure, under the shade of a large tree. The outhouses are currently used for storage and the chicken coop is maintained by the resident caretaker

Figure 258. The two timber outhouses.

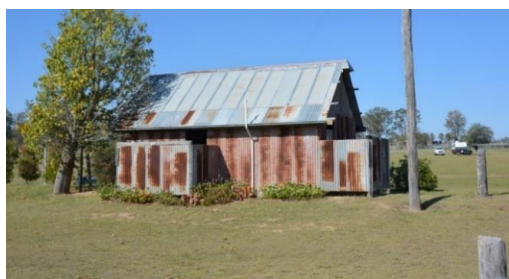
Figure 262. The north-east elevation of the toilet block located a short distance to the south-east of the stone store building.

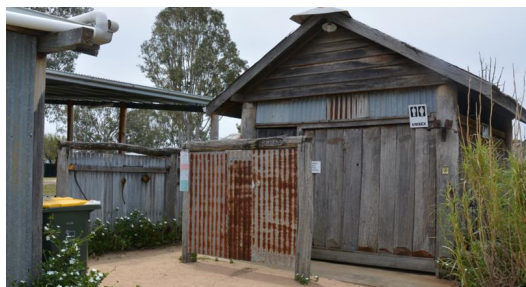
Figure 263. The south-west elevation of the toilet block located adjacent to the 'Big Top' extension.

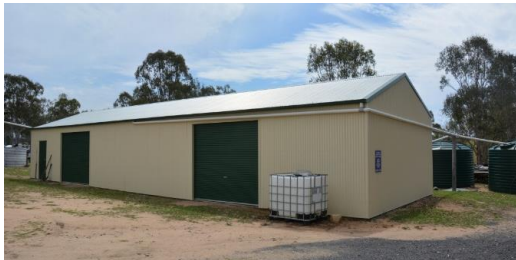
Figure 266. The south-east elevation of the shed.

Note the two water tanks at the right.

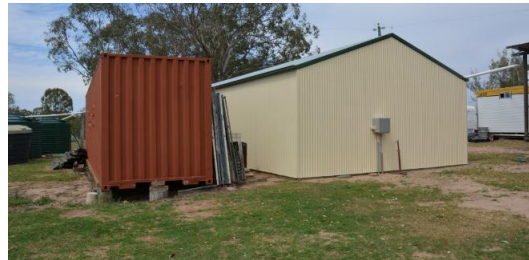
Figure 267. The south-west elevation of the shed, showing the shipping contained installed adjacent at the rear.

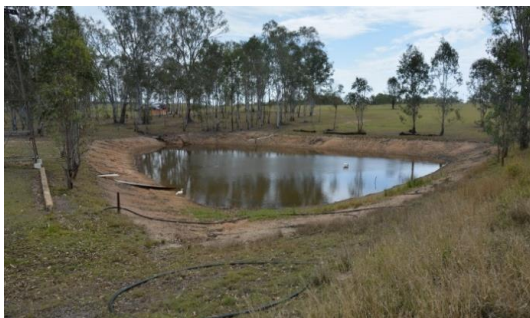
A large, irregular-shaped dam is located in the north-west aspect of the Boondooma Homestead property. It is surrounded by several tall gum trees. An embankment has been constructed at one end, which forms an access track between the caravan parking areas further to the north-west and the main homestead aspect of the property.

Figure 268. View facing north-west of the dam located on the Boondooma Homestead property.

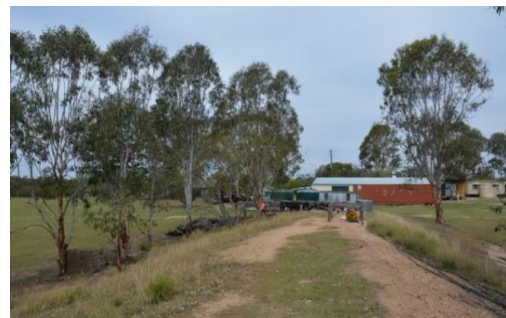
Figure 269. View facing south-east towards the main aspect of the Boondooma Homestead complex from atop the dam embankment.

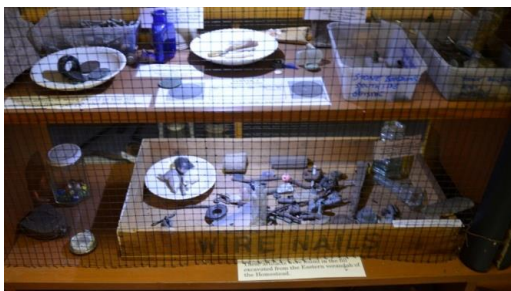
Figure 271. An example of the isolated historical artefacts currently displayed in the Boondooma Homestead's on-site museum building, reputedly recovered from fill excavated out from under the stone building and main homestead during restoration works. *Source:* Boondooma Museum & Heritage Association (2021).

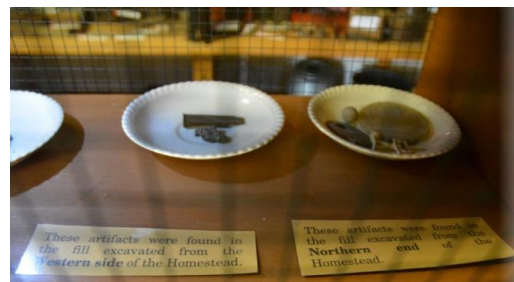
Figure 272. An example of the isolated historical artefacts currently displayed in the Boondooma Homestead's on-site museum building, reputedly recovered from fill excavated out from under the stone building and main homestead during restoration works. *Source:* Boondooma Museum & Heritage Association (2021).

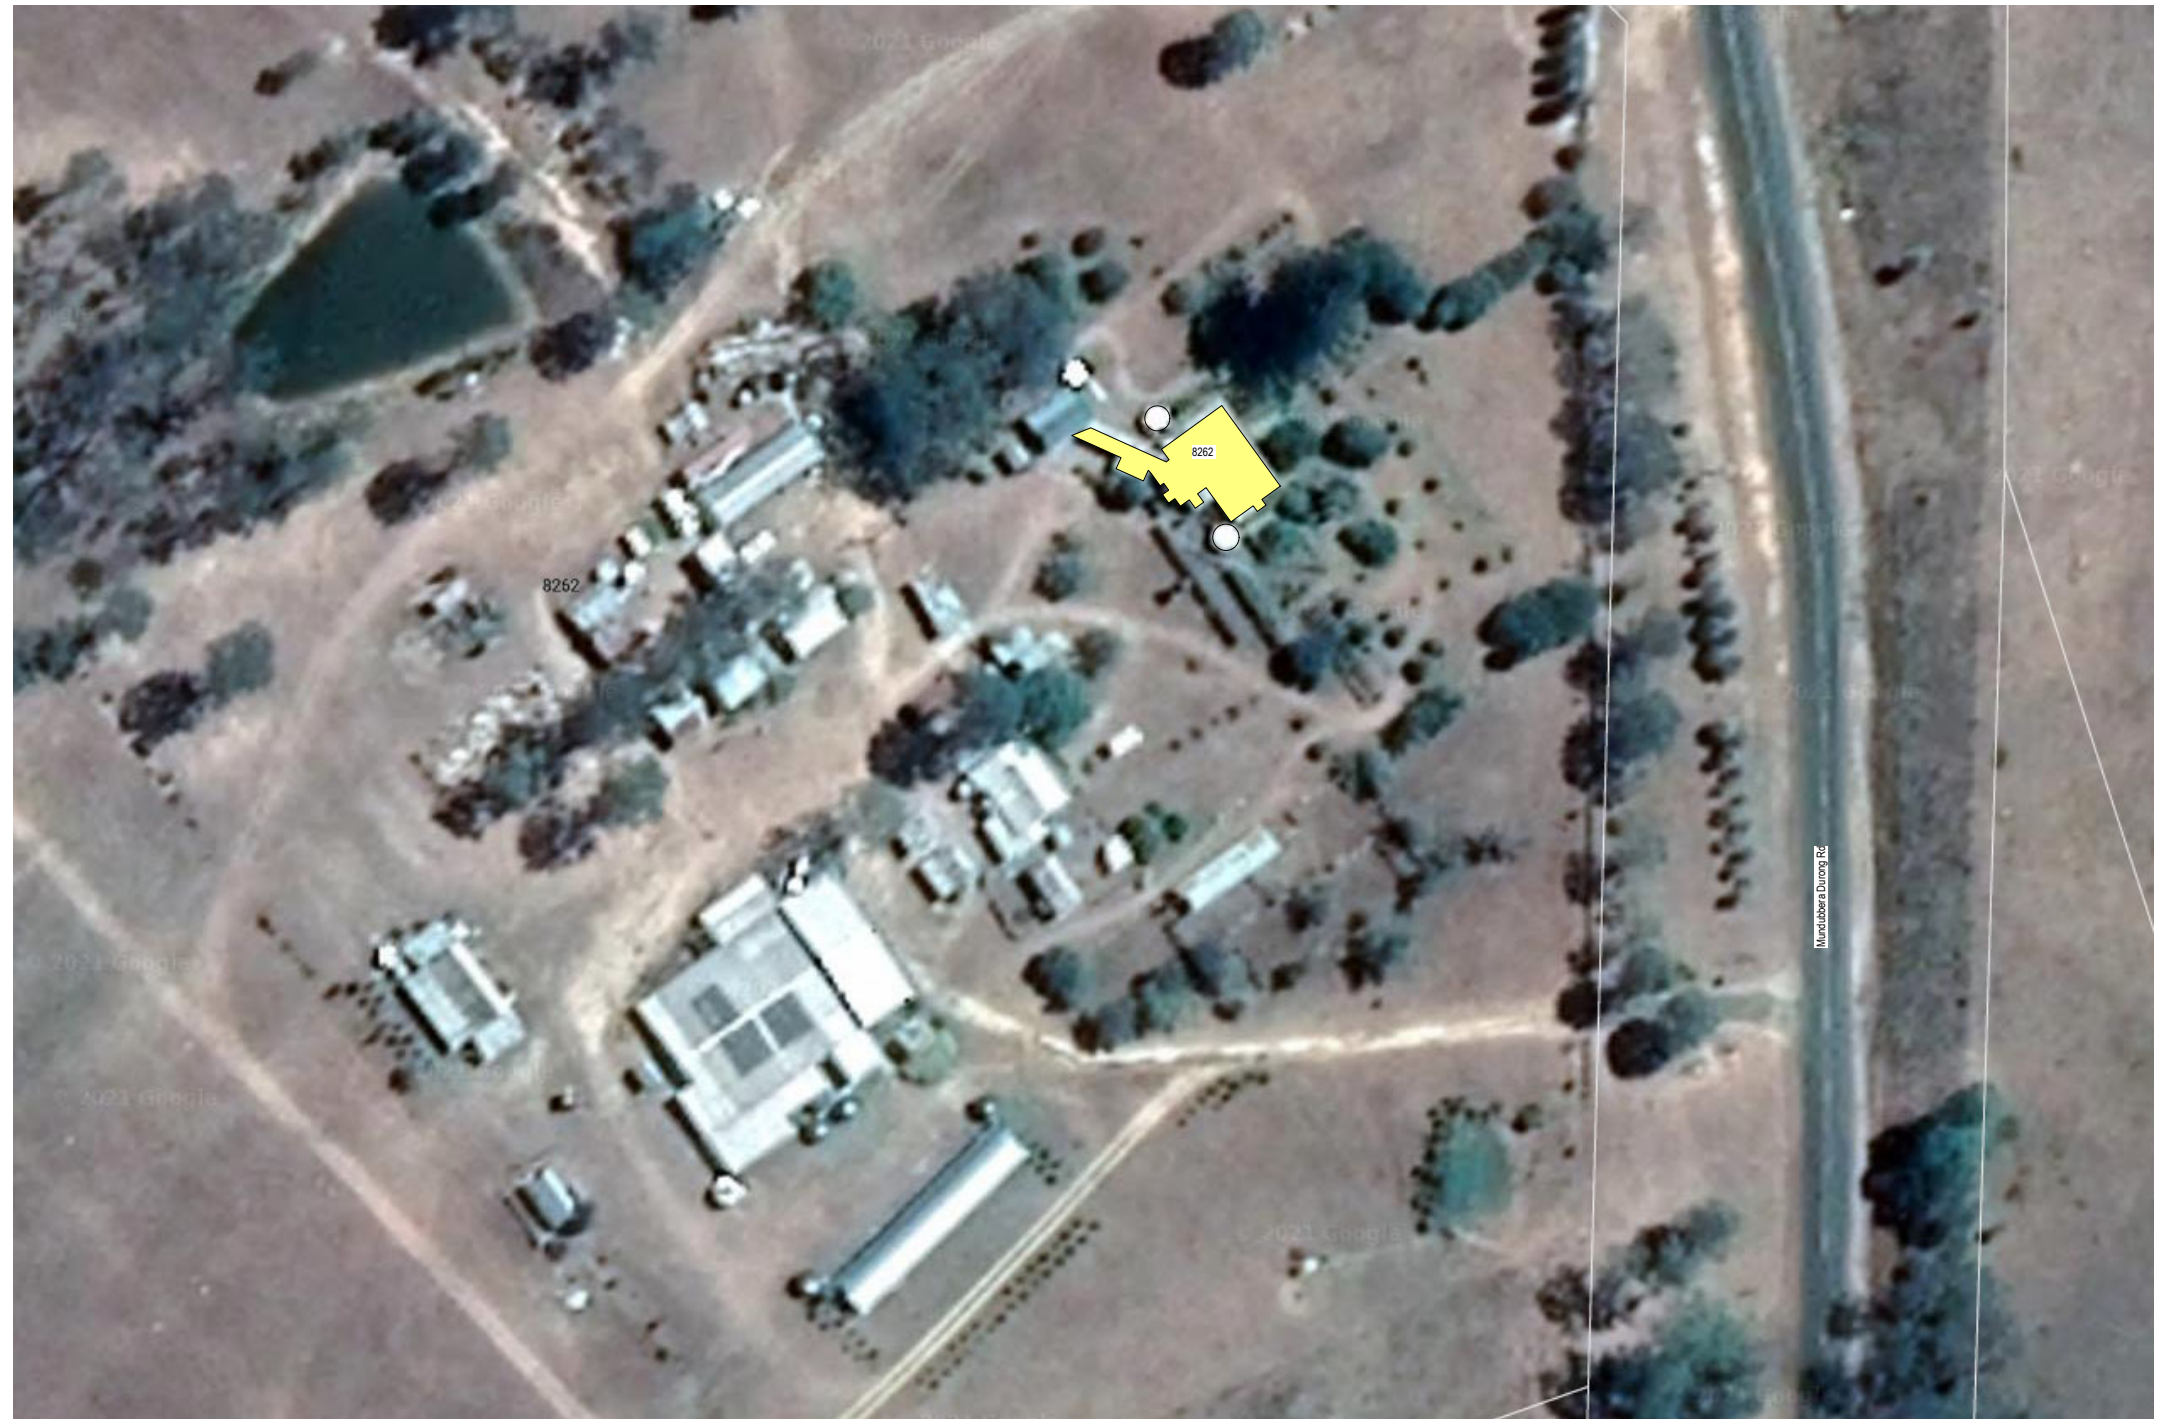
SITE NOTES:
 DIRECT STORM WATER DRAINAGE AWAY FROM BUILDING VIA STORM WATER SWALE AT REAR AS INDICATED
 STORM WATER TO DRAIN AWAY FROM THE BUILDING TO OPEN AREA OR STORMWATER PIT.
 ENSURE FINISHED GROUND LEVELS FALL AWAY FROM THE BUILDING ON ALL SIDES.
