SOUTH BURNETT
REGIONAL COUNCIL

AGENDA

Liveability Standing Committee Meeting Wednesday, 10 August 2022

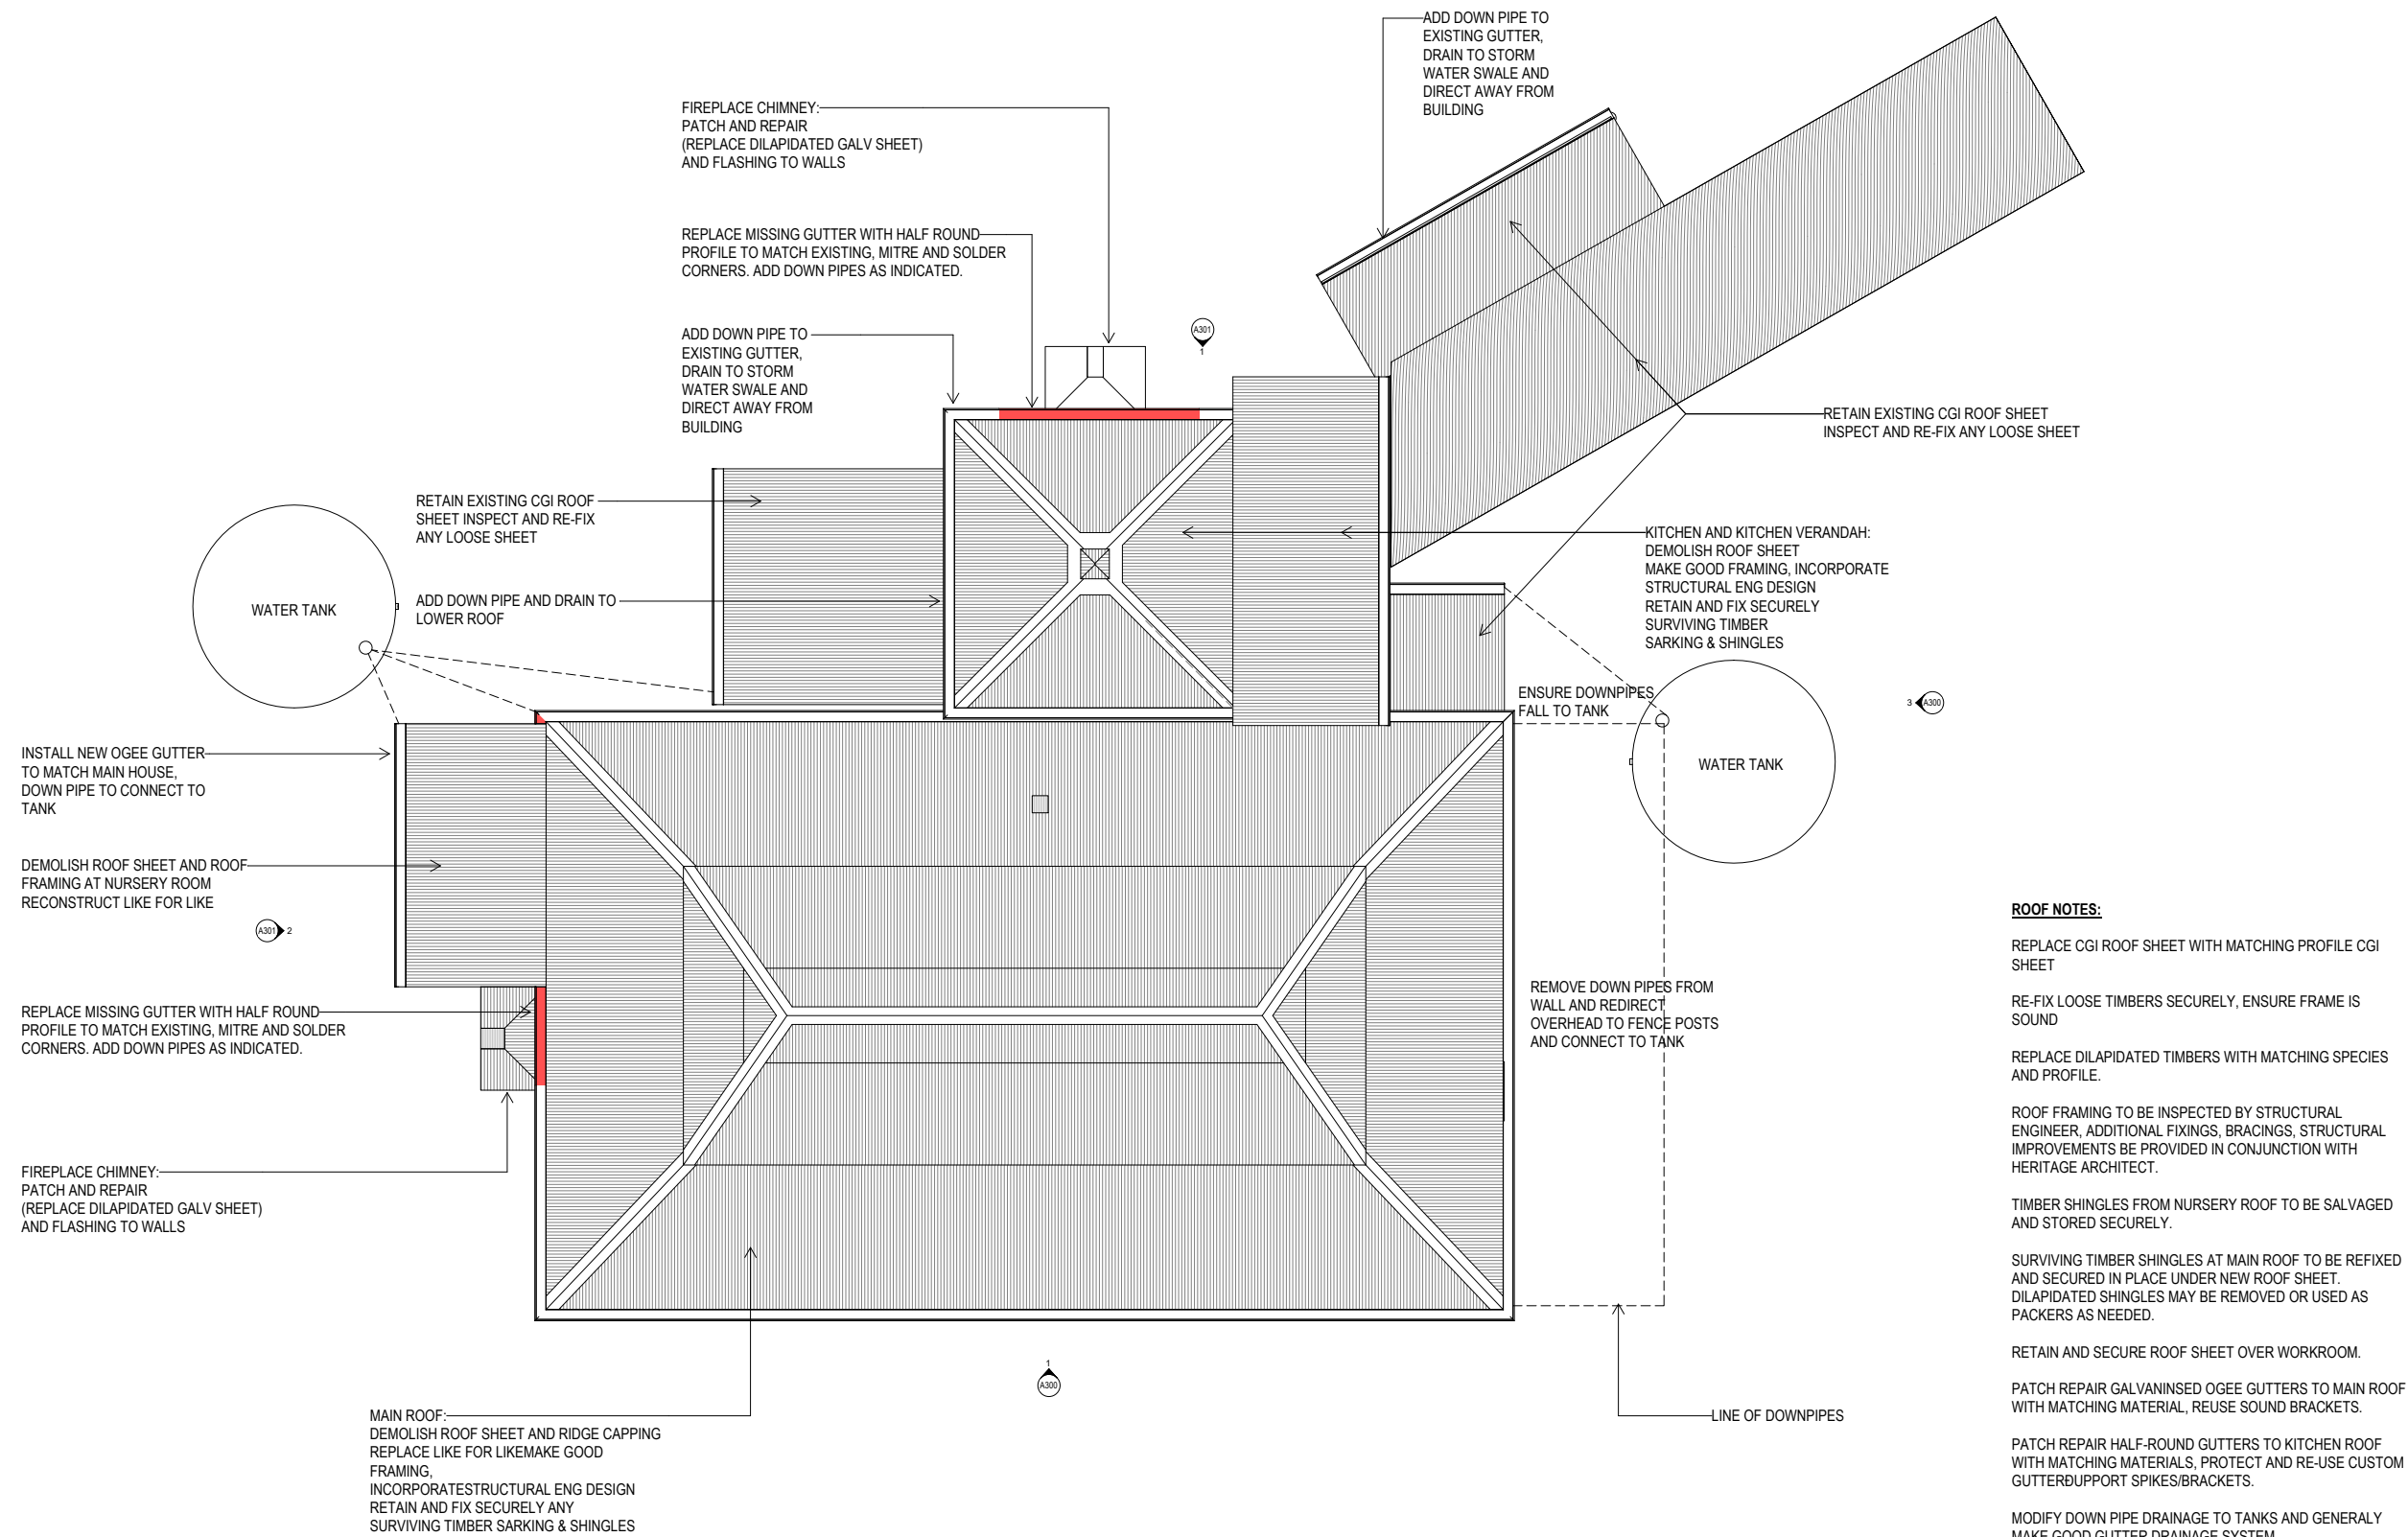
- ROOF NOTES:**
- REPLACE CGI ROOF SHEET WITH MATCHING PROFILE CGI SHEET
 - RE-FIX LOOSE TIMBERS SECURELY, ENSURE FRAME IS SOUND
 - REPLACE DILAPIDATED TIMBERS WITH MATCHING SPECIES AND PROFILE.

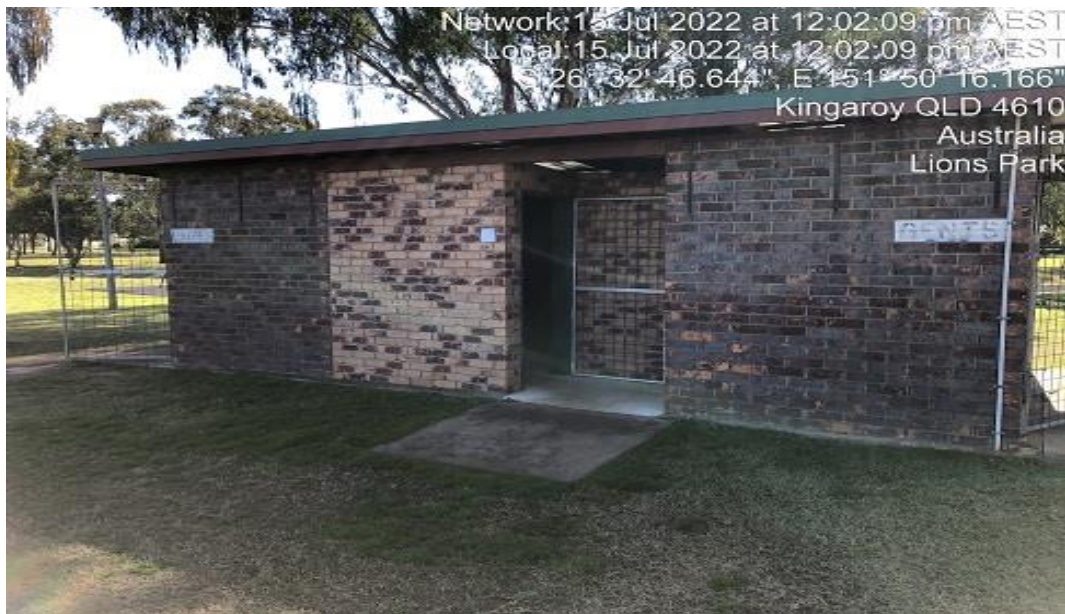
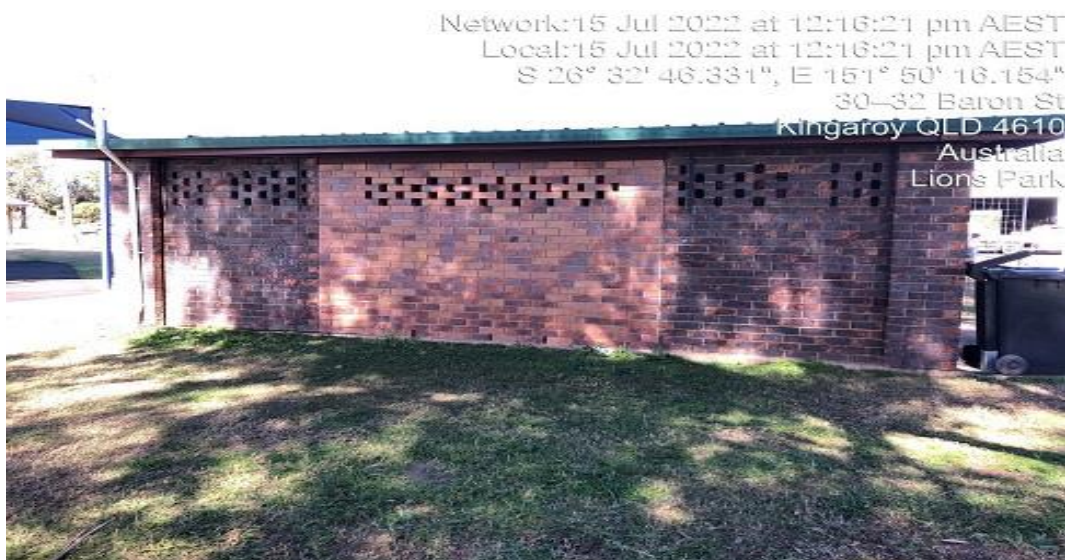
Kingaroy Lions Park – Public Toilet

The building is of slab on ground construction with single skin loadbearing external brick walls. The roof structure is sawn hardwood with a lightweight metal roof over. The roof has polycarbonate sheet inserts for light provision.

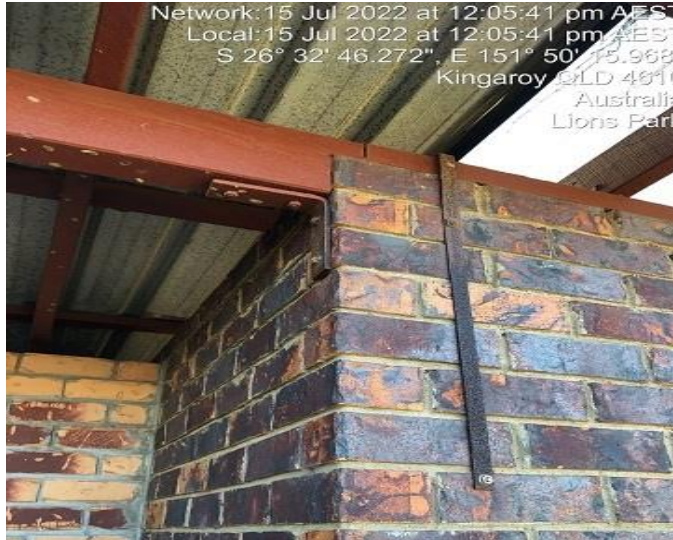
Tie Down – Structure

The wall plates to which the rafters are attached are tied to the supporting single skin brickwork with steel straps and small diameter dynabolts. Also note the angle bracket tying the roof beam to the upper courses of brickwork.

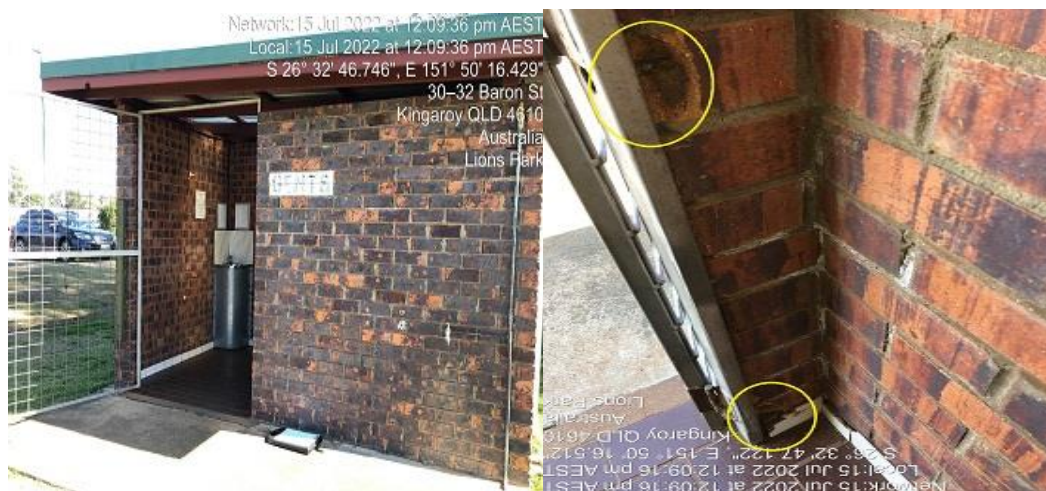
Gates swing out and cannot be secured

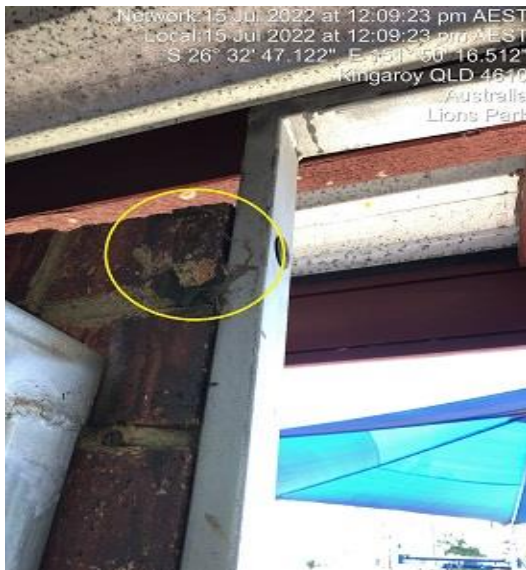
Damaged brickwork

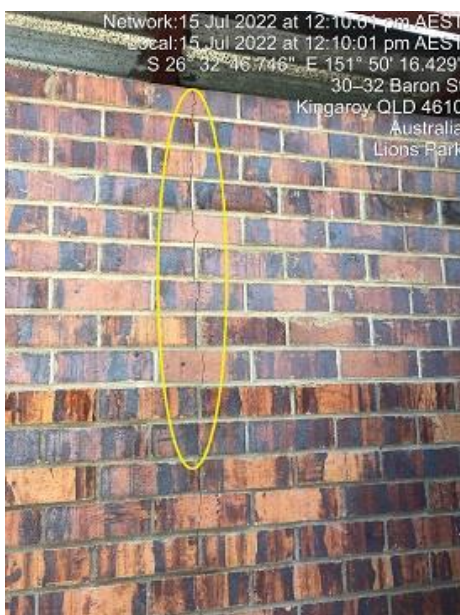
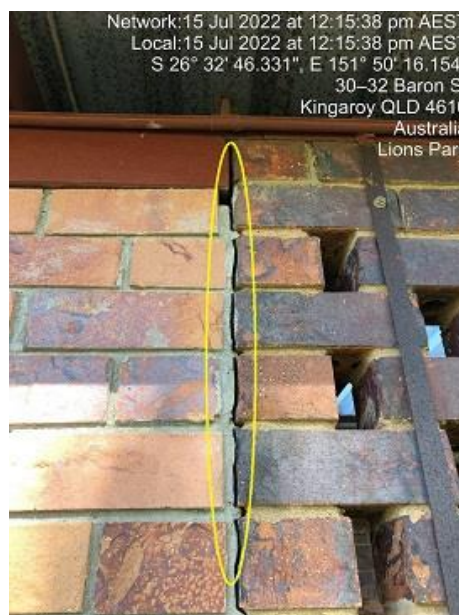
There are several cracks in the brick walls. The degree of cracking is not major (as defined in AS2870-2011) but will mirror through any applied finish such as render. The cracking cannot be effectively controlled for two reasons.

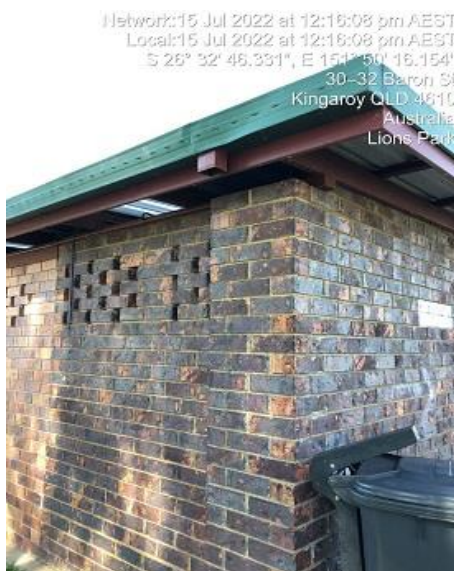
The gutter on the rear of the building is damaged and will require replacement. There is no downpipe or stormwater drainage system resulting in a concentration of water at the northwest corner.

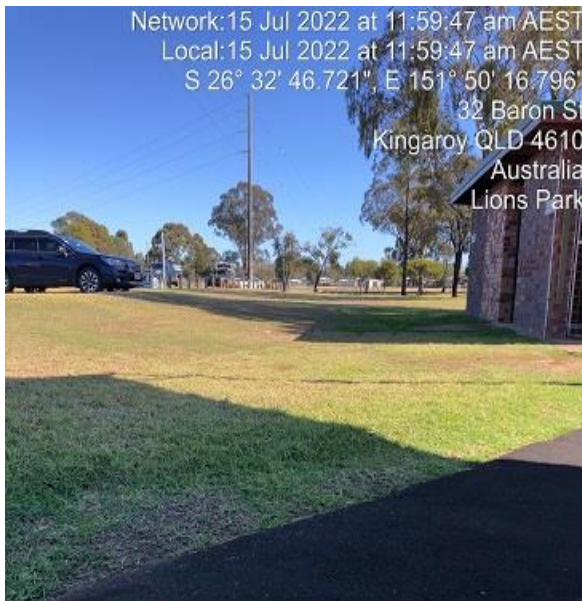
There is a noticeable fall from the carpark to the toilet level. Further detail will be required to enable a compliant ramp / path to be designed for suitable PWD access.

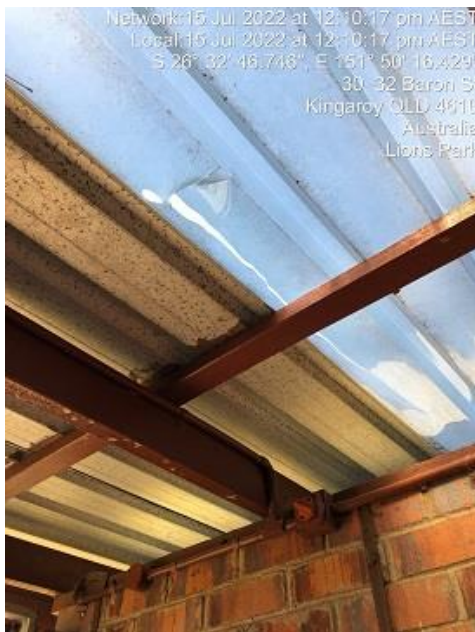
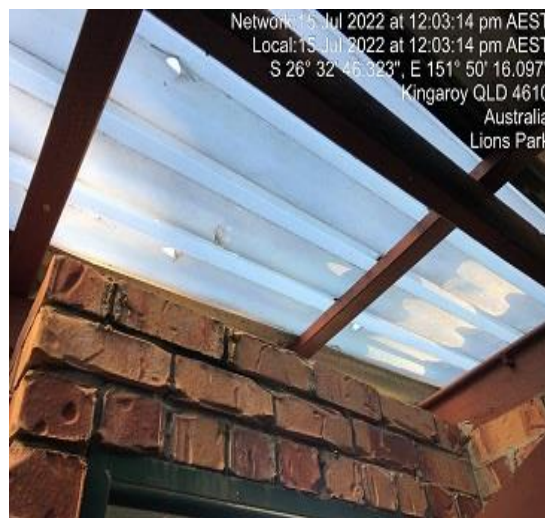
Several polycarbonate roof sheets have been incorporated to allow natural light into the rooms. Every sheet is damaged or broken possibly by hail or tree limbs but more likely because of vandalism.

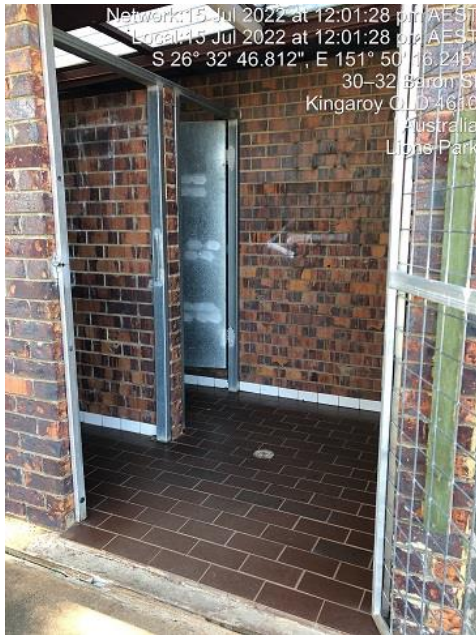
Floor / Walls – Internal

Existing tiles will require removal and the concrete slab will require grinding prior to the application of an epoxy floor finish.

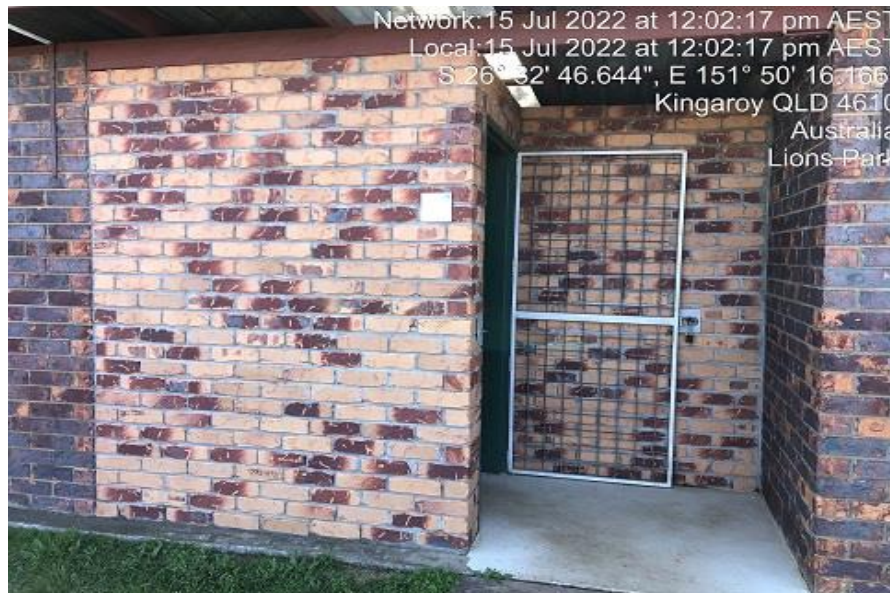
The existing door is too narrow and the circulation space available inadequate to achieve compliance with the requirements of AS1428.1-2009.

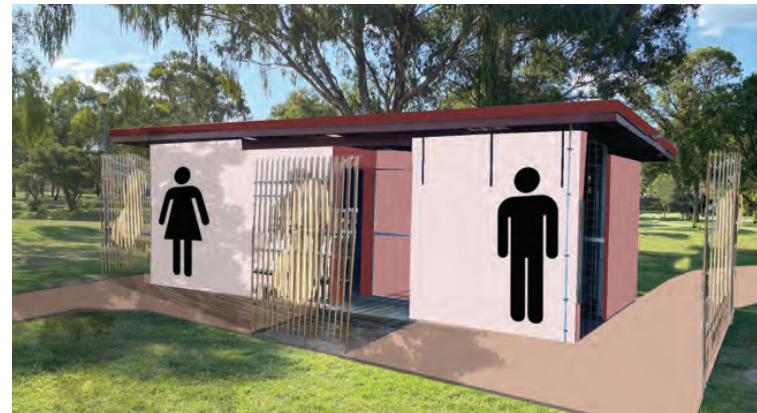
Amenities Block

Upgraded, rendered and timber screens with peanut motif recessed. Option for local artist mural or continued peanut theme on back wall.

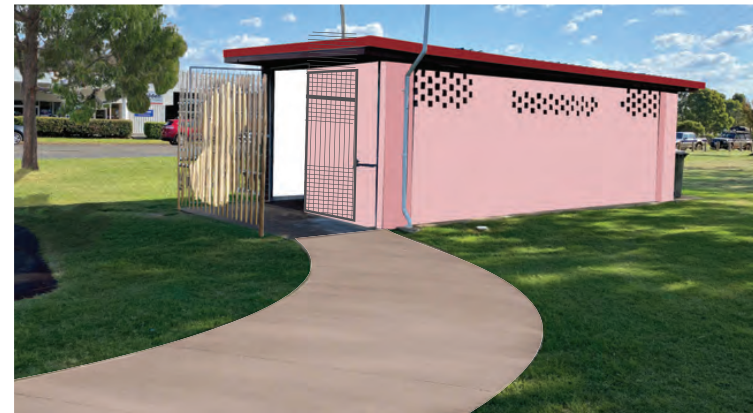
Screen Precedent

Example of recessed motif in decorative timber screen. As pedestrian moves, the recessed image appears.
