# Boondooma Homestead, 8262 Mundubbera–Durong Road Conservation Management Plan

Prepared for Boondooma Museum & Heritage Association Inc.

June 2022—FINAL

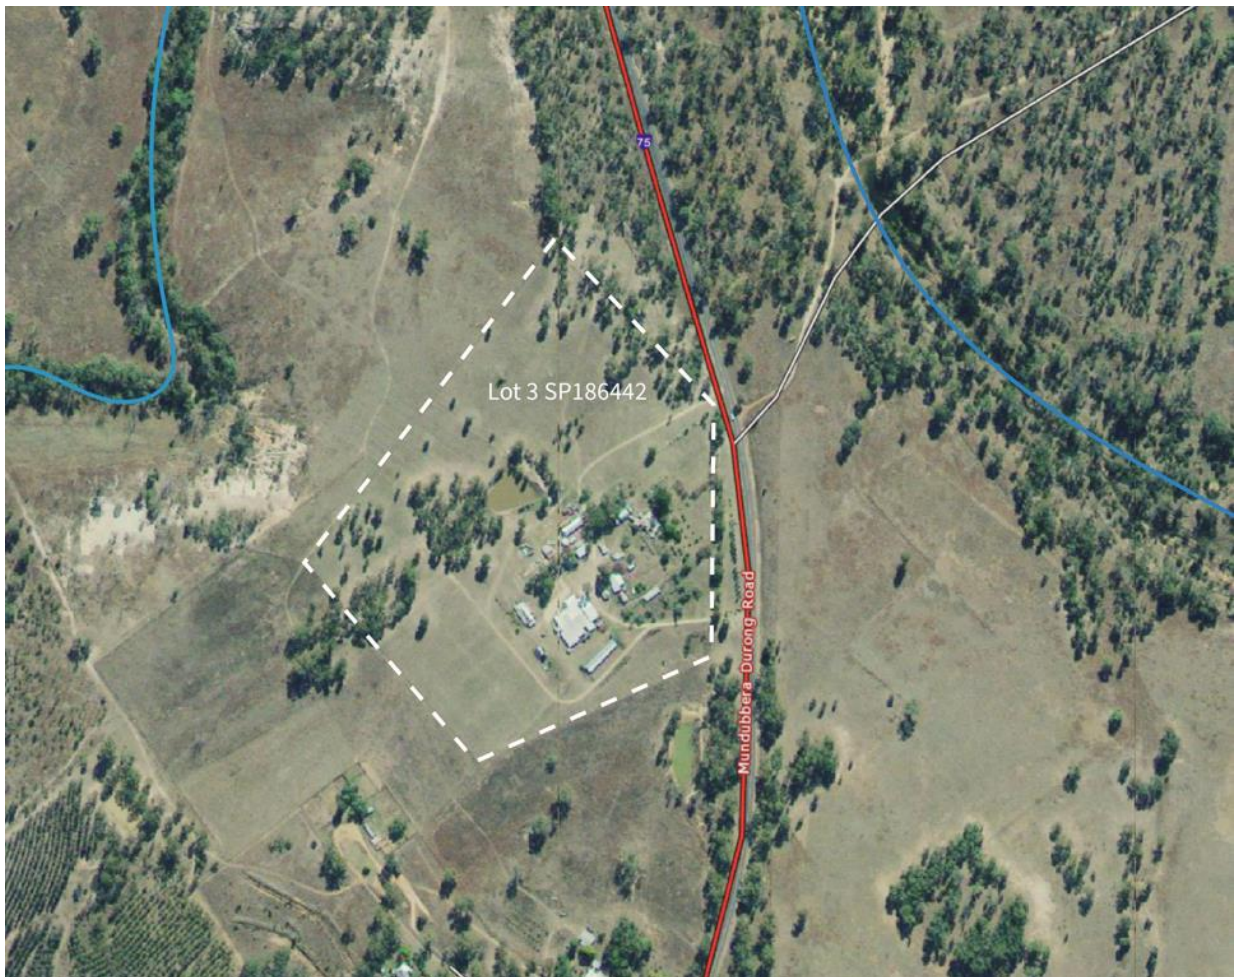
Figure 3. Existing site plan for Boondooma Homestead, identifying the site's principal and ancillary structures in relation to the lot and QHR boundaries. Source: Extent Heritage (2021).

Figure 3, below, presents existing site plans of the Boondooma Homestead property, in both lot plan view. This site plan also identifies the site's principal and ancillary structures, numbered 1 through to 38.

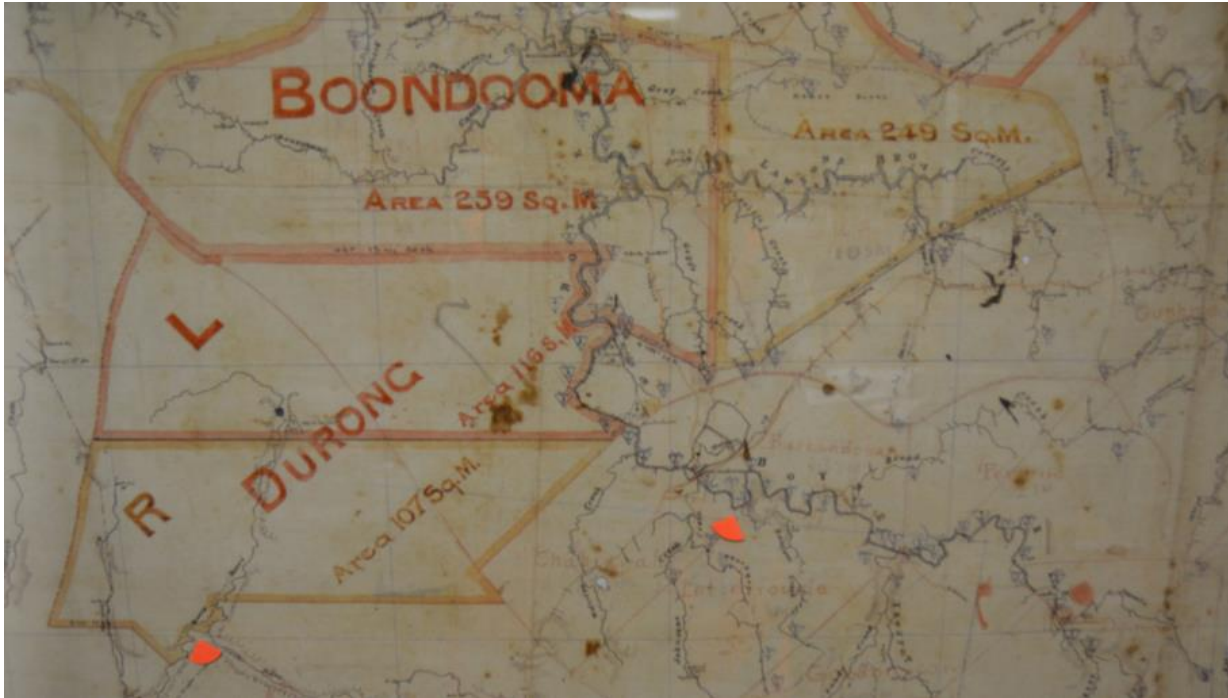
Figure 13. A photograph of a portion of an original district map, illustrating the 259 square miles portion of leased land in the name of ‘Gilchrist, Watt & Co’ , and the separate 249 square mile portion of resumed land comprising Boondooma as result of the holding being brought under the provisions of the Crown Lands Act 1884. *Source:* Boondooma Museum & Heritage Association Inc (2021).

In 1885, the combined holdings of Boondooma were brought under the provisions of the *Crown Lands Act 1884* (see Figure 11, below), and were subsequently resumed and divided into two separate portions: 259 square miles of leased land in the name of Gilchrist, Watt and Co, and 249 square miles of resumed land (Queensland Government 2016a) (see Figure 10–Figure 13, below). The formal documentation of this division of the consolidated Boondooma run included a detailed description of the extent of the respective resumed and leased portions; Figure 12, below, presents an excerpt of this description. At this time, George Munro had succeeded the Lawsons as manager of Boondooma, and he served in this role until his death on 24 March 1895, after which he was succeeded by his son, Peter Munro (see Part 4.4, page 53).

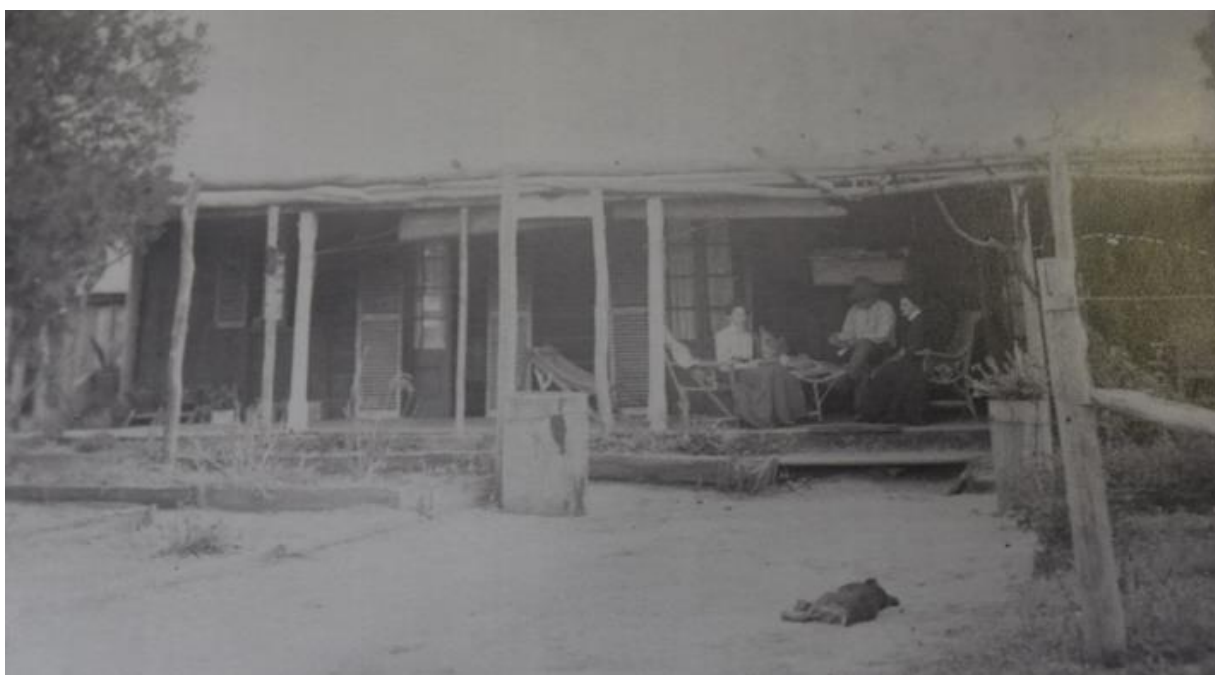
Figure 19. A man and two women sit on the front (north-east facing) verandah of the main Boondooma homestead, c.1910. Source: Boondooma Museum & Heritage Association (2021)

*Note the sets of French or double doors from the central three rooms leading onto the verandah and the timber-framed windows, some of which have fixed-louvre shutters.*

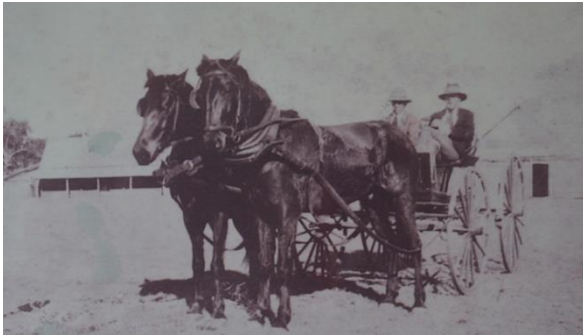
Figure 20. H Somerset and Archibald Graham Snr in a horse-drawn buggy on Boondooma c.1915, with the stone store building (left background) and the blacksmith's shed (right background). *Source:* Boondooma Museum & Heritage Association (2021).

*Note: This image is important as it illustrates that by 1915, there were lean-to verandah additions on the long and short sides of the stone store building and therefore, these structures were relatively early features. It also illustrates the blacksmith's shed, which is no longer extant.*

At some point, possibly in the 1870s, the stone building's original shingle roof was replaced with corrugated iron sheeting. While it is unclear whether Brill's original c.1850s construction had lean-to verandah additions (apart from the butcher's shop on the south-western façade), historical photographs show such additions present on both the long and short sides of the stone building by at least 1915 (see Figure 20, below). Nonetheless, these verandah additions, constructed of post and sapling frames, are relatively early features. By the late 1940s, the lean-to verandahs were in a deteriorated condition (see Figure 21, below) and were progressively removed and reconstructed over the course of the next forty years. By the early 2000s, the lean-to verandah additions on the long sides of the stone building had been reconstructed and enclosed with vertical timber slabs on the western ends of their northern and southern facades, and on their short western facades (Queensland Government 2016a). However, the verandah additions on the short sides of the stone building appear to have been reconstructed later, post-2002 (see Figure 22–Figure 23, below).

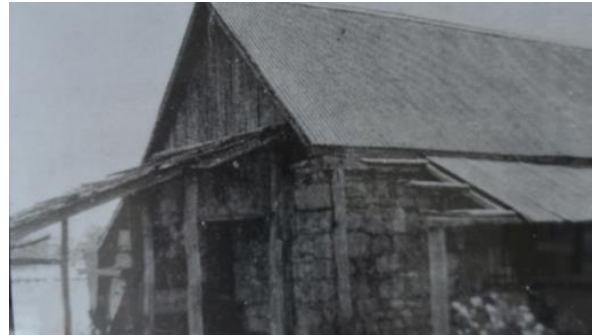
Figure 21. The stone store building c.1949, with the remnants of the timber 'butcher's shop' attached to the south-western façade. *Source:* Boondooma Museum & Heritage Association (2021).

*Note: This image illustrates the early lean-to verandah additions to the long and short sides of the stone store building, which are in a deteriorated condition here in the mid-twentieth century.*

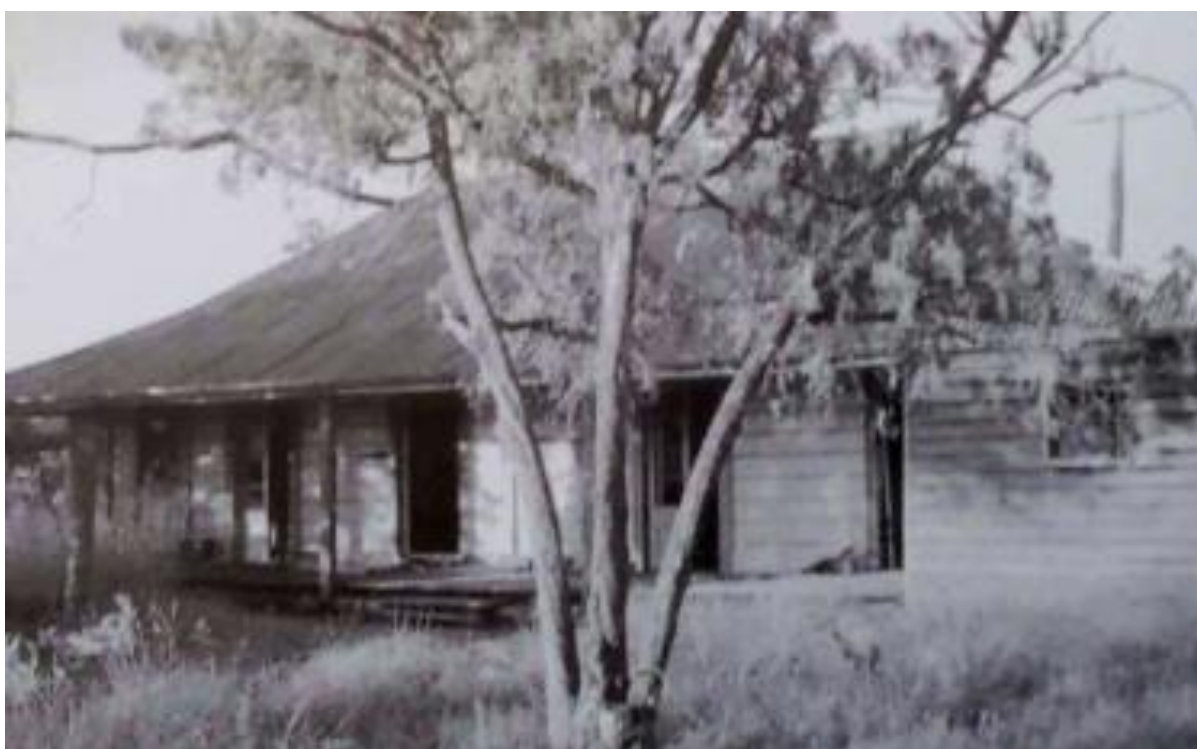
Figure 29. The main homestead at Boondooma, c.mid-1980s prior to the commencement of major restoration works, the majority of which were carried out by Albert ‘Buddy’ Thomson. Imagery courtesy of the Thomson family. *Source:* Matthews (2008, 38).

- re-pointing of stone walls;
  - the construction of replacement verandah additions on the long and short sides of the building; and
  - earthworks to excavate soil out from under the structure to facilitate its restoration.
- Main homestead:
- a complete reconstruction of the foundations to floor level;
  - repair of damaged timber wall sections;
  - repair of damaged roof sections and roof cladding;
  - restoration (partial) of the covered walkway and trolley system;
  - restoration (partial) of the detached ‘dining room’ structure, or possibly the location of the original homestead; and
  - earthworks to excavate soil out from under the structure to facilitate its restoration.

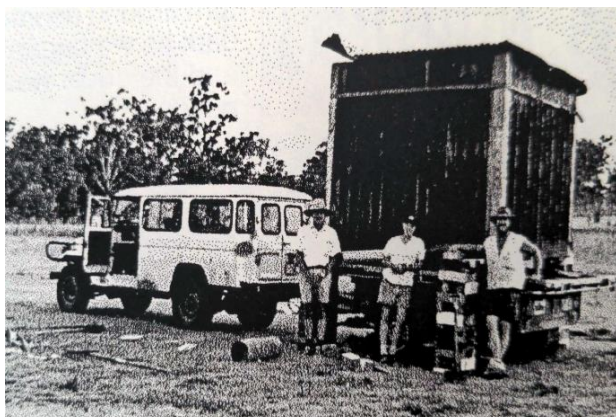
Figure 30. Lionel, Helen, and Phill pose in front of the structure known as the boundary rider's hut following its relocation to Boondooma, where it was re-stumped. *Source:* Boondooma Museum & Heritage Association (2021)<sup>54</sup>

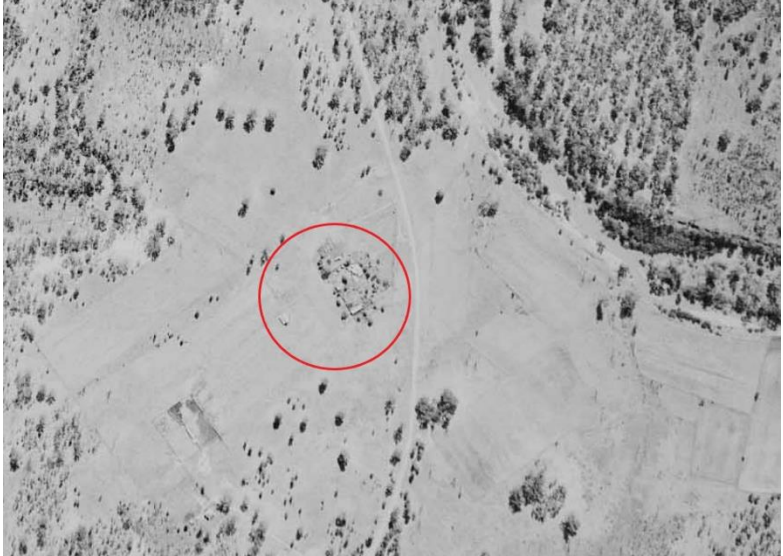
<p>Figure 45. Aerial image of Boondooma Homestead (red circle) and its immediate surrounds, 1 June 1952. Image FilmWAP0281 Frame 044. <i>Source:</i> QImagery (2021).</p>
1966	<p>Tracts of land surrounding the Boondooma Homestead complex appear to have been set aside and utilised for agricultural and pastoral purposes.</p> <p>A small dam has been constructed to the north-west of the complex.</p>

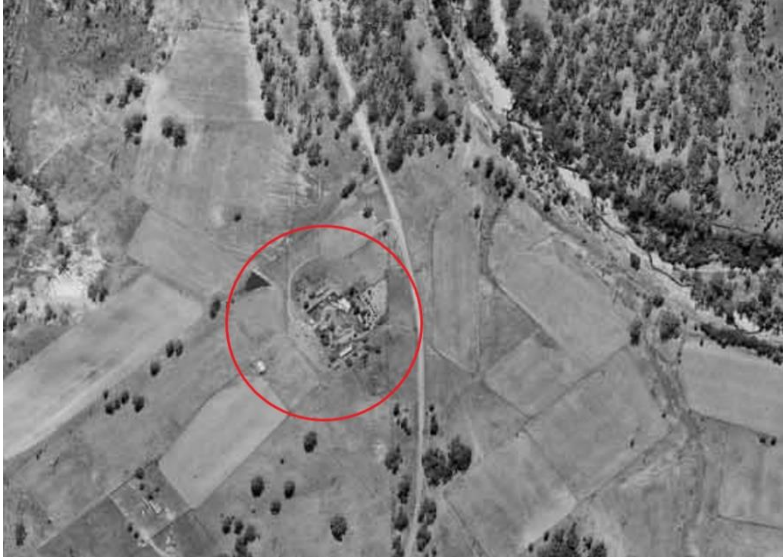
<p>Figure 46. Aerial image of Boondooma Homestead (red circle) and its immediate surrounds. 1 May 1966. Image Film QAP1684 Frame 050. <i>Source:</i> QImagery (2021).</p>

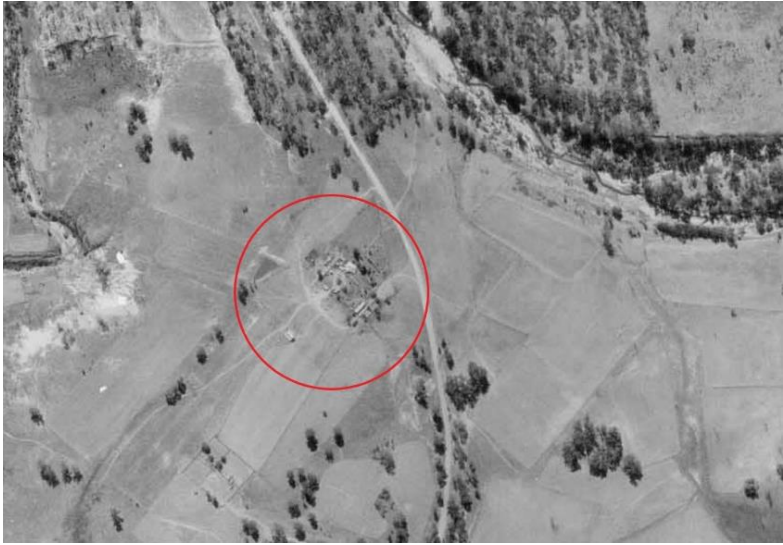
<p>Figure 47. Aerial image of Boondooma Homestead (red circle) and its immediate surrounds, 1 June 1971. Image Film QAP2233 Frame 065. <i>Source:</i> QImagery (2021).</p>
1984	<p>Evidence of further land clearing activities by this time.</p> <p>A new access track has been constructed connecting the Boondooma Homestead complex and Mundubbera-Durong Road.</p>

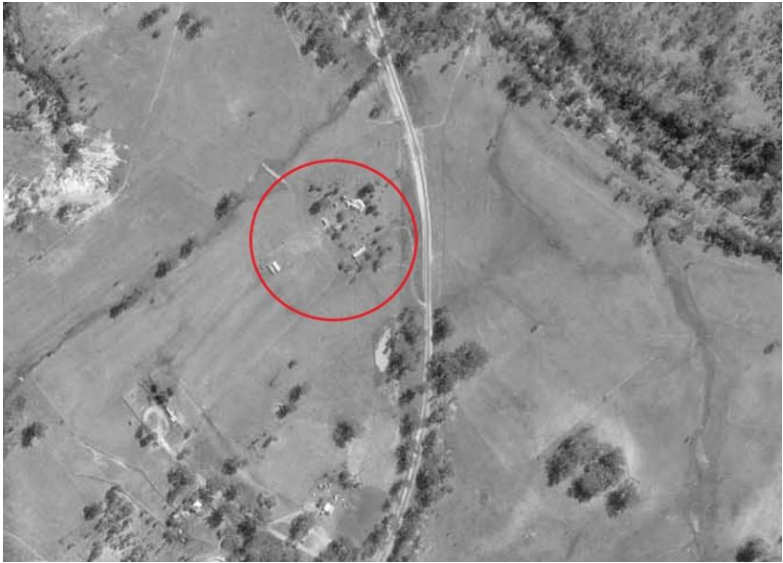
<p>Figure 48. Aerial image of Boondooma Homestead (red circle) and its immediate surrounds, 1 August 1984. Image Film QAP4306 Frame 171. <i>Source:</i> QImagery (2021).</p>

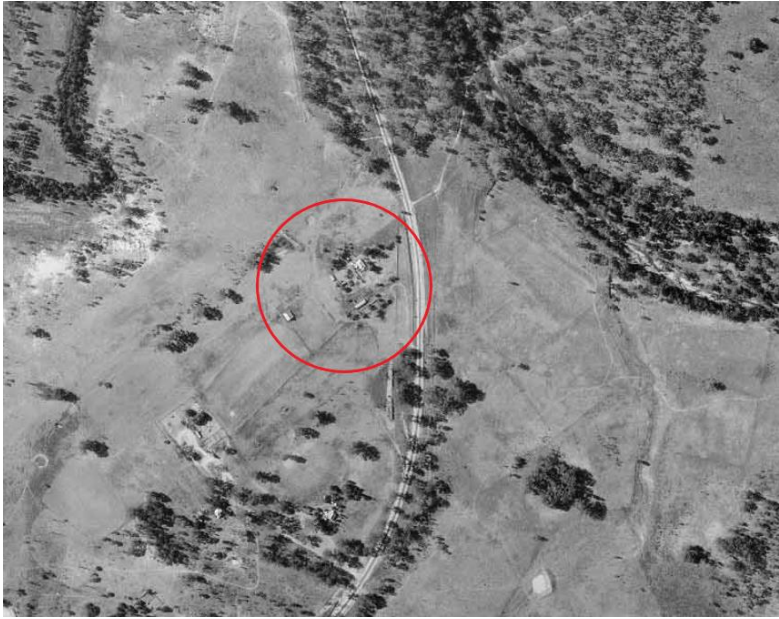
<p>Figure 49. Aerial image of Boondooma and its immediate surrounds, 1 March 1991. Image Film QAP4929 Frame 157. Source: QImagery (2021).</p>
2002	<p>A caretaker's cottage has since been relocated to the Boondooma Homestead complex.</p> <p>A number of additional structures have since been constructed including the 'Big Top' entertainment area, archives building and museum building, all within the area between the stone store building and the main homestead.</p>

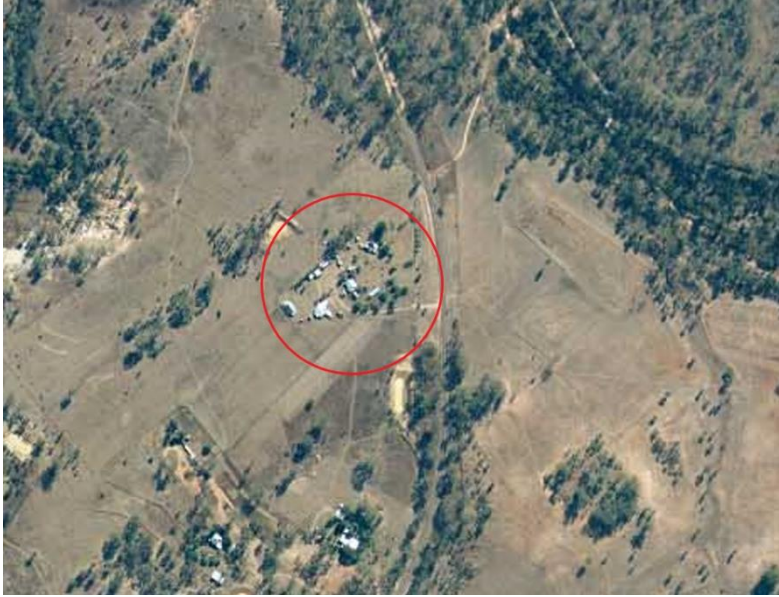
<p>Figure 50. Aerial image of Boondooma and its immediate surrounds, 1 July 2002. Image Film QAP6010 Frame 048. Source: QImagery (2021).</p>

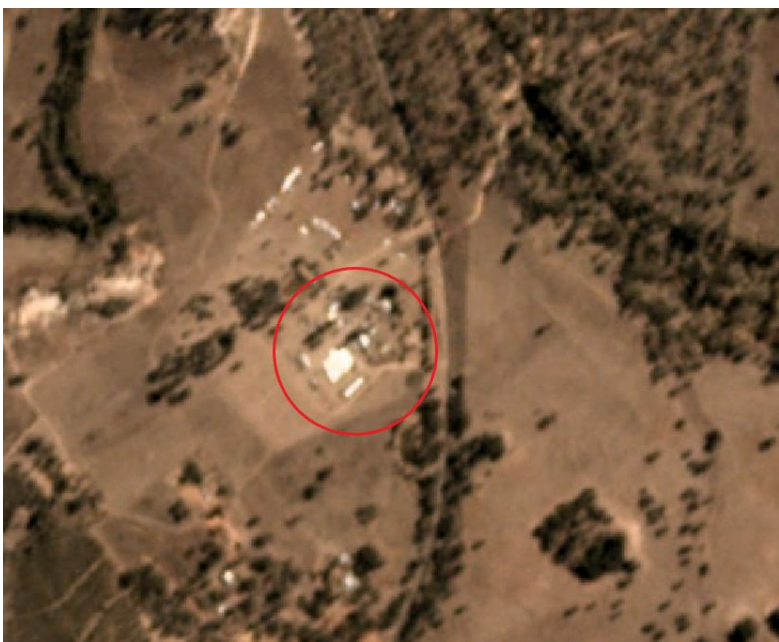
<p>Figure 51. Aerial image of Boondooma and its immediate surrounds, 1 July 2017. Image L16-7538E-3477N. <i>Source:</i> QImagery (2021).</p>

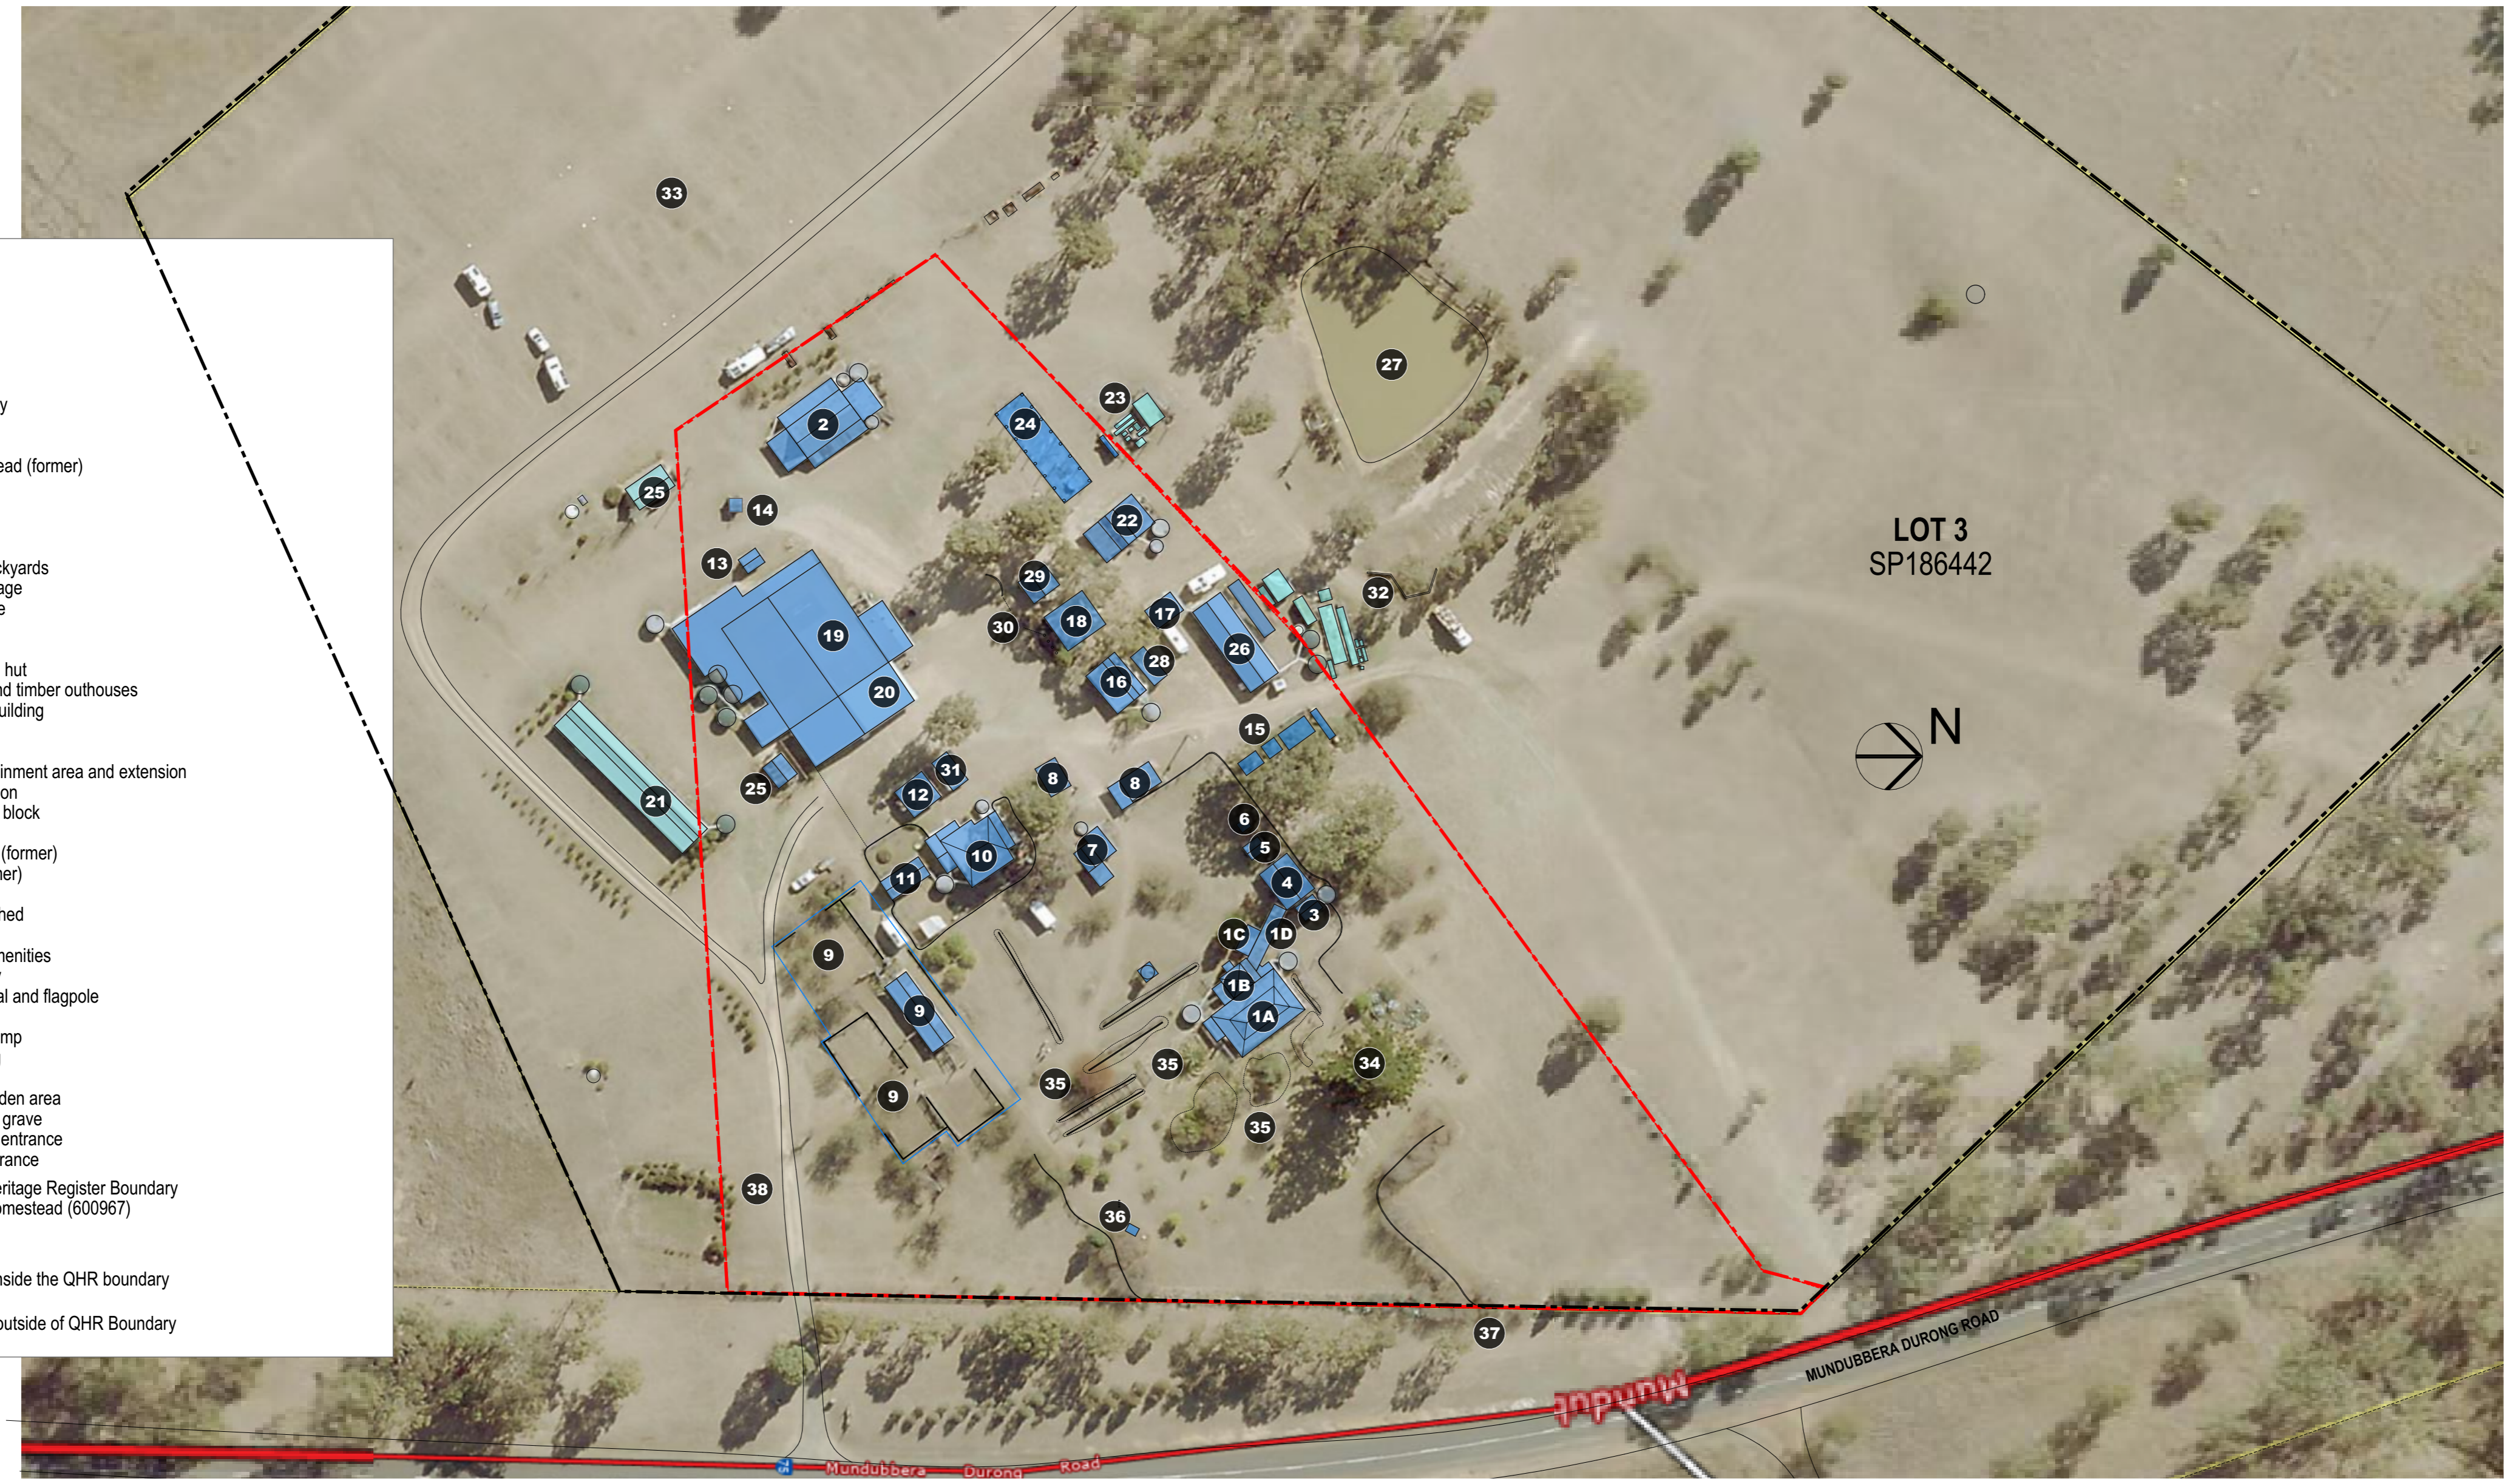
Figure 55. Existing aerial view site plan for Boondooma Homestead, identifying the site's principal and ancillary structures in relation to the place's QHR boundary. Source: Extent Heritage (2021).

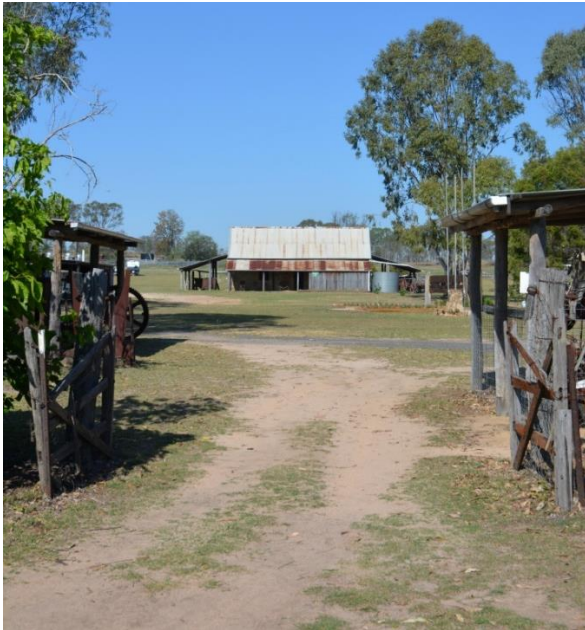
Figure 58. View facing west from the gate of the main homestead (i.e., adjacent to the postal receiving office) towards the stone store building.

*From this vantage, there is a clear view line to the stone store building. However, if standing further to the north-east (i.e., behind the photographer at the rear of the homestead building itself), the stone store building is not as readily visible.*

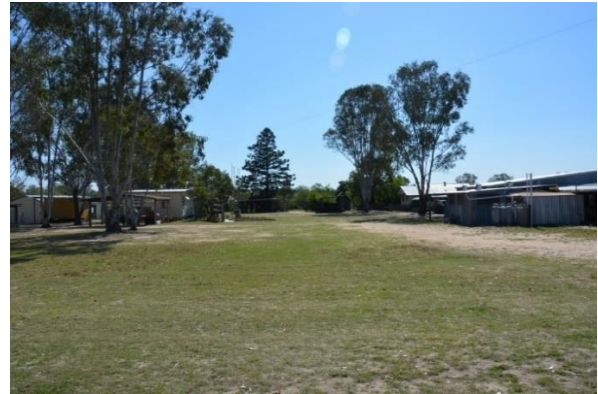
Figure 59. View facing east from the stone store building towards the main homestead.

*From this vantage, the main homestead is not readily visible due to the garden and vegetation surrounding the building. As an indication, the mature hoop pine is in the homestead's front garden.*

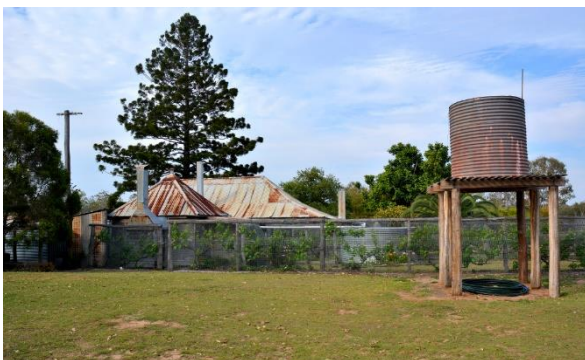
Figure 60. View facing east of the rear elevation of the main homestead from the open space between the cluster of other historical structures.

*Note: The milking bails and stockyards are located to the right, out of frame, the postal receiving office behind the photographer, and the cool and meat houses to the left, out of frame.*

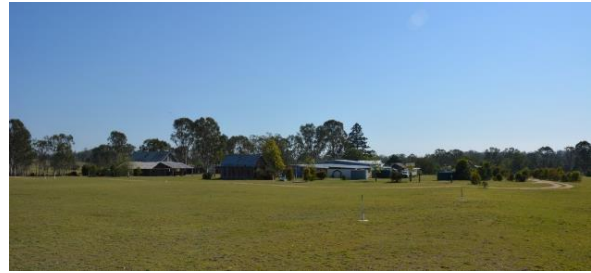
Figure 63. View from the open grassed area utilised for caravans and campers, facing north-east the main cluster of buildings and structures comprising the Boondooma Homestead complex.

*This view captures the stone store building (left), one of the toilet blocks (centre), and the 'Big Top' entertainment area. Ca*

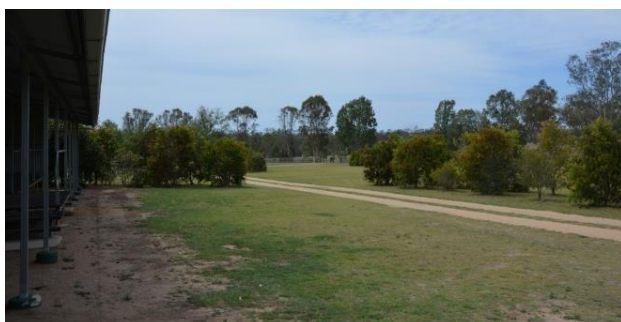
Figure 68. View facing east showing the gravel entrance driveway, at the point where it branches off to provide access along the accommodation building.

The driveway, comprising a packed gravel base, leads into the property in a westerly direction and at the point where it meets the stockyards, splits into a fork: one route branches to the south-west, providing access to the accommodation building and the large, grassed caravan and camping areas in the rear aspects of the property; and the other route continues west, terminating at a small, grassed visitor car parking area adjacent to eastern corner of the 'Big Top' entertainment area.

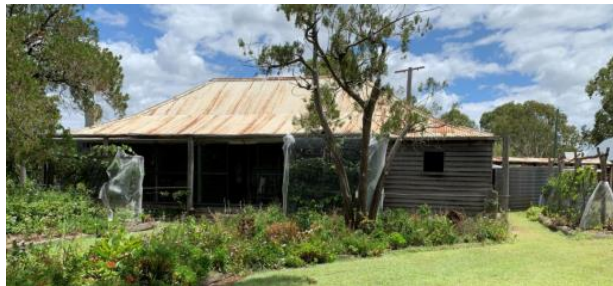
Figure 80. The south-west (rear) elevation of the main homestead.

*Note the pyramid roof profile of the detached kitchen.*

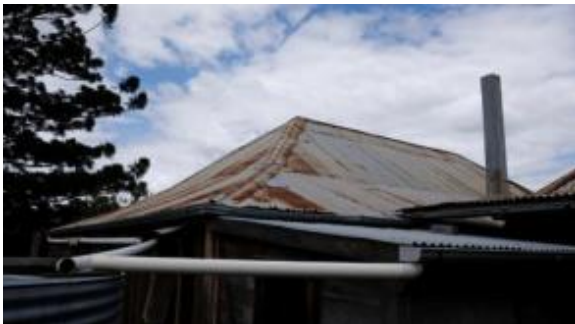
Figure 86. View facing north-east showing the 'broken back' roof profile of the main homestead, and the skillion-roof of one of the small extensions.

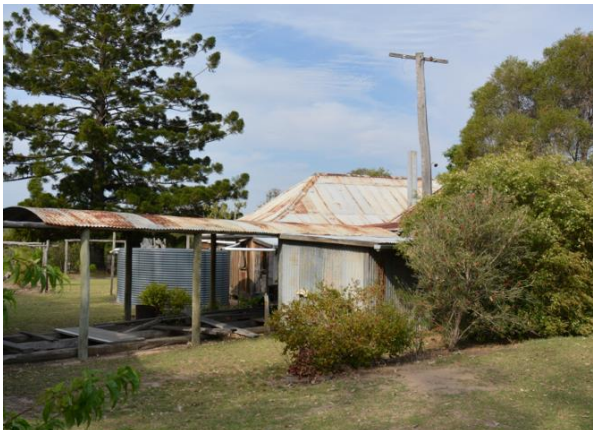
Figure 87. View facing north-east showing covered walkway, constructed of a post-and-sapling frame with a corrugated iron roof, connected to the main homestead.

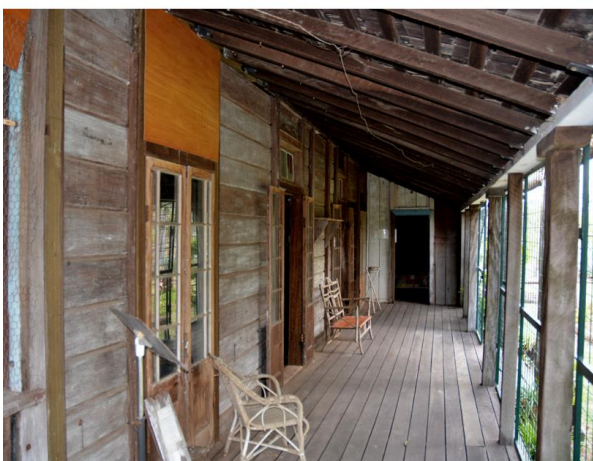
Figure 88. The front verandah of the main homestead, showing the modern, powder-coat steel, grid-mesh screening that encloses the verandah for security purposes.

The exterior is largely unpainted; however, the exterior walls facing the verandahs at the rear verandah and kitchen area are painted, possibly in a lime-based paint. Some window and door joinery has been painted, or refinished clear. The verandahs have been enclosed by modern, powder-coat steel, grid-mesh screening, and gates for security purposes.

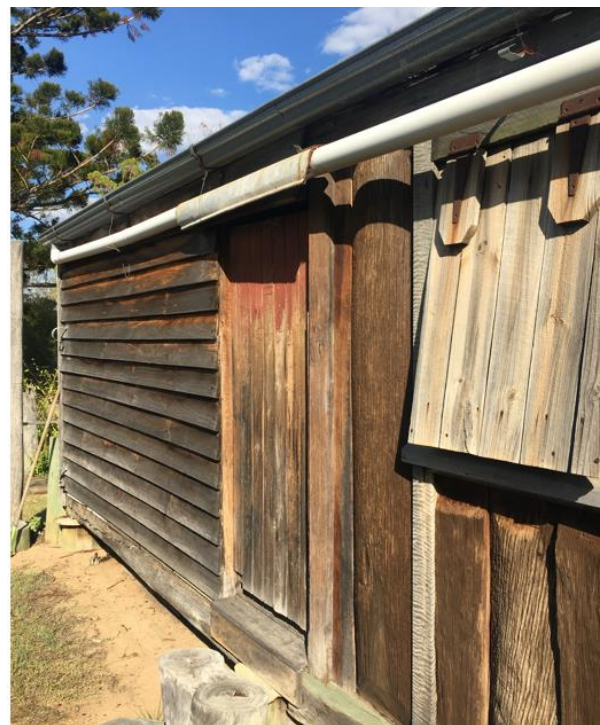
Figure 92. Example of the homestead's timber-framed windows with fixed-louvre shutters.

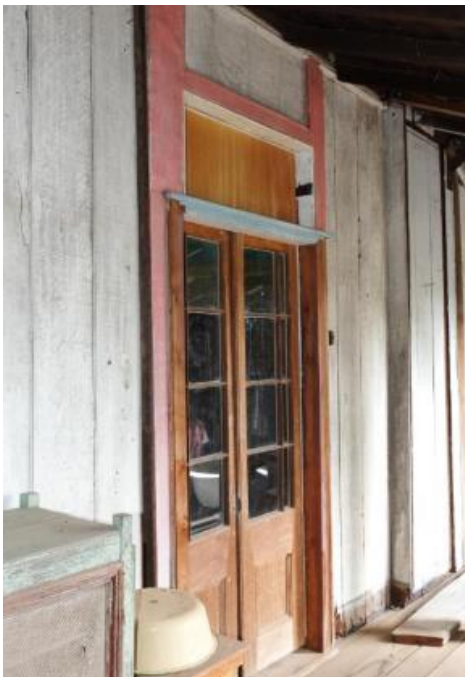
Figure 95. Example of the reconstructed timber window awnings fitted to window openings on the homestead's north-west elevation.

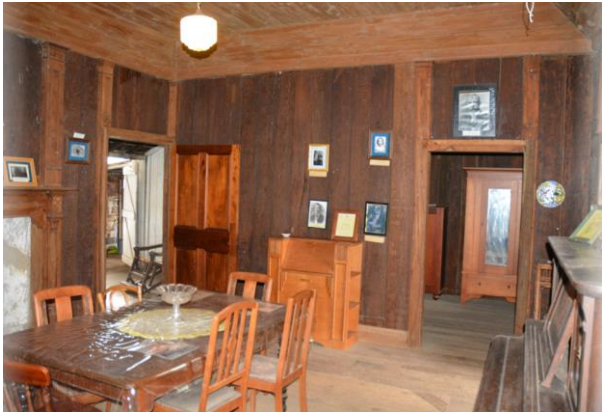
Figure 102. *Left and Right.* Interior of the main homestead's dining room.

*Note the finely detailed timber joinery in this main section of the house, and the contrast between the dark hardwood timber used for the internal walls compared to the lighter milled timber used to line the ceiling. The early paint/lime wash finish on the ceilings is no longer extant.*

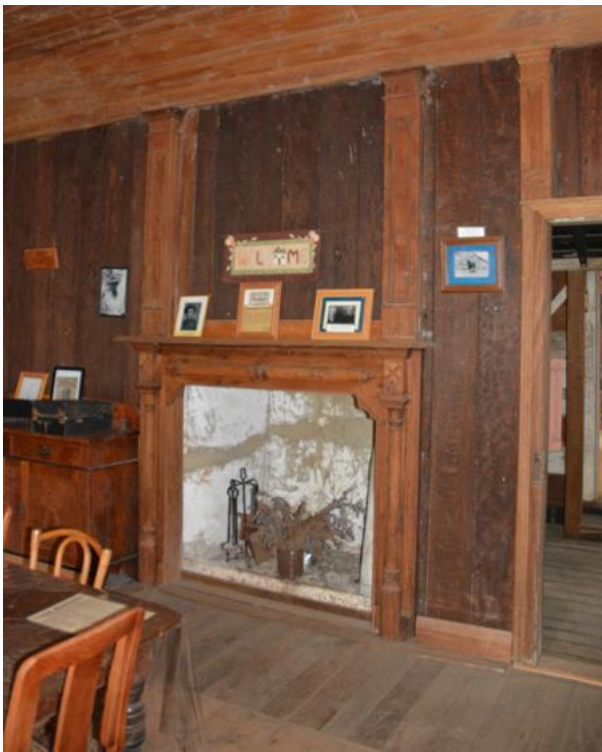
Figure 104. Interior of the main homestead's central dining room.

*Note the internal walls of dark hardwood, rough-hewn slabs, fitted vertically. The door to the right of the mannequin leads to Bedroom 1.*

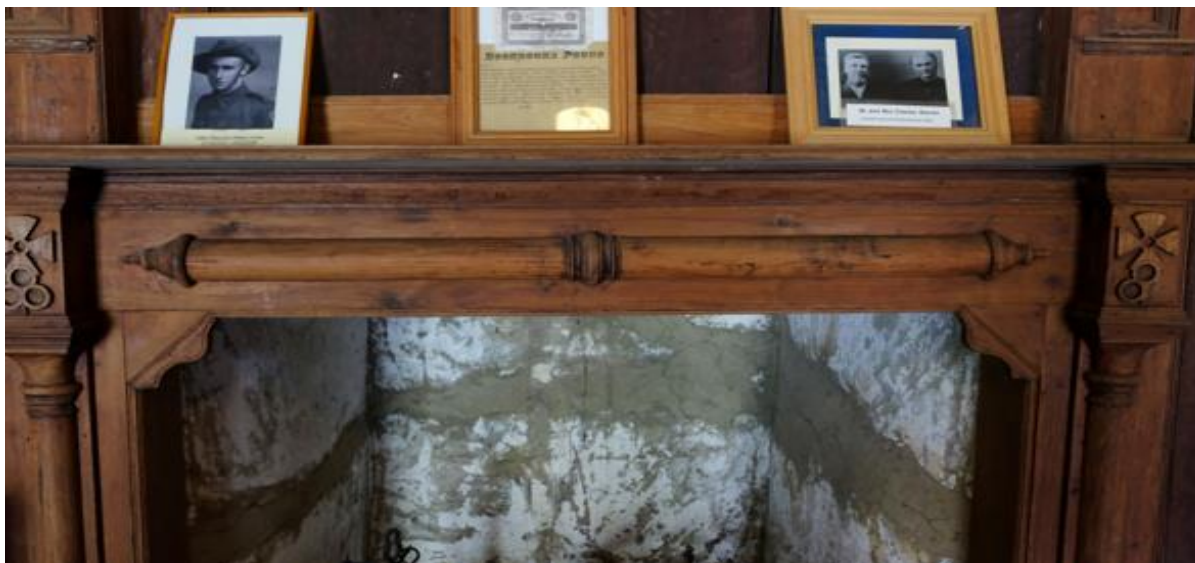
Figure 107. Detail of the timber mantelpiece of the dining room fireplace in the main homestead.  
*Note the finely-detailed timber joinery and mouldings. The early shellack and wax finish of the mantelpiece has been removed.*

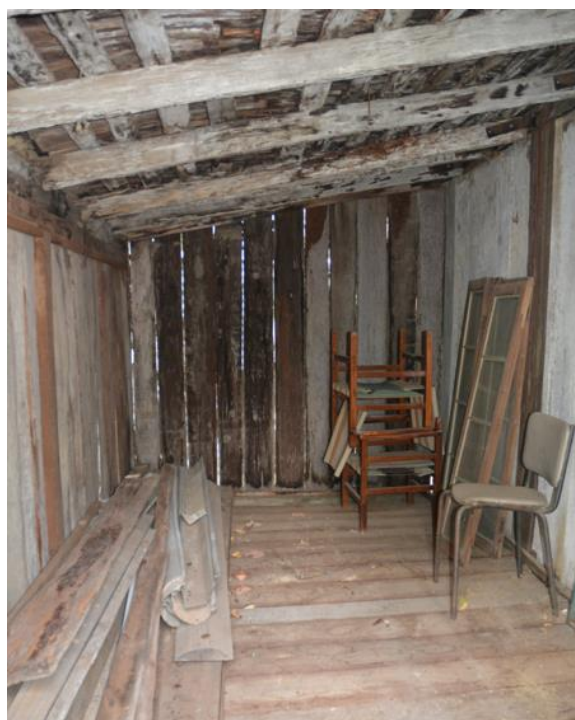
Figure 110. Interior of Bedroom 1 showing the wall under the low side of the ceiling with a small timber slab door that accesses an additional room, which is considered to have been used as a nursery.

*Note the reconstruction clad in galvanised iron sheet that replicates a fireplace, adjacent to the nursery door.*

Bedroom 1 may have been extended at some point, and opens through to include a section of verandah area. This is evident in the low-pitched ceiling, partly painted, falling from the beam that may once have contained a wall. The wall under the low side of the ceiling has a doorway that accesses the small additional room, which is considered to have been used as a nursery. A reconstruction clad in galvanised iron sheet replicates a fireplace adjacent to the nursery door. Some framing elements are painted and remnants of wall paper are found above the doorway leading to the dining room. The room is fitted with period furniture. The room has a four-panel timber door to the dining room and French doors open to the front and rear verandah.

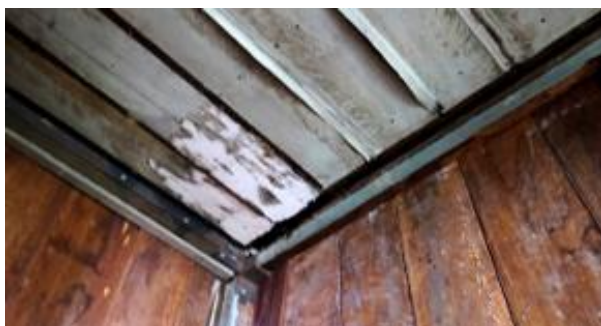
Figure 112. Detail of the north-west corner of the ceiling in Bedroom 2, showing water penetration affecting the ceiling, and movement at wall and ceiling junction.

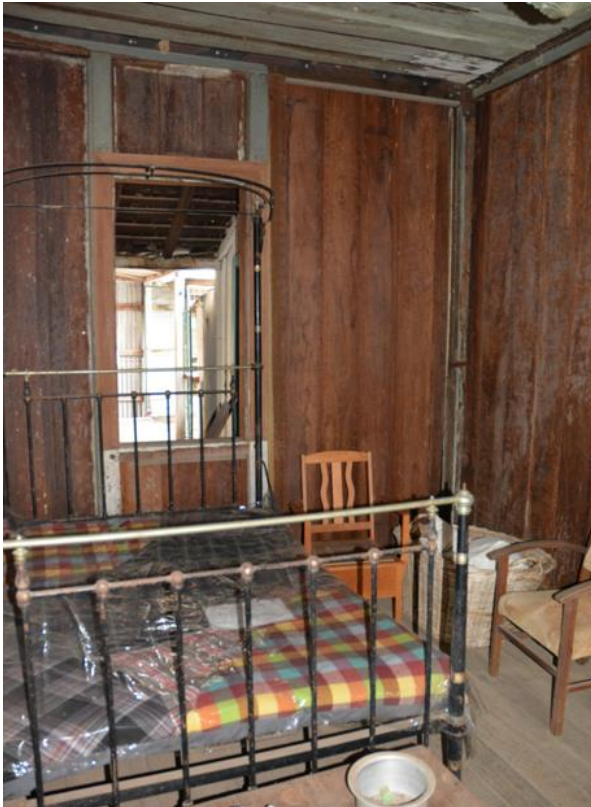
Figure 113. The south-east corner of Bedroom 2, which is showing evidence of water penetration affecting the timber ceiling fabric.

Bedroom 2 is constructed and finished in a similar manner to the dining room: a sash window opens to the rear verandah, and a French door opens to the front verandah. The four-panel door through to the dining room is restored; however, significant water damage is evident, with calico ceiling linings becoming dilapidated. Substantial movement at the north-west corner is also evident.

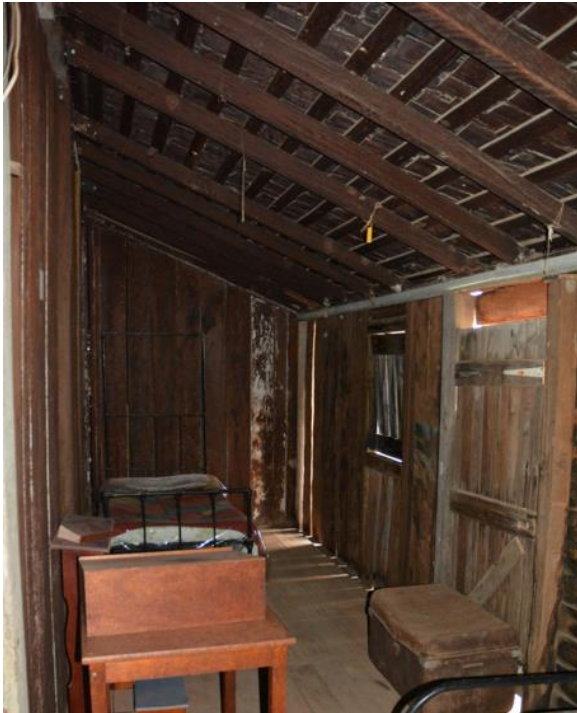
Figure 117. Interior of Bedroom 3, an enclosed section at the western end of the front verandah.

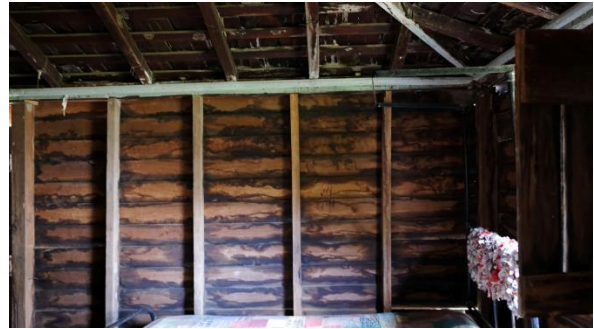
Figure 118. Interior of Bedroom 3, showing the surviving roof shingles fixed under the roof sheet.

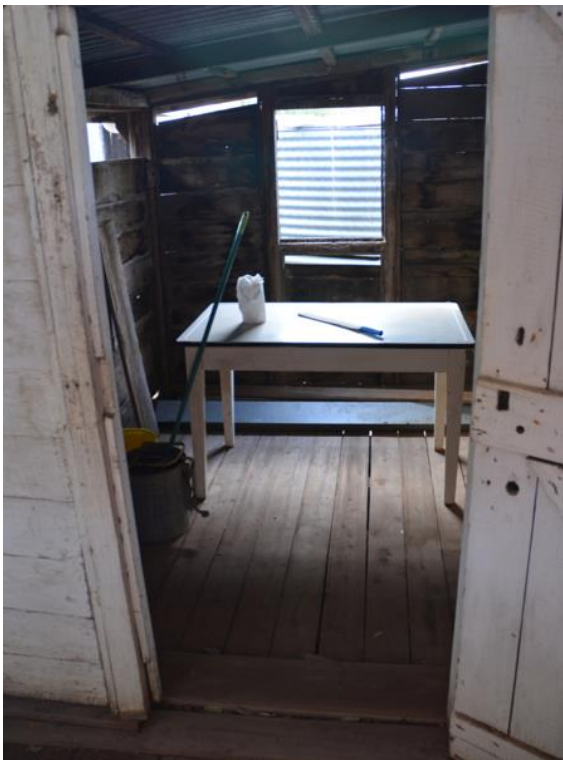
Figure 119. Interior of Bedroom 3 showing the single-skin construction framing exposed in this room.

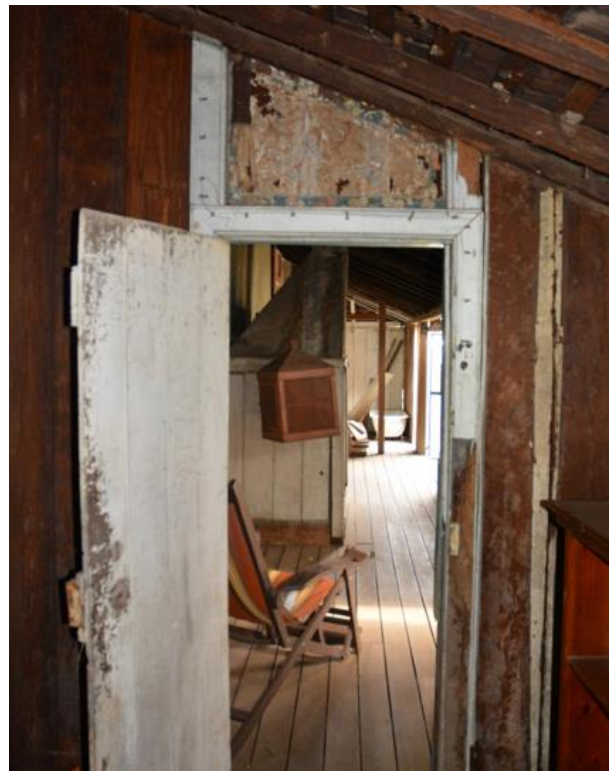
Figure 120. Interior of the small room of unknown use created through the addition of a skillion-roof extension.

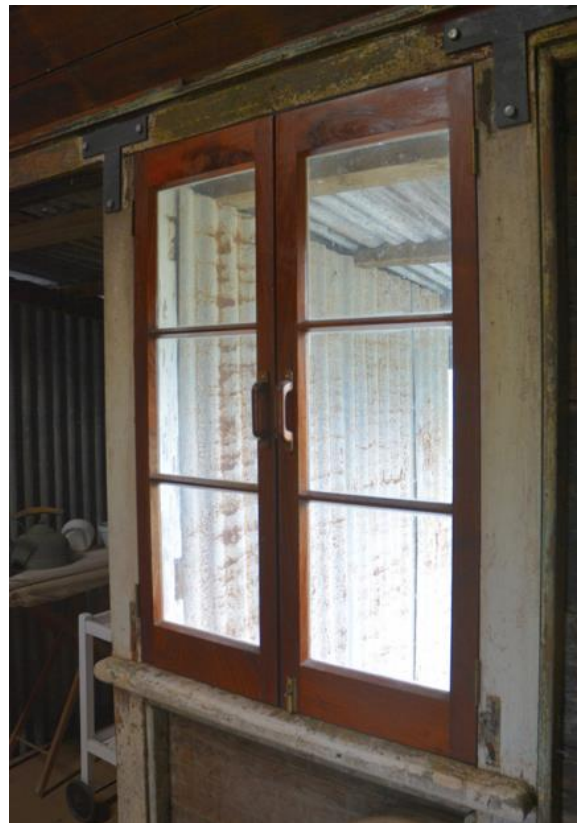
Figure 125. Example of the replacement timber casement windows in the kitchen, which are non-sympathetic additions.

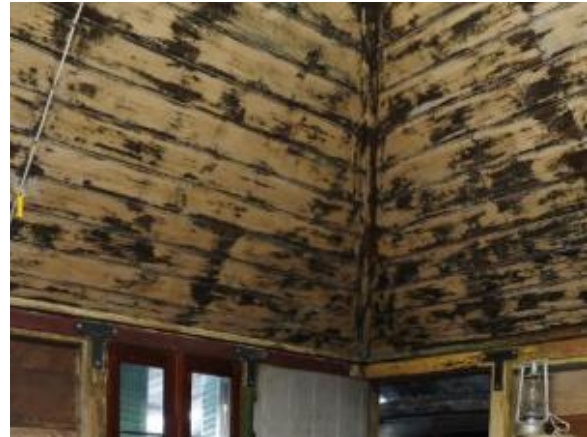
Figure 126. Interior of the detached kitchen, with the doorway to the semi-enclosed verandah (and beyond that, the dining room), at the left.

*Note the unlined walls.*

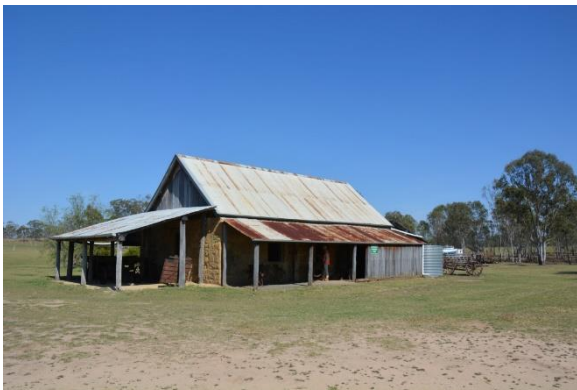
Figure 131. The north-east elevation of the stone store building.

*Note the lean-to verandah additions, constructed of post-and-sapling frames with a corrugated iron sheeting roof, on all sides.*
