# Boondooma Homestead, 8262 Mundubbera–Durong Road Conservation Management Plan

Prepared for Boondooma Museum & Heritage Association Inc.

June 2022—FINAL

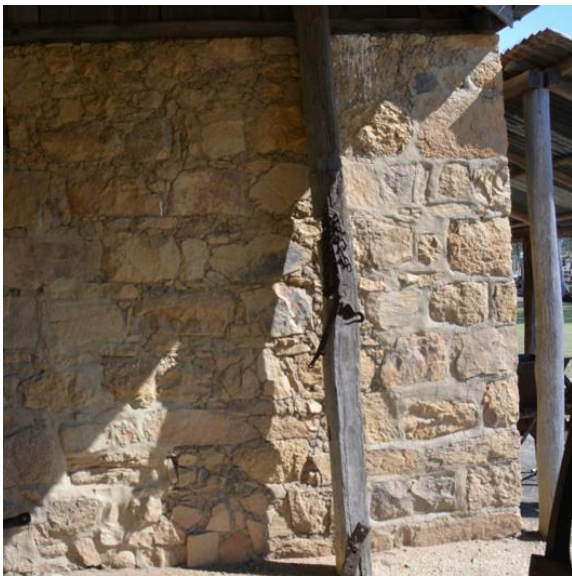
Figure 135. Typical example of the central core, constructed of large sections of stone arranged roughly in courses, between which smaller pieces have been inserted.

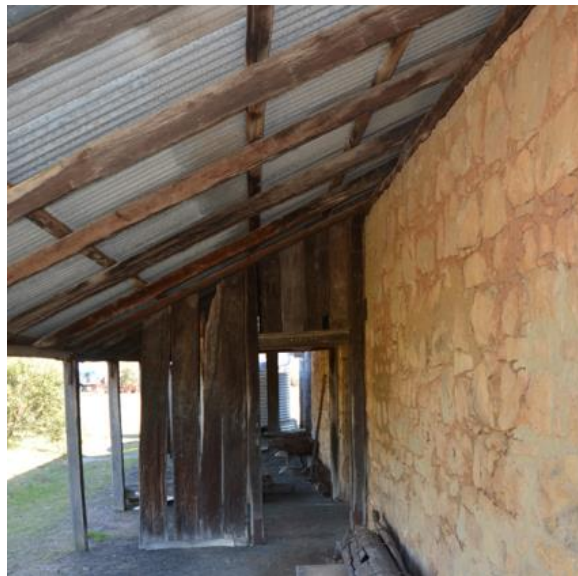
Figure 136. Example of the post-and-sapling frame construction of the lean-to verandah additions, which are reconstructions of earlier features.

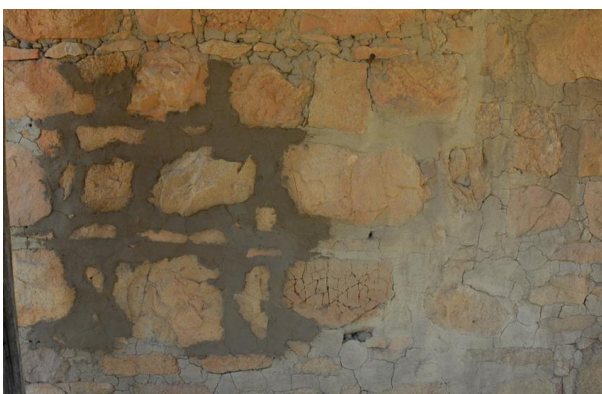
Figure 139. Detail of a section of re-pointed stonework utilising the incorrect mortar mix, as part of previous restoration works.

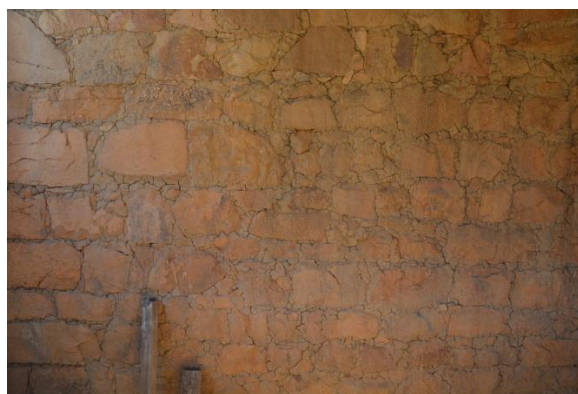
Figure 140. Detail of the typical stonework held together with ant bed mortar.

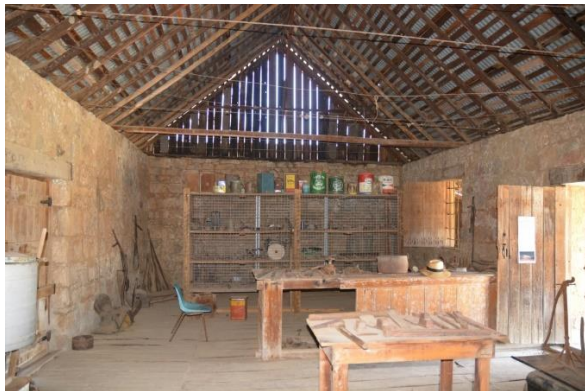
Figure 141. Interior of the north-west end of the stone store.  
*Note the exposed timber rafters and roof framing.*

Internally, the building is rectangular in plan and features no internal walls or partitions, although paint on the stonework may be indicative of previous partitioning. The stone walls are unlined. The timber rafters and roof framing are exposed and the battening from the original shingle roof is still visible. A number of ironbark roof ties are also in place. The floor is constructed of wide, hardwood shot-edge boards atop timber joists and bearers, which were restored and reconstructed in the early 2000s.

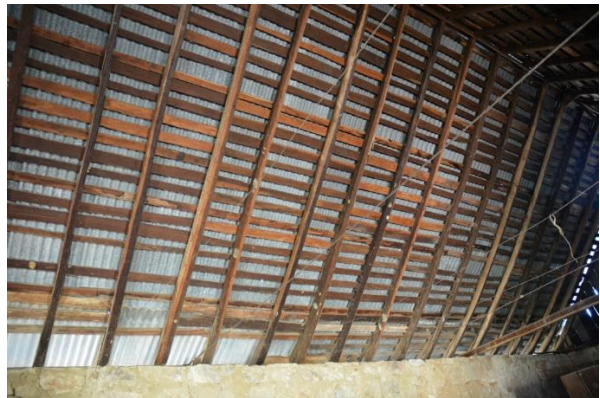
Figure 142. Detail view of the stone store's exposed internal roof structure.

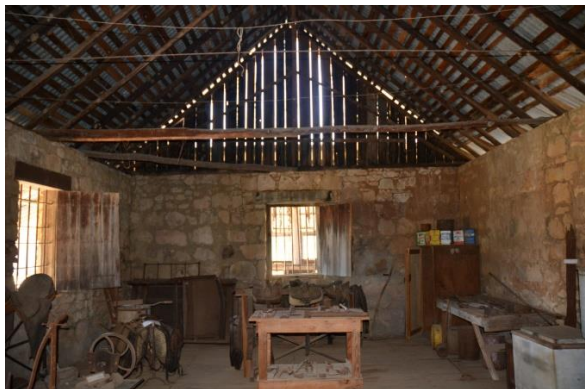
Figure 143. Interior of south-east end of the stone store.  
*Note the two windows with vertical iron bars and timber shutters.*

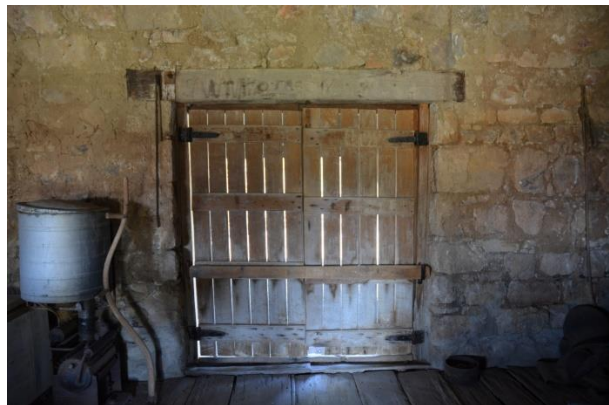
Figure 144. Detail of the timber double doors, which provide access to the stone store.

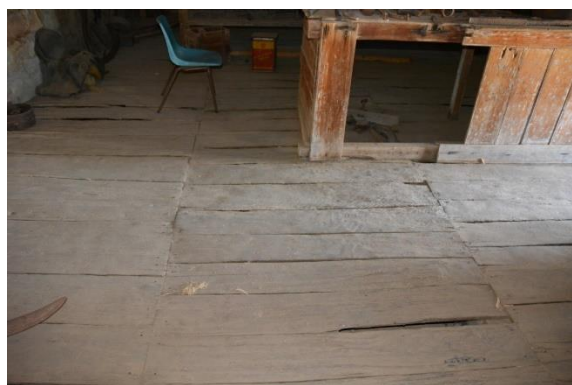
Figure 146. Interior view of hardwood shot-edge boards of the Stone Store.

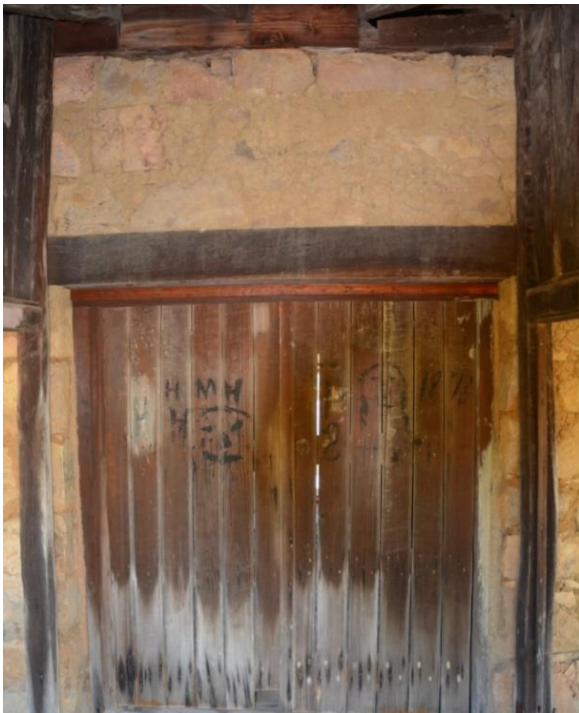
Figure 147. Exterior view of the store's double entrance doors.

*Note here how the stonework continues to the underside of the main roof.*

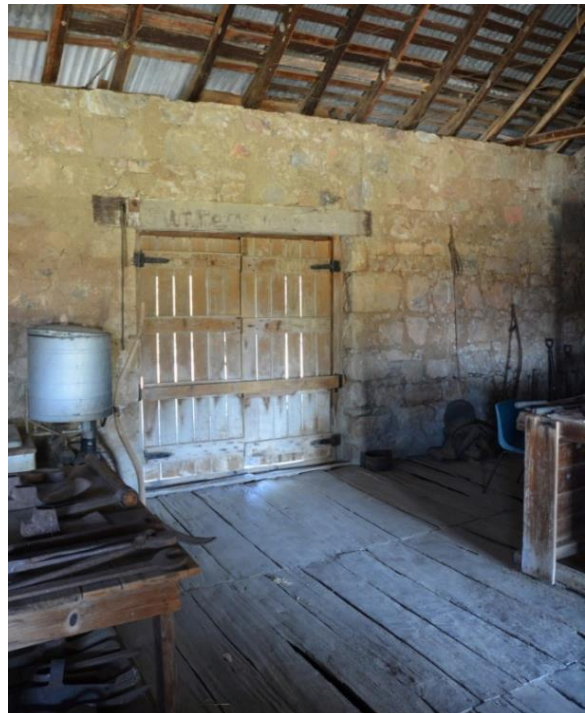
Figure 148. Interior view of the south-west wall of the stone store, showing the floor constructed of wide, hardwood shot-edge boards atop timber joists and bearers, which were restored and reconstructed in the early 2000s.

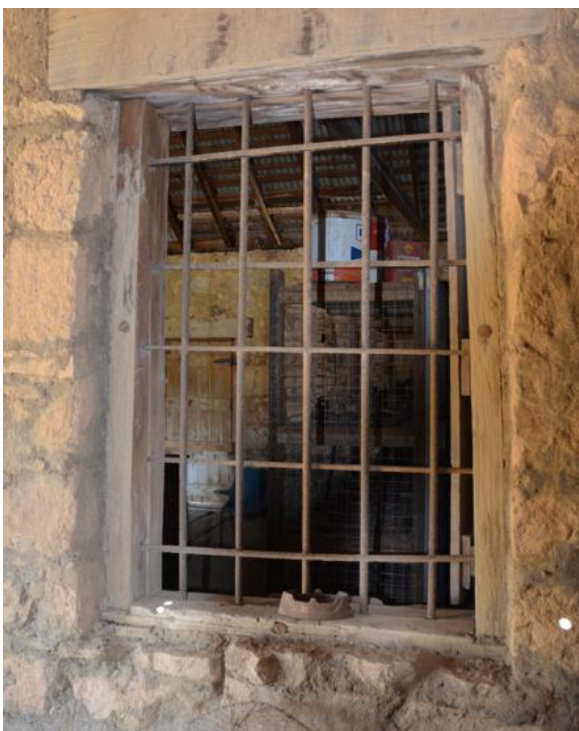
Figure 149. Detail of a typical window with timber lintels and frames and iron bars.

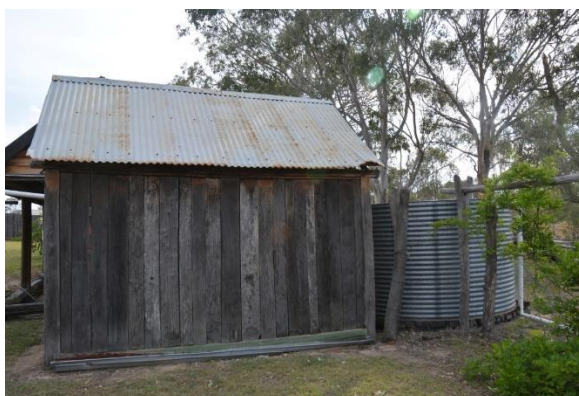
Figure 151. The north-east elevation of the meat house with a large water tank adjacent.

*Note the timber slab and bed log construction and gable roof clad in corrugated iron.*

Constructed c.1870s, the meat house is located to the north-west of the main homestead, on the northern side of the covered walkway. It was traditionally used as a domestic meat store for the occupants of Boondooma homestead. The structure is of timber slab and bed-log construction with a compacted earth floor and gable roof clad in corrugated iron sheet.

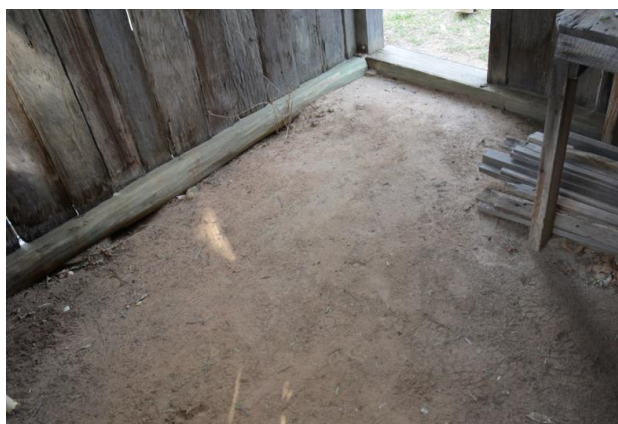
Figure 154. Interior of the meat house showing the compacted earth floor.

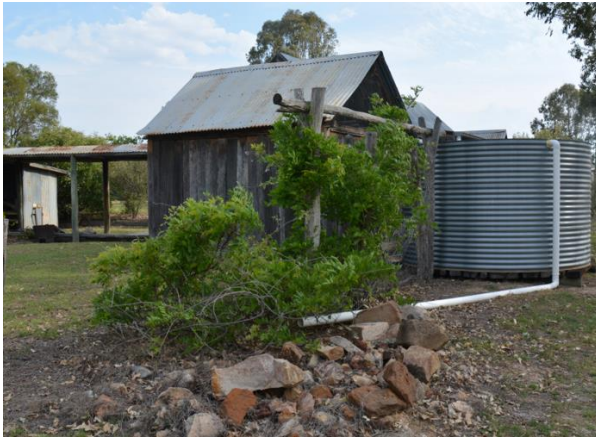
Figure 155. View facing south-west of the meat house, showing the adjacent water tank and timber trestle supporting the rainwater goods.

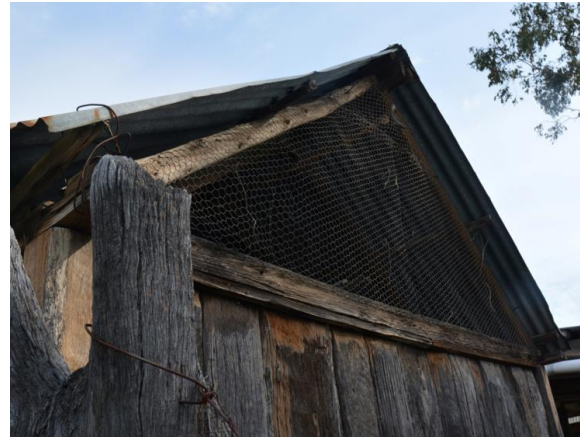
Figure 156. Detail of the chicken wire mesh gable infill.

Due to the structure's natural deterioration, it was reconstructed in the early 2000s. The two gable ends are now infilled with chicken wire mesh and a large contemporary water tank and timber trestle are positioned on the north and north-east sides of the structure.

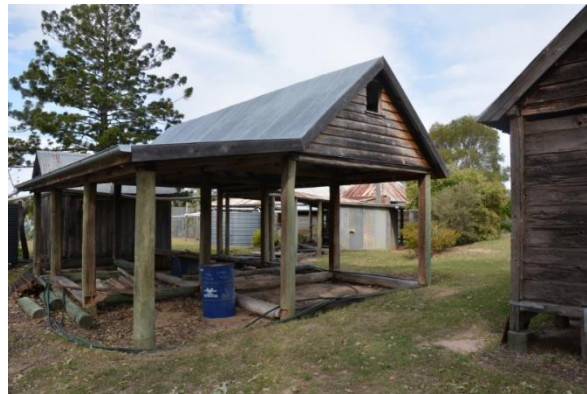
Figure 158. View facing north-east of the incomplete reconstruction of the detached c.1870s 'dining room' structure, or possibly an earlier dwelling.

*Note the gable roof with timber infill.*

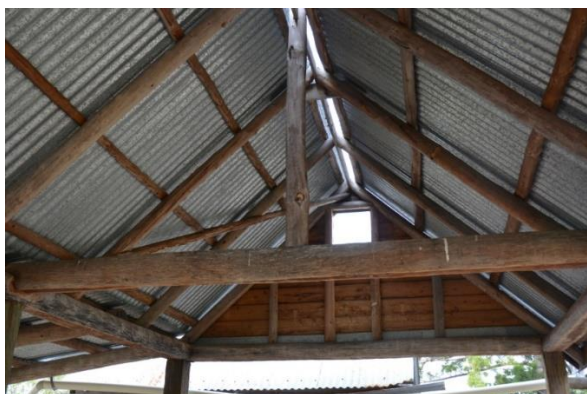
Figure 159. Interior view of the reconstructed timber roof framing built using traditional bush carpentry construction.

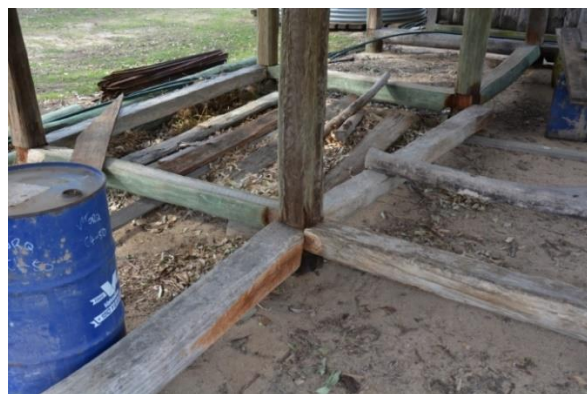
Figure 160. The reconstructed timber bearers and columns comprising the structure.

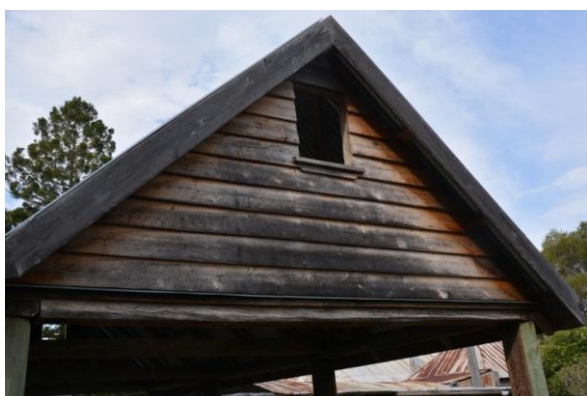
Figure 161. Detail of the timber gable infill.

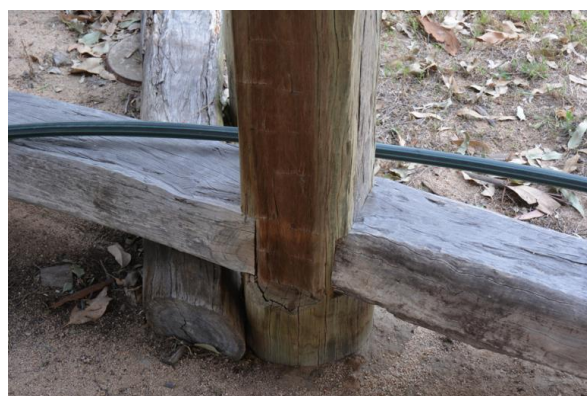
Figure 162. Detail of the intersection of a column and bearer reconstructed using traditional bush carpentry techniques.

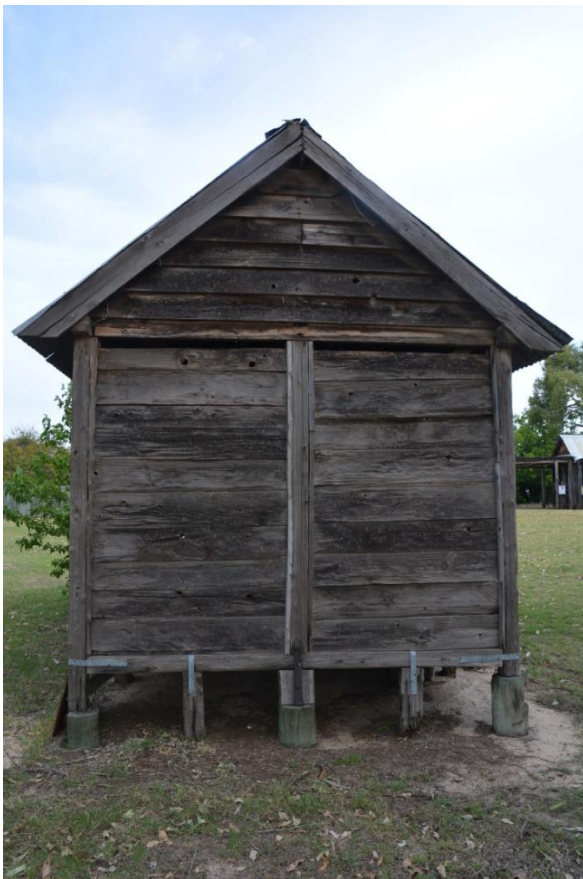
Figure 163. The rear north-west elevation of the cool house, which has been re-stumped in recent years.

*Note the contemporary steel tie-downs.*

The cool house is located between a timber outhouse (see Part 5.10, below) and the reconstruction of the detached 'dining room' structure (see Part 5.8, above). It is constructed of horizontal timber slabs of Cypress pine with a gable roof form clad in corrugated iron and a compacted earth floor. It is believed to have been completed sometime in the early 1860s and is believed to have been used for hanging meat after slaughter. It features openings through to the ground in the lower wall perimeter, allowing cooler air to enter. The building has been re-stumped at some point in recent years, and has contemporary steel brackets/tie-downs.

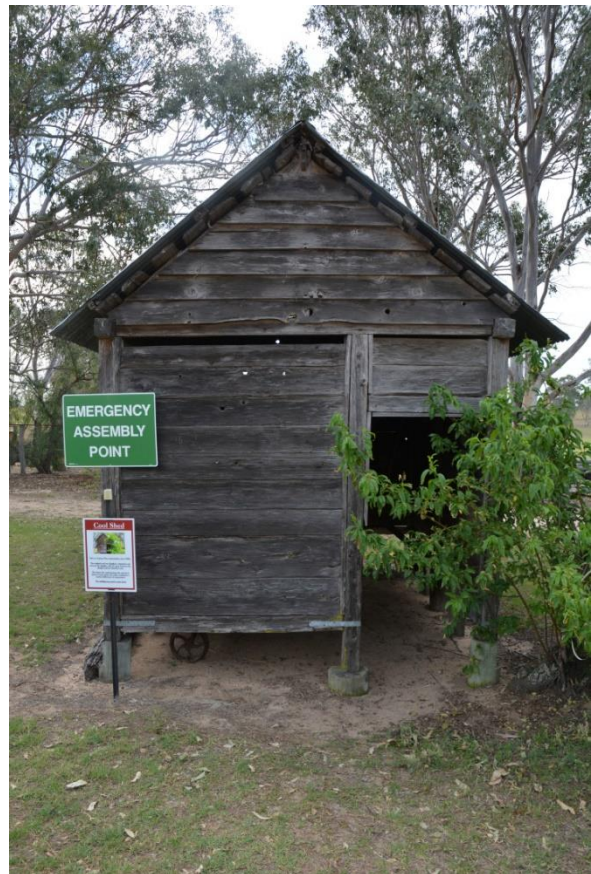
Figure 164. The main south-east elevation of the cool house, constructed of Cypress pine slabs, horizontally fitted.

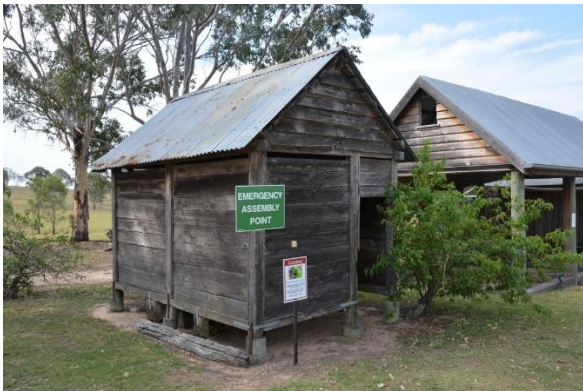
Figure 165. The south-east elevation of the cool house, with the reconstruction of the detached c.1870s 'dining room' structure adjacent.

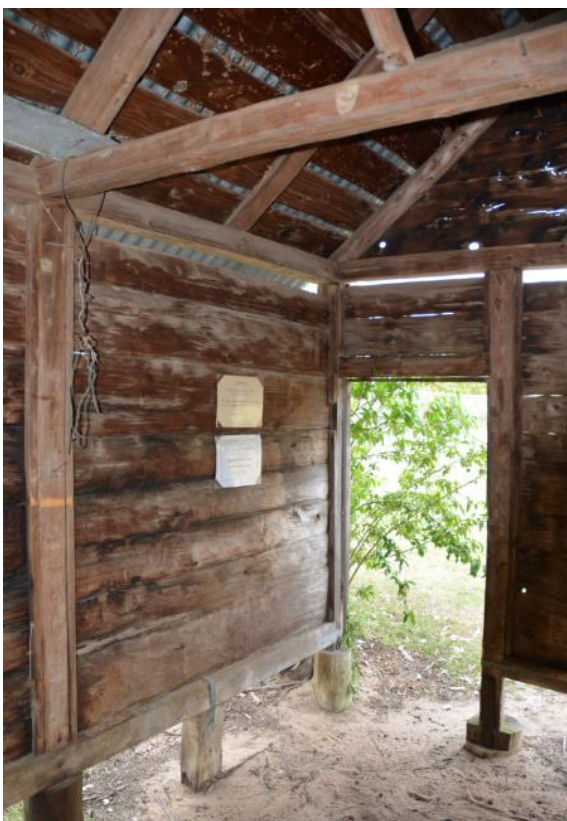
Figure 167. Interior of the cool house, illustrating its construction of horizontal timber slabs of Cypress pine.

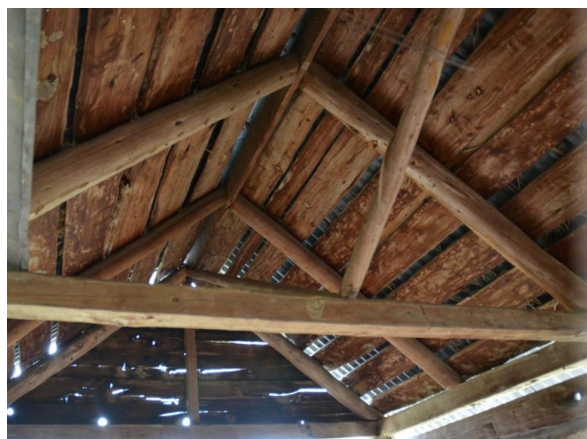
Figure 168. Interior of the cool house showing the gable roof form and horizontal timber slabs of Cypress pine.

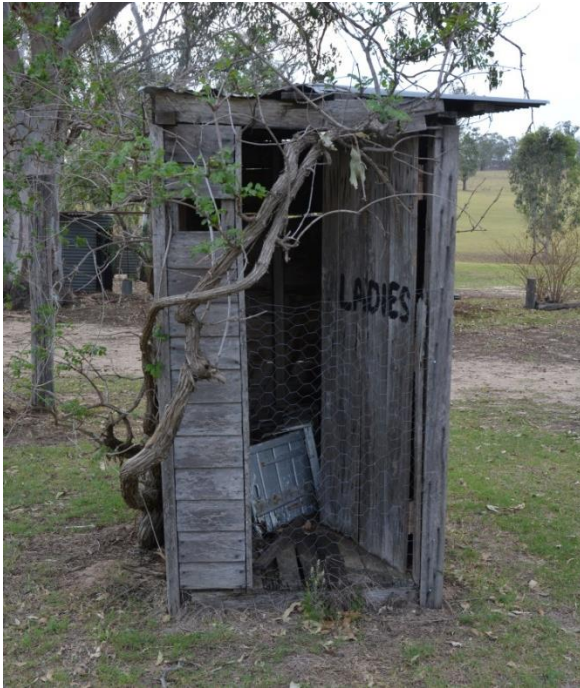
Figure 169. The south-east elevation of the outhouse.

A single timber outhouse is located adjacent to the cool house, west of the main homestead, and is constructed of timber chamferboards with a bent corrugated iron sheet roof. The outhouse is in a dilapidated condition, and a tree has wrapped itself along the western and northern sides. It has been disused for decades, and currently stores miscellaneous items.

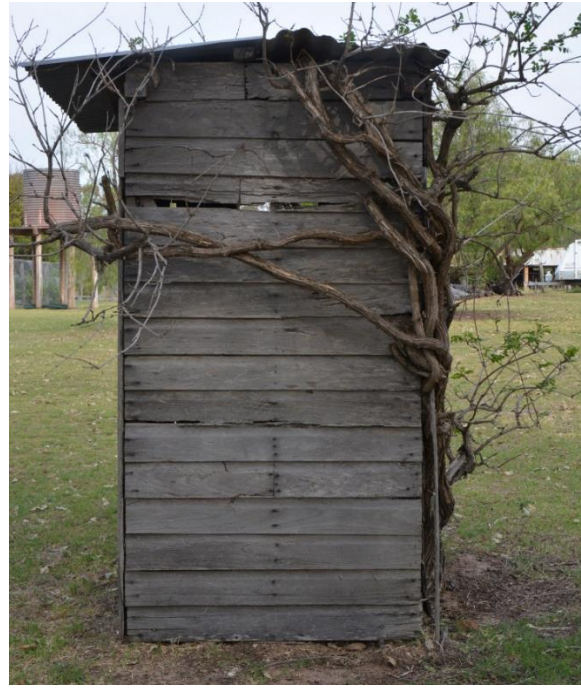
Figure 170. The north-west elevation of the outhouse, showing the extent of the tree growth around the structure.

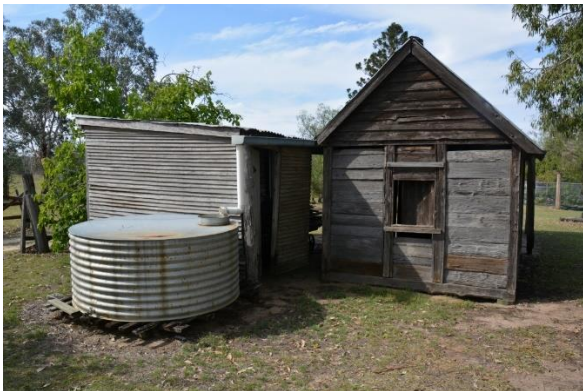
Figure 171. The rear south-west elevation of the postal receiving office, showing the adjacent carport skillion-roof extension and water tank.

In the 1950s, two extensions were constructed, a skillion-roofed awning, and a carport, both of bush carpentry construction and with a corrugated iron roof. The carport is currently being used as a storage space for salvaged timbers.

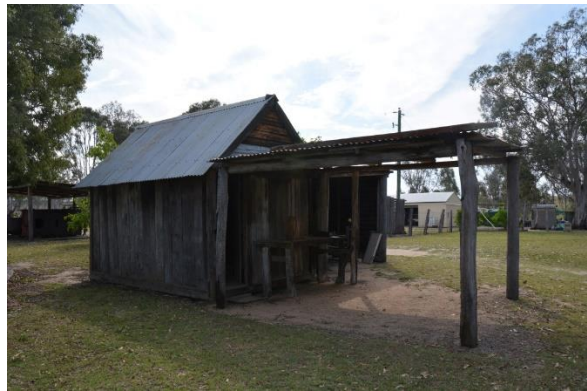
Figure 172. The south-east elevation of the postal receiving office, showing the c.1950s skillion awning attached to the front.

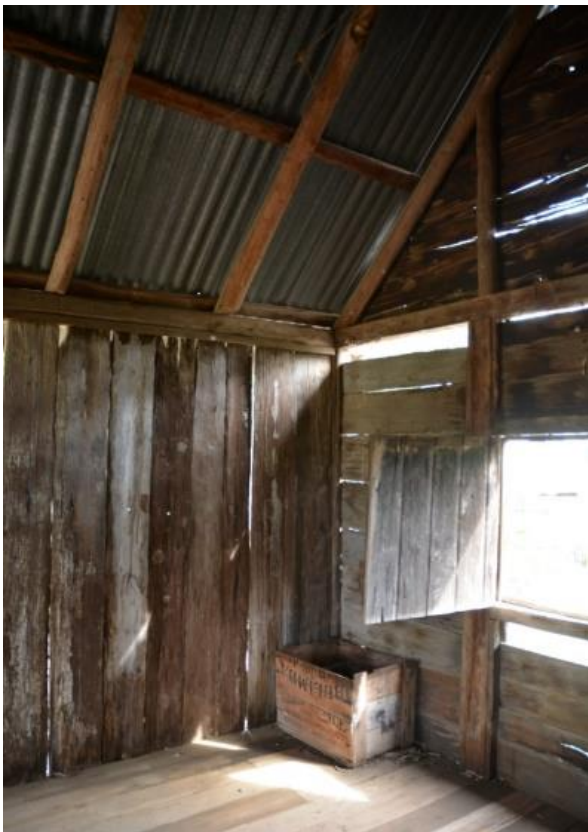
Figure 173. Interior of the postal receiving office, showing the timber slab case window in the rear elevation.

*Note the left wall is clad in vertically-fitted timber slabs, compared to the use of horizontally-fitted timber slabs on the right wall.*

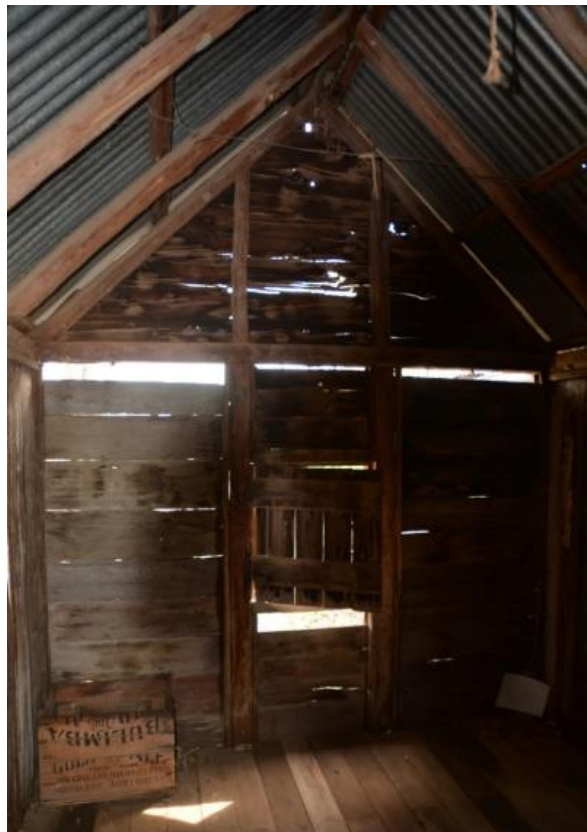
Figure 174. Interior of the postal receiving office with the timber casement window visible in the centre.

*Note the reconstructed timber floor.*

Internally, the post office is well-preserved as a result of having its floor reconstructed and being restumped in the early 2000s.

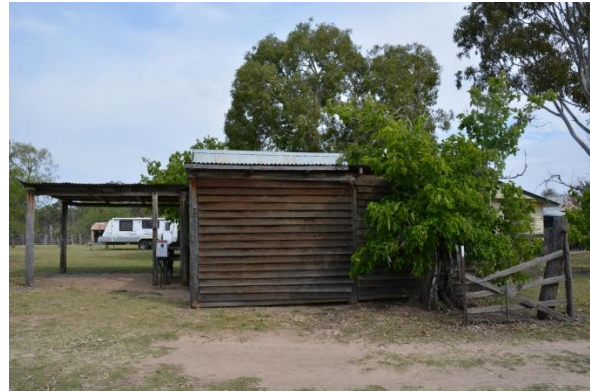
Figure 176. The north-west elevation of the postal receiving office, showing the thin chamferboards used in the c.1950s construction of the carport extension.

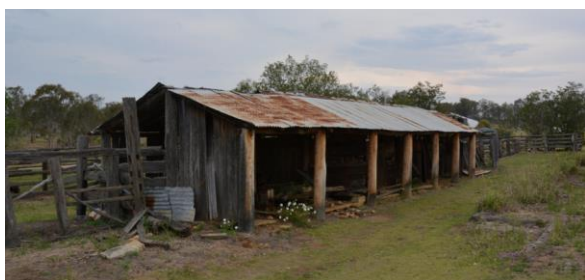
Figure 181. The north-west elevation of the milk bails structure.  
*Note the rough-sawn timber slabs, fitted vertically, that partially enclose the structure at this end and the timber posts supporting the structure.*

The milking bails structure is long and rectangular in plan with a gable roof clad in corrugated iron. The walls are clad in rough-sawn timber slabs, fitted vertically, which partially enclose the structure along its perimeter. Seven rows of three round timber posts support the structure. Internally, the milking bails structure is being used to store a range of equipment, tools, and timber pieces. Dilapidated timber slabs internally divide the structure along its length, creating individual stalls. Over the course of its use and adaptation, a substantial amount of fabric has been lost or damaged.

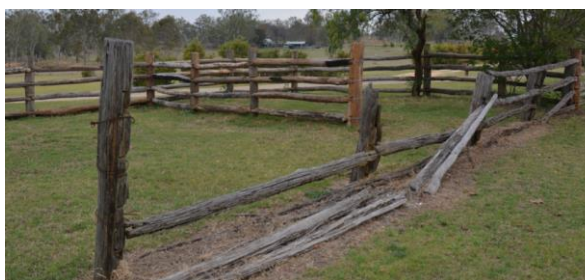
Figure 182. View facing south-west from showing the combination of dilapidated timber posts and rails comprising the former stockyards and recently reinstated erect sections.

The former stockyards and cattle-loading dock, which is situated to south-west and south-east of the milking bails, presents as a combination of dilapidated timber posts and rails and recently reinstated, erect sections.

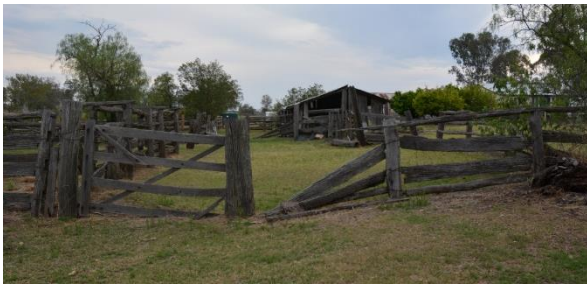
Figure 183. View facing south-west showing the dilapidated section of the stockyards and the milking bails structure behind.

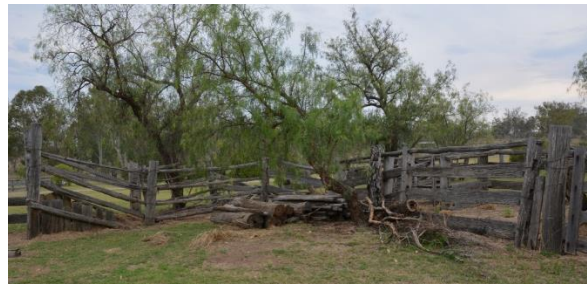
Figure 184. The dilapidated cattle-loading dock, which has a few pepperina plantings either side.

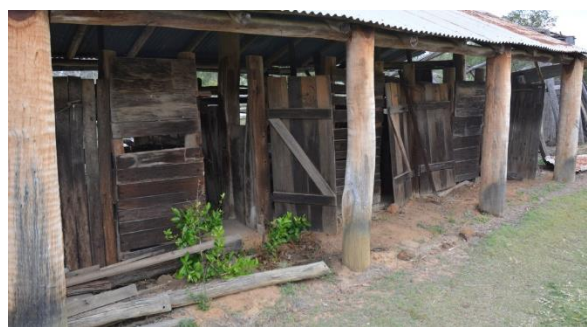
Figure 186. The timber slab doors that divide the milking bails structure internally to create individual stalls.

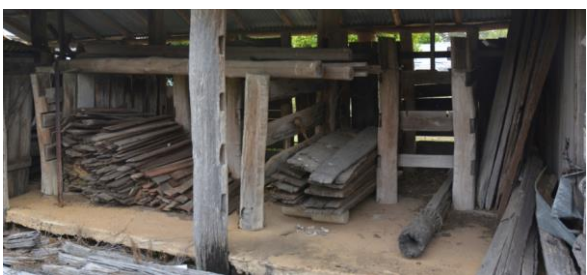
Figure 187. Typical interior view of the milking bails structure, which is not readily accessible due to the use of the structure for storage of timber.

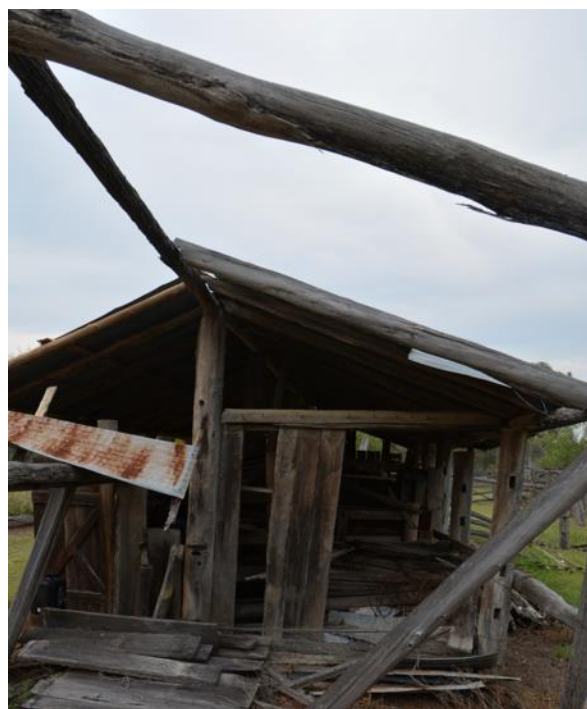
Figure 188. The north-eastern end of the milking bails structure, which is substantially deteriorated.

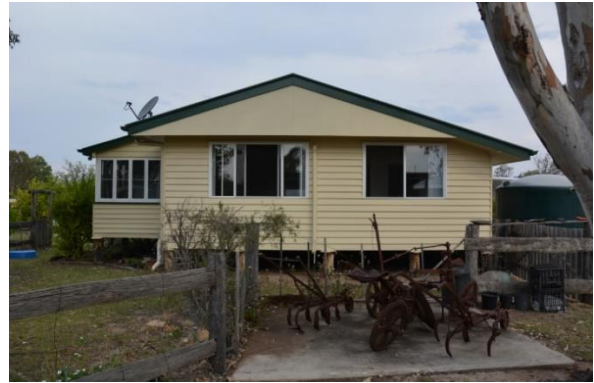
Figure 192. The south-west elevation of the caretaker's cottage.

*Note the contemporary aluminium-framed windows on this elevation.*

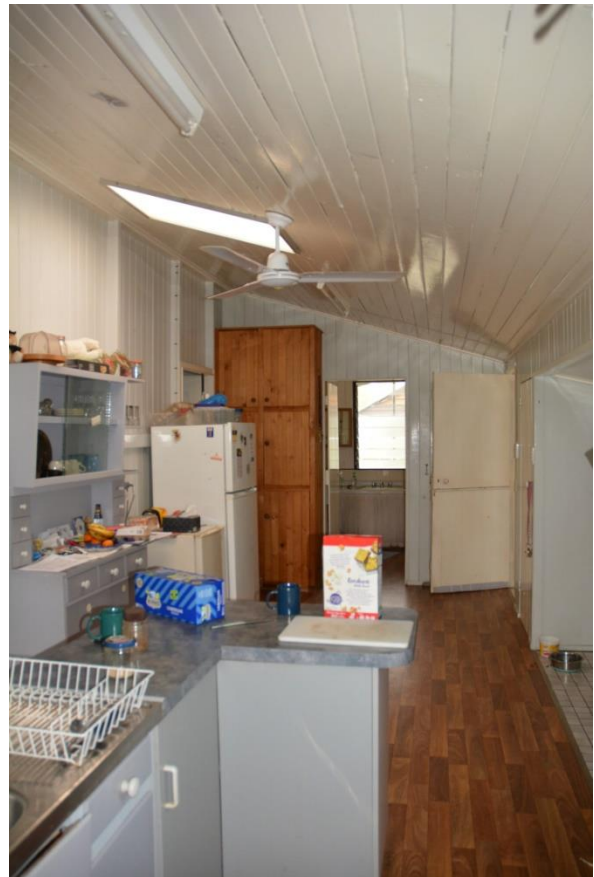
Figure 194. Internal view of the caretaker's cottage.

*Note the VJ-lined walls and ceilings and exposed internal stud typical of worker cottage construction.*

Internally, the cottage features VJ-lined walls and ceilings, and the internal timber studs are exposed. Contemporary timber flooring has been installed since its relocation.

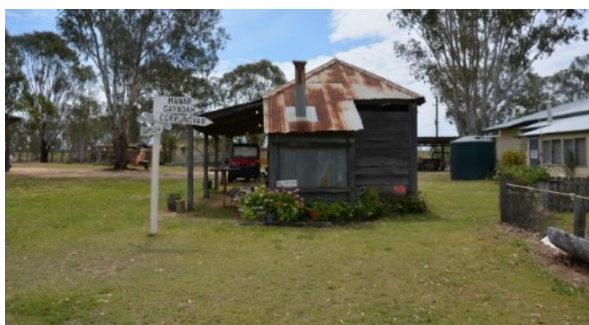
Figure 201. The south-east elevation of Brownie’s hut.  
*Note the fireplace/stove skillion extension.*

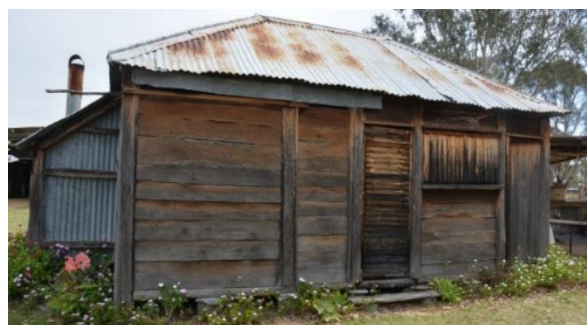
Figure 202. The north-east elevation of Brownie’s hut.  
*Note the wide timber weatherboard slabs, fitted horizontally.*

The building is constructed with traditional bush carpentry techniques using rough-sawn, square timber posts and wide timber weatherboard slabs. It has a hipped and gable roof with a fireplace/stove skillion extension on the south-east elevation. A verandah skillion extension has been constructed on the main south-west elevation. The building features two doors constructed from thin timber boards, horizontally fixed, on the south-west and north-east elevations. Internally, a horizontal timber board wall divides the space into two. The interior spaces contain displayed historical items, tools, and equipment relevant to the domestic life of the area in the early twentieth century. Two windows with a top-hung timber shutter are located adjacent to the doors. Two windows with a top-hung timber shutter are located adjacent to the doors.

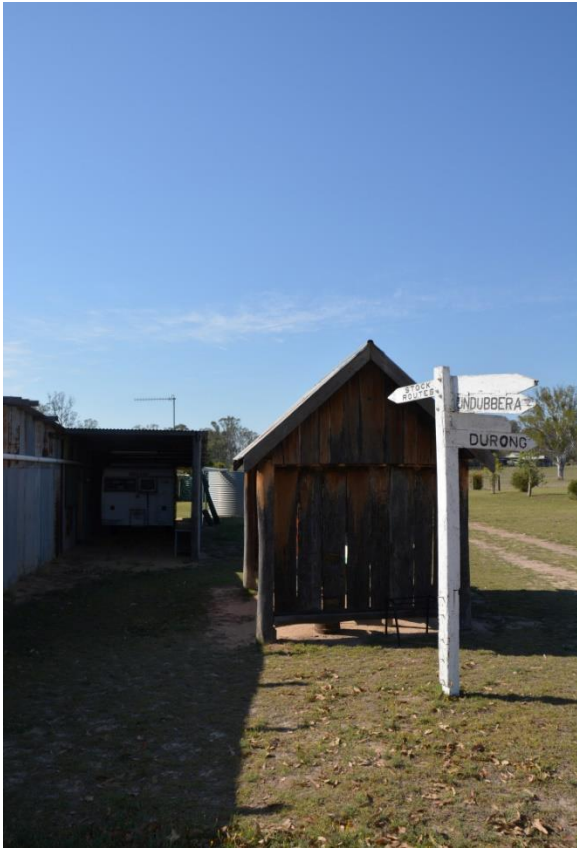
Figure 206. The south-west elevation of the DPI shelter, showing the remnant timber post of the cattle dip installed herein 2006 known as 'Stockie's Stump'.

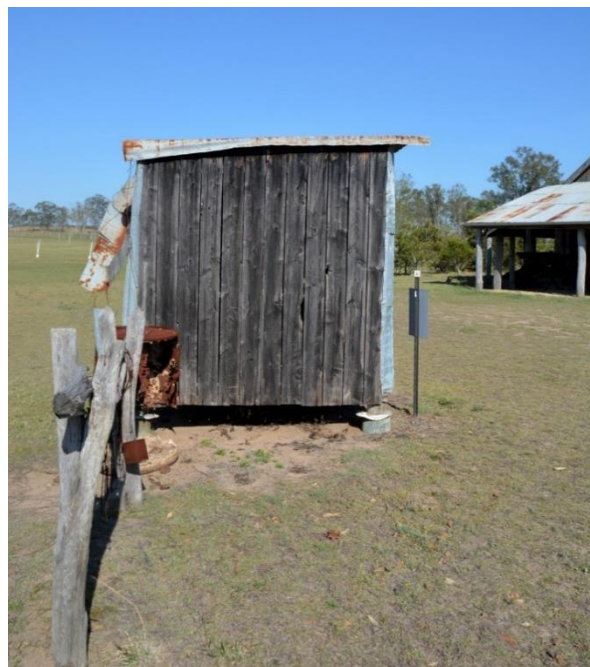
Figure 210. The eastern elevation of the boundary rider's hut, with the stone store building partially visible at the right.

*Note the rusted water barrel and make-shift guttering attached to the structure.*

In 1999, the structure was relocated to Boondooma and re-stumped upon arrival. The hut comprises a combination of corrugated iron sheets and thin timber boards, vertically fitted. Located immediately adjacent to the south-east corner of the hut is the rusted remains of a barrel and make–shift guttering; these items were retained when the hut was relocated from Delgar to Boondooma.

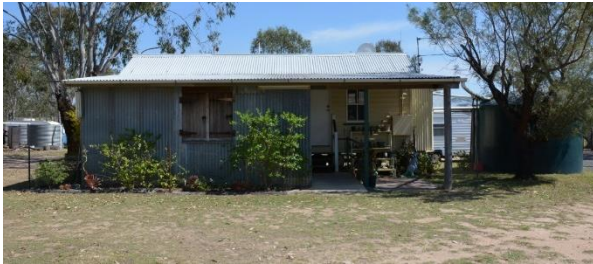
Figure 213. The main south-eastern elevation of the administration building.

*Note the partially enclosed skillion extension at the left of the main entrance.*

A corrugated iron skillion extension has been constructed on the main south-east-facing elevation, and it is partially enclosed. This extension is used for storage of supplies and other office materials associated with the operations of the Boondooma Museum & Heritage Association. The open section of the extension frames the entrance to the building, leading to a timber stair that provides entry to the interior. Internally, the building has been divided to accommodate an administration office in the eastern end and a dark room in the western end.

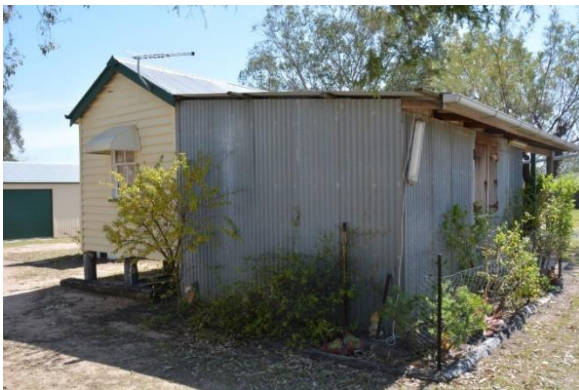
Figure 215. The south-eastern corner of the administration building, showing the corrugated iron skillion extension.

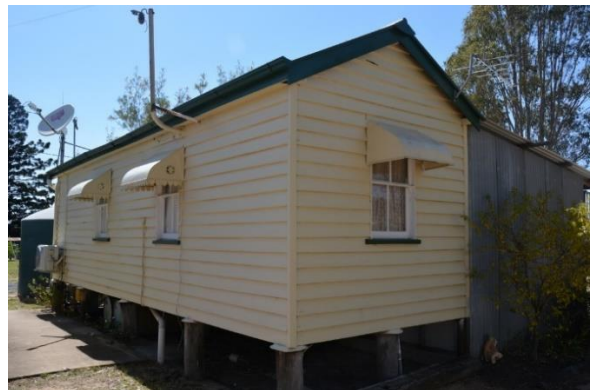
Figure 216. The south-western corner of the administration building.

*Note the single sash windows with decorative-cut, galvanised iron hoods.*

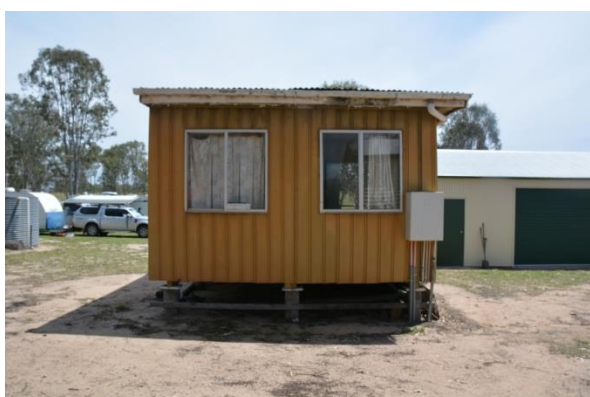
Figure 217. The north-eastern elevation of the archives building.

*Note the two aluminium-framed sliding windows.*

Externally, the building appears in a makeshift manner, with an area of timber stud framing exposed and a patchwork of cladding sheets. Internally, the building is clad in fibrous sheeting (possibly asbestos) and has five aluminium-framed sliding windows.

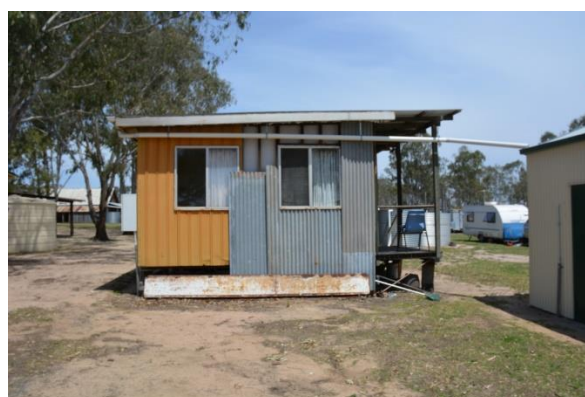
Figure 218. The north-eastern elevation of the archives building.

*Note the different corrugated iron sheeting, which creates a patchwork effect.*

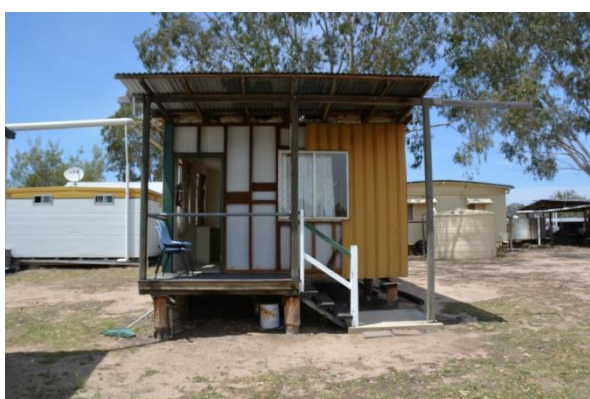
Figure 219. The main north-western elevation of the archives building, showing the external timber stair and landing.

*Note the exposed timber stud framing visible on this elevation.*

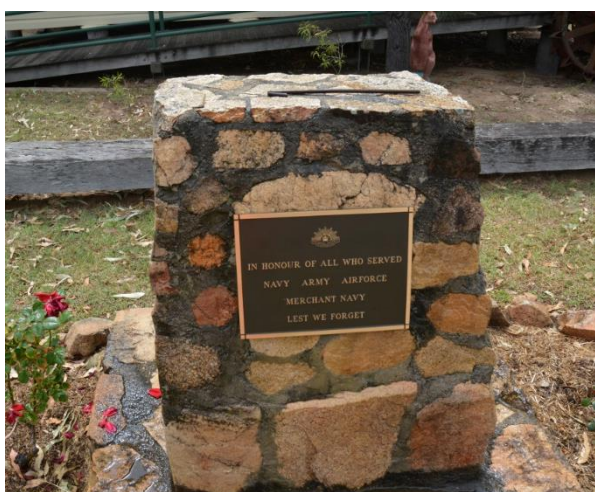
Figure 221. The shaped, commemorative stone cairn forming part of the site's ANZAC memorial.

The ANZAC memorial is provided in two components, the earlier existing consisting of a bronze plaque fixed to the sloped face of a shaped, commemorative stone cairn. The stone cairn is set on a small stone-paved pad, edged with small stones creating a small garden bed. Three flagpoles are set behind providing a back drop. This part of the memorial installation is located in front of the south-east elevation of the museum building.

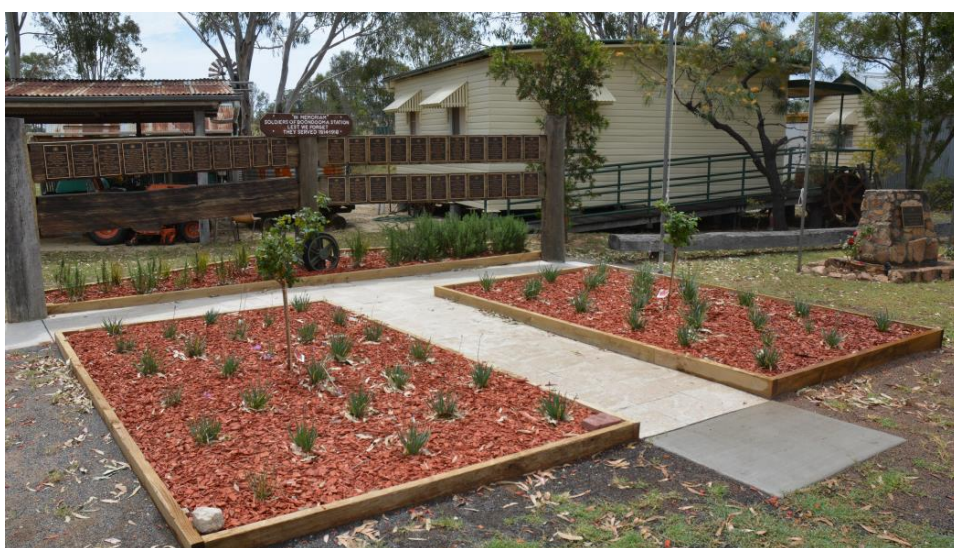
Figure 223. The more recent memorial installation comprising a contemporary timber post-and-rail frame with individual plaques for service personnel associated with Boondooma station and district. *Note the museum building behind to the north-west.*

Immediately adjacent to the south-west is a more recent memorial installation, a contemporary timber post-and-rail frame with individual plaques for service personnel associated with Boondooma station and district. This is set in a landscaped garden bed, edged with timber boards and divided by a T-shaped concrete path.

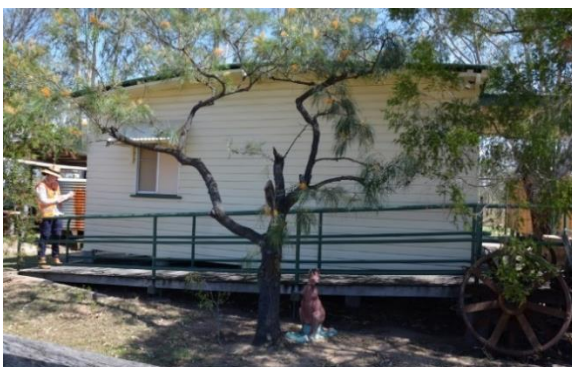
Figure 226. The south-eastern elevation of the museum building, showing timber-framed ramp providing disabled access.

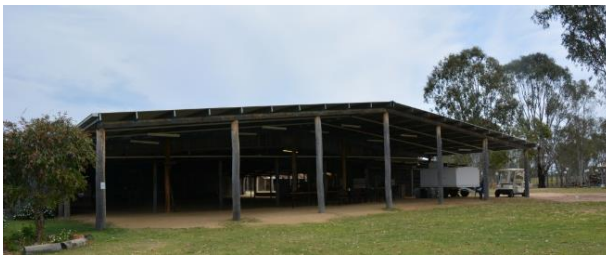
Figure 228. The north-eastern elevation of the ‘Big Top’ extension.

The full width of the main roof of the ‘Big Top’ was extended on its north-eastern gable during the late 2000s. This extension is rectangular in plan and supported on tall timber log posts. The roof is framed in substantial steel purlins and clad with corrugated galvanised iron sheeting.

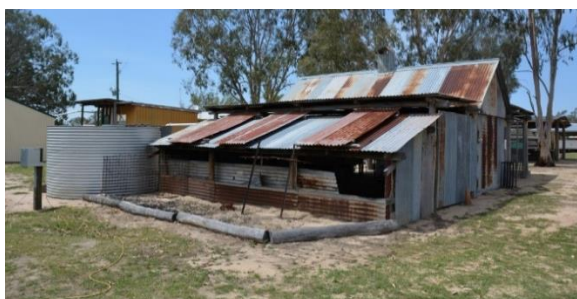
Figure 246. The north-western elevation of the camp kitchen.

*Note the enclosed skillion extension on this elevation.*

The camp kitchen is of recent construction and is located to the rear of the museum building, adjacent to the footprint of the former blacksmith shop. This makeshift building presents as a slim corrugated iron shed set on a concrete slab, with timber bush carpentry framing and a gable roof form. Two skillion roof extensions have been constructed to the north-west and south-east elevations, with the former skillion being entirely enclosed. Re-purposed corrugated galvanised iron sheeting encloses the rest of the structure, whilst the south-east elevation is enclosed with a permeable contemporary steel grill fence and gate. Two large water tanks are positioned on the north-eastern corner of the building. Internally, the building is divided into a cooking area and a preparation area, and contains several cooking appliances that appear disused. It is provided for use by campers and persons staying in caravans on the premises.

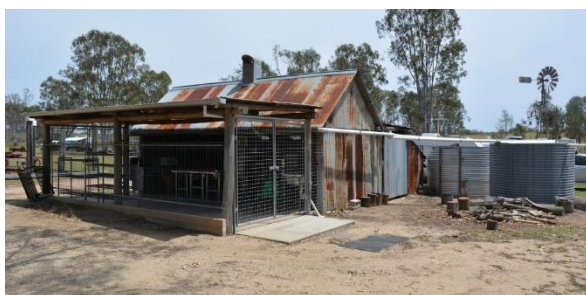
Figure 247. The south-eastern elevation of the camp kitchen.

*Note the skillion extension.*

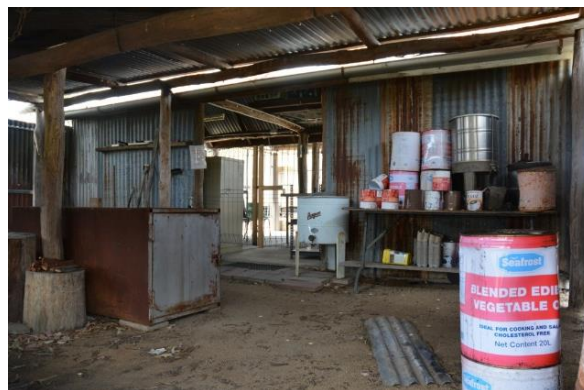
Figure 248. Interior of the rear north-west enclosed skillion extension attached to the camp kitchen.

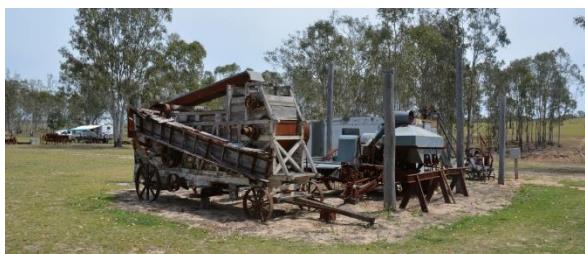
The former machinery shed is believed to have been located in the western aspect of the site, between the former blacksmith's shop and the dam. The location of the former shed is today evidenced by a series of tall, contemporary timber posts that have been re-erected in recent decades to show where the structure once stood. Within the boundary of these posts, several machinery pieces and farming equipment items are on display.

Figure 250. The south-eastern corner of the former machinery shed, with contemporary timber posts re-erected in recent decades to show where the structure once stood.

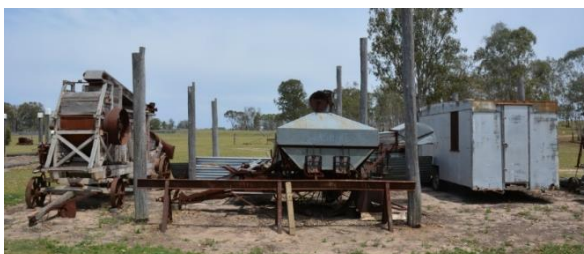
Figure 251. The north-eastern side of the former machinery shed, which now contains a display of machinery pieces within a series of timber posts.

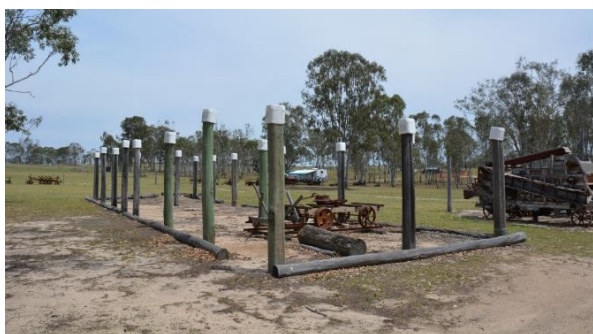
The former blacksmith's shop is believed to have been located short distance to the north-west of the stone store building, in the rear western aspect of the site. The location of the former shed is today evidenced by a series of tall, contemporary timber posts and bearers that have been re-erected in recent decades to show where the structure once stood.

Figure 254. The south-eastern corner of the former blacksmith's shop, with contemporary timber posts and bearers re-erected in recent decades to show where the structure once stood.

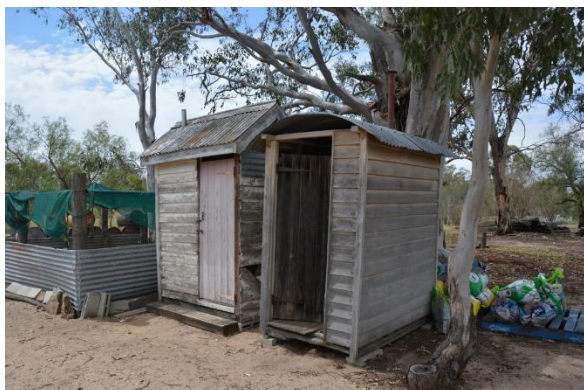
A chicken coop of recent construction and two, dilapidated timber outhouses are positioned north of the cool house and original homestead (former) or 'dining room' structure, under the shade of a large tree. The outhouses are currently used for storage and the chicken coop is maintained by the resident caretaker

Figure 258. The two timber outhouses.

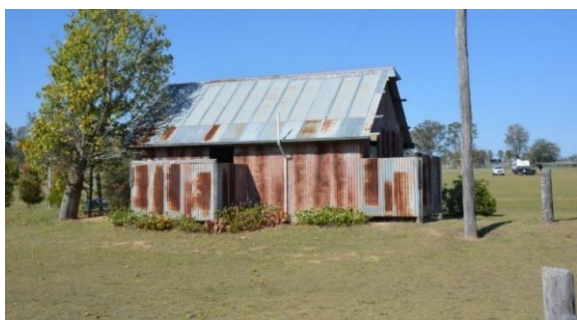
Both blocks are constructed of repurposed, rusted corrugated iron sheeting as a single skin with exposed timber framing internally. A timber-framed and corrugated iron-clad fence screens the entrance to the amenities. Both blocks feature modern amenities internally and are divided internally to create male and female toilets. One toilet block is located adjacent to the eastern end of the 'Big Top' extension structure, while the other toilet block is located a short distance to the south-east of the stone store building.

Figure 262. The north-east elevation of the toilet block located a short distance to the south-east of the stone store building.

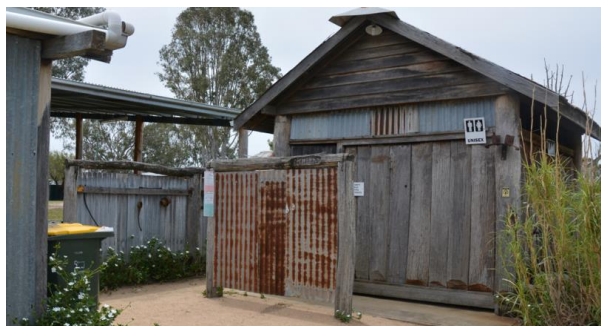
Figure 263. The south-west elevation of the toilet block located adjacent to the 'Big Top' extension.
