# Boondooma Homestead, 8262 Mundubbera–Durong Road Conservation Management Plan

Prepared for Boondooma Museum & Heritage Association Inc.

June 2022—FINAL

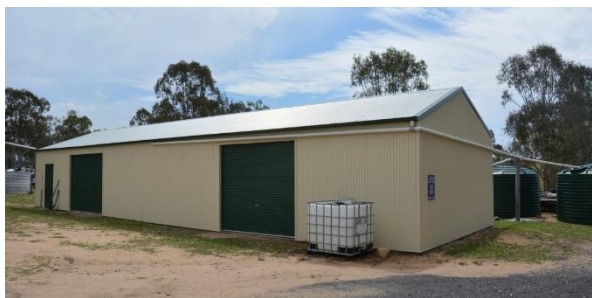
Figure 266. The south-east elevation of the shed.

*Note the two water tanks at the right.*

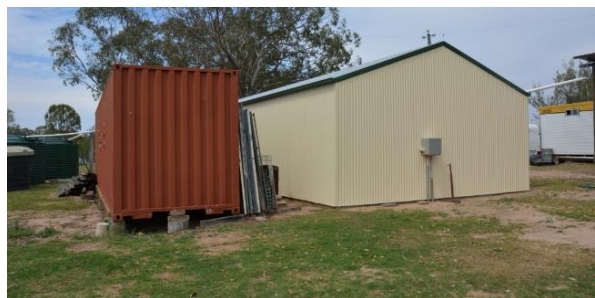
A collection of old machinery, miscellaneous equipment and a large shipping container is located immediately adjacent to the north-west elevation of the shed structure. Two large, plastic water tanks are positioned on the north-west corner.

Figure 267. The south-west elevation of the shed, showing the shipping contained installed adjacent at the rear.

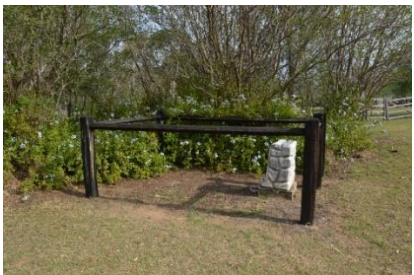
George Munro's headstone and fencing	<b>Poor</b>

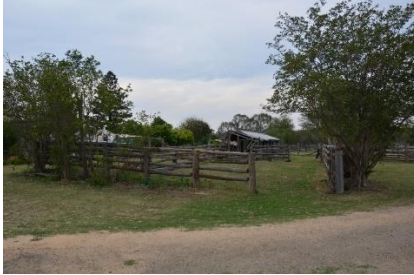
<i>Ancillary structures</i>		
Stockyards	<b>Poor</b>

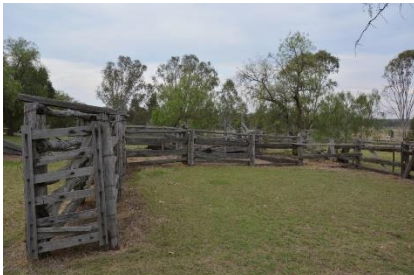
Milk bails	<b>Poor</b>

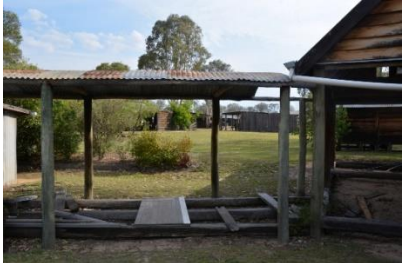
Element	Condition	Comment
Covered walkway	Fair–Poor

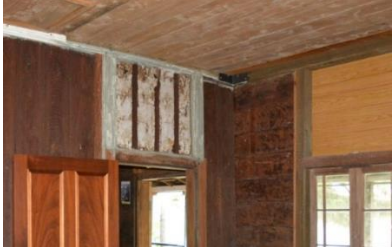
Surviving wallpaper and ceiling/backing material	Poor

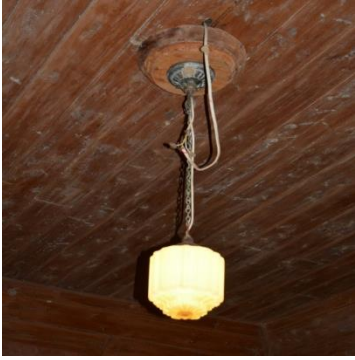
Lighting	Poor

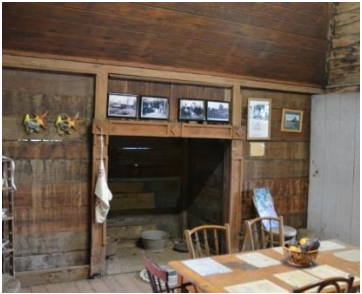
Fireplaces	Poor

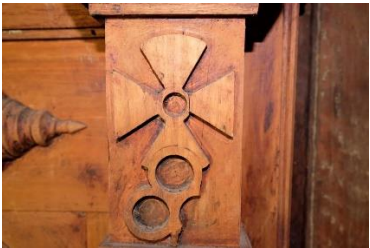
Timber joinery and mouldings	Variable Good–Poor

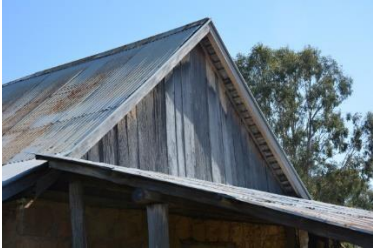
Element	Condition	Comment
Roof fabric: corrugated iron sheeting	Poor	 
Remnant timber shingles	Poor	 
Timber gable infill	Fair

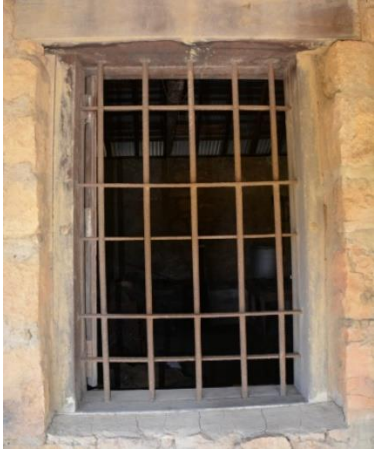
Element	Condition	Comment
Vertical iron window bars	Fair

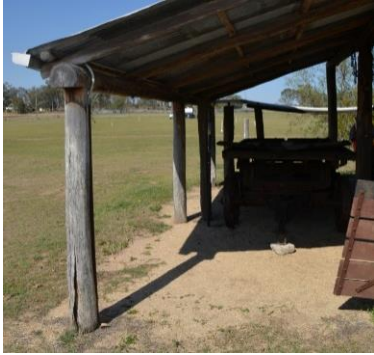
Remnant timber posts from former adjoining meat house	Poor

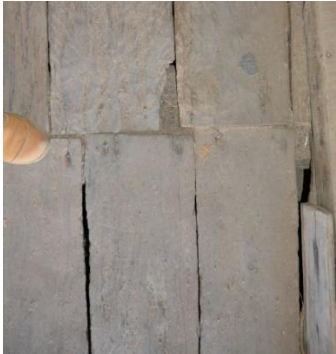
Element	Condition	Comment
<p>Timber flooring: wide, shot-edge hardwood boards</p>	<p><b>Poor</b></p>

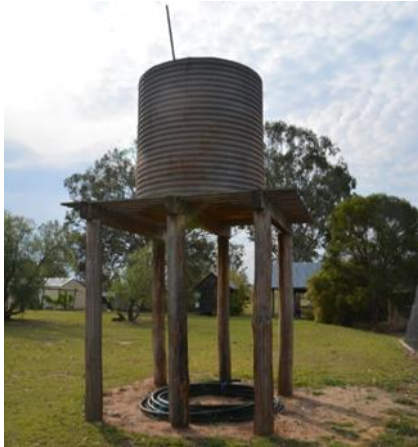
Element	Relative heritage significance	Image
Remnant timber shingles (preserved underneath sheeting)	<b>Exceptional</b>	 
Rainwater goods and replaced quad gutters	<b>Moderate</b>	 
Water tank and stand	<b>Moderate</b>

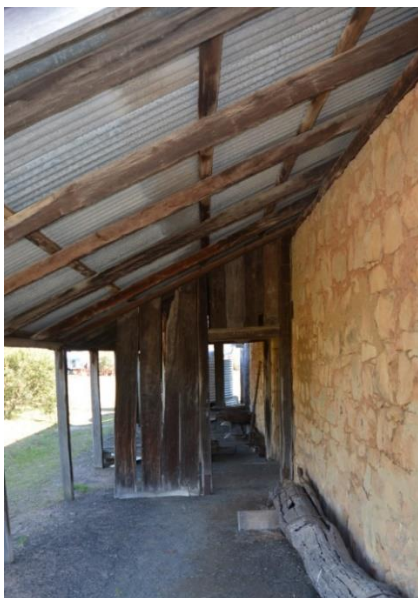
External walls: stone rubble joined together by termite mound mortar	<b>Exceptional</b>	 
Lean-to verandah additions: post and sapling-framed enclosed with timber slabs	<b>High</b>

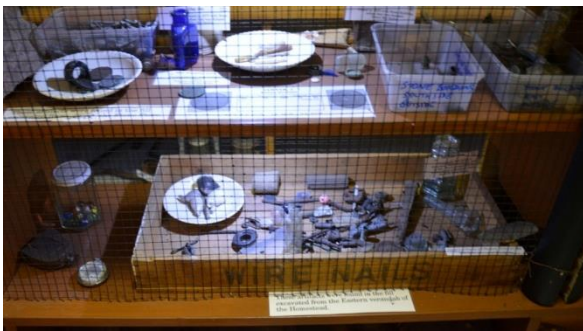
Figure 271. An example of the isolated historical artefacts currently displayed in the Boondooma Homestead's on-site museum building, reputedly recovered from fill excavated out from under the stone building and main homestead during restoration works. *Source:* Boondooma Museum & Heritage Association (2021).

In addition, a number of historical artefacts have been found over time during restoration works to the stone building and main homestead, particularly from the fill excavated out from these structures. To date, this has predominantly isolated domestic items found out of context (e.g. weight measures, glass bottles, currency, metal, ceramic and glass fragments, etc.) and not as part of any formal archaeological investigation. Nonetheless, their presence attests to the potential for surviving isolated historical artefacts associated with the early domestic activities of the homestead. These items are currently on display on-site in the museum building with minimal interpretation.

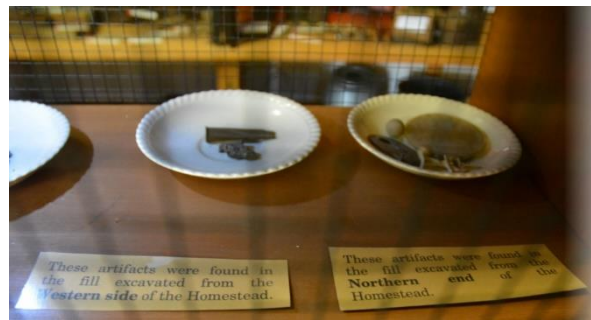
Figure 272. An example of the isolated historical artefacts currently displayed in the Boondooma Homestead's on-site museum building, reputedly recovered from fill excavated out from under the stone building and main homestead during restoration works. *Source:* Boondooma Museum & Heritage Association (2021).

- isolated historical artefacts: over the course of Boondooma’s history of use, numerous artefacts will likely have been dropped and discarded (as evidenced by the finds recovered ad-hoc to date from underneath the stone store and main homestead); these artefacts are often found on or close to the surface, but otherwise out of context;
