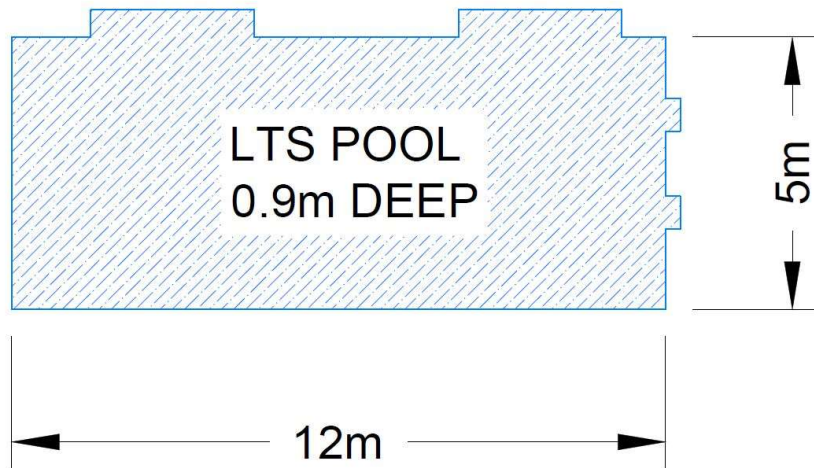
Exposed Roof Trusses.

Leaks from the pool are visible at the panel joints. The pool is in a sheet metal enclosure (shed) with exposed trusses.
